3.2 Images of Change: Africa's Lakes

Africa's Killer Lakes

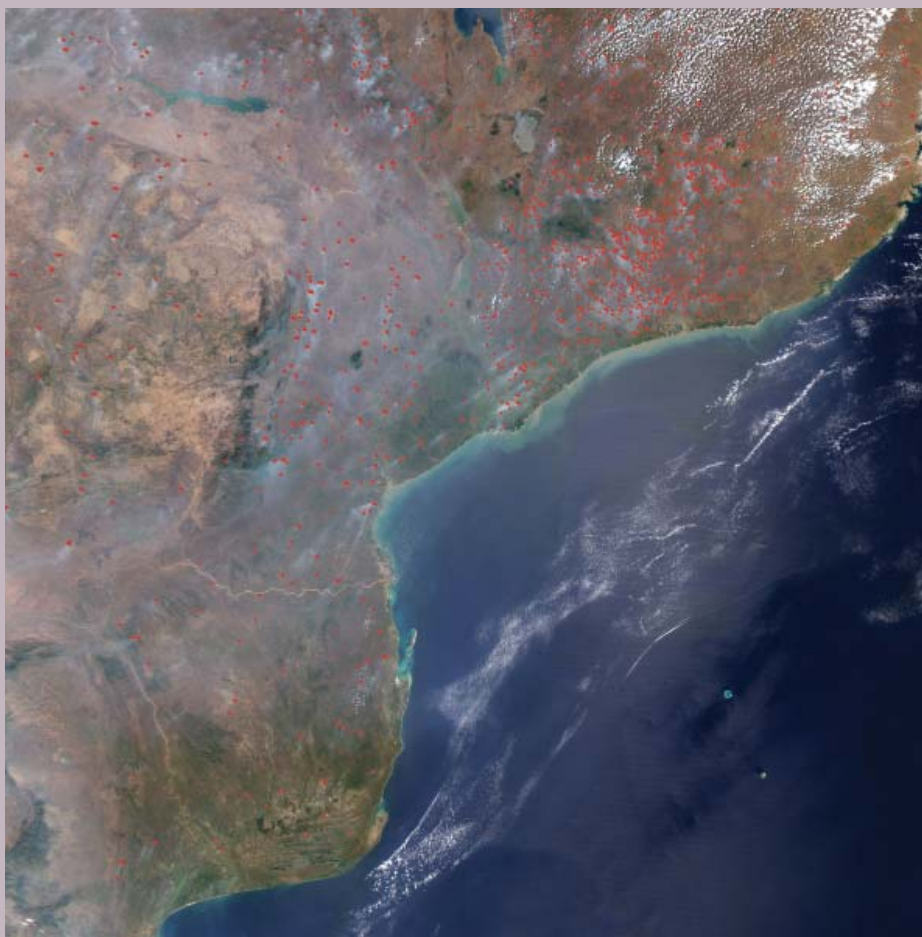
This image of southeastern Africa, acquired on 25 September 2004, shows scores of fires burning in Mozambique south of Lake Malawi, whose southern tip is at the top center of the image. Active fire detections are marked in red. The fires created a layer of smoke that darkened the surface of the land beneath it. At upper left in the image, the turquoise-colored body of water is the Lake Cahora Basa, created by a dam on the Zambezi River just inside Mozambique after the river leaves its course along the border of Zambia and Zimbabwe (NASA 2004).

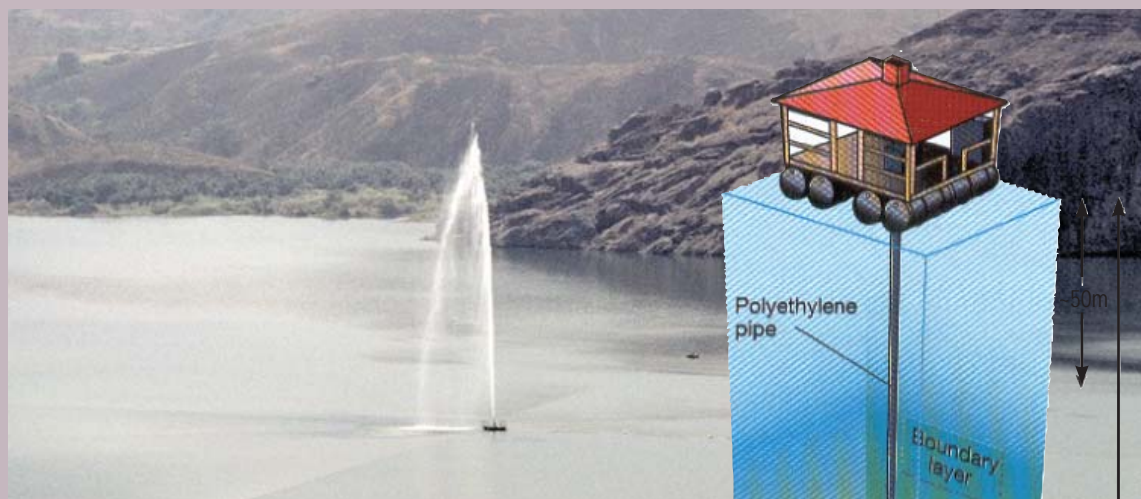
French scientists degassing Lake Nyos.

earnest. The procedure involves lowering a strong polyethylene pipe to the lake bottom. Some water is pumped out at the top, and as the deep water rises through the pipe the carbon dioxide starts to bubble out. The gas and water then become buoyant and suck more water in at the bottom in a self-sustaining process.

In 1995 an international team of scientists and engineers tested a procedure to degas the lower parts of Lakes Nyos and Monoun in a controlled way, and a team is now in the region to begin the project in

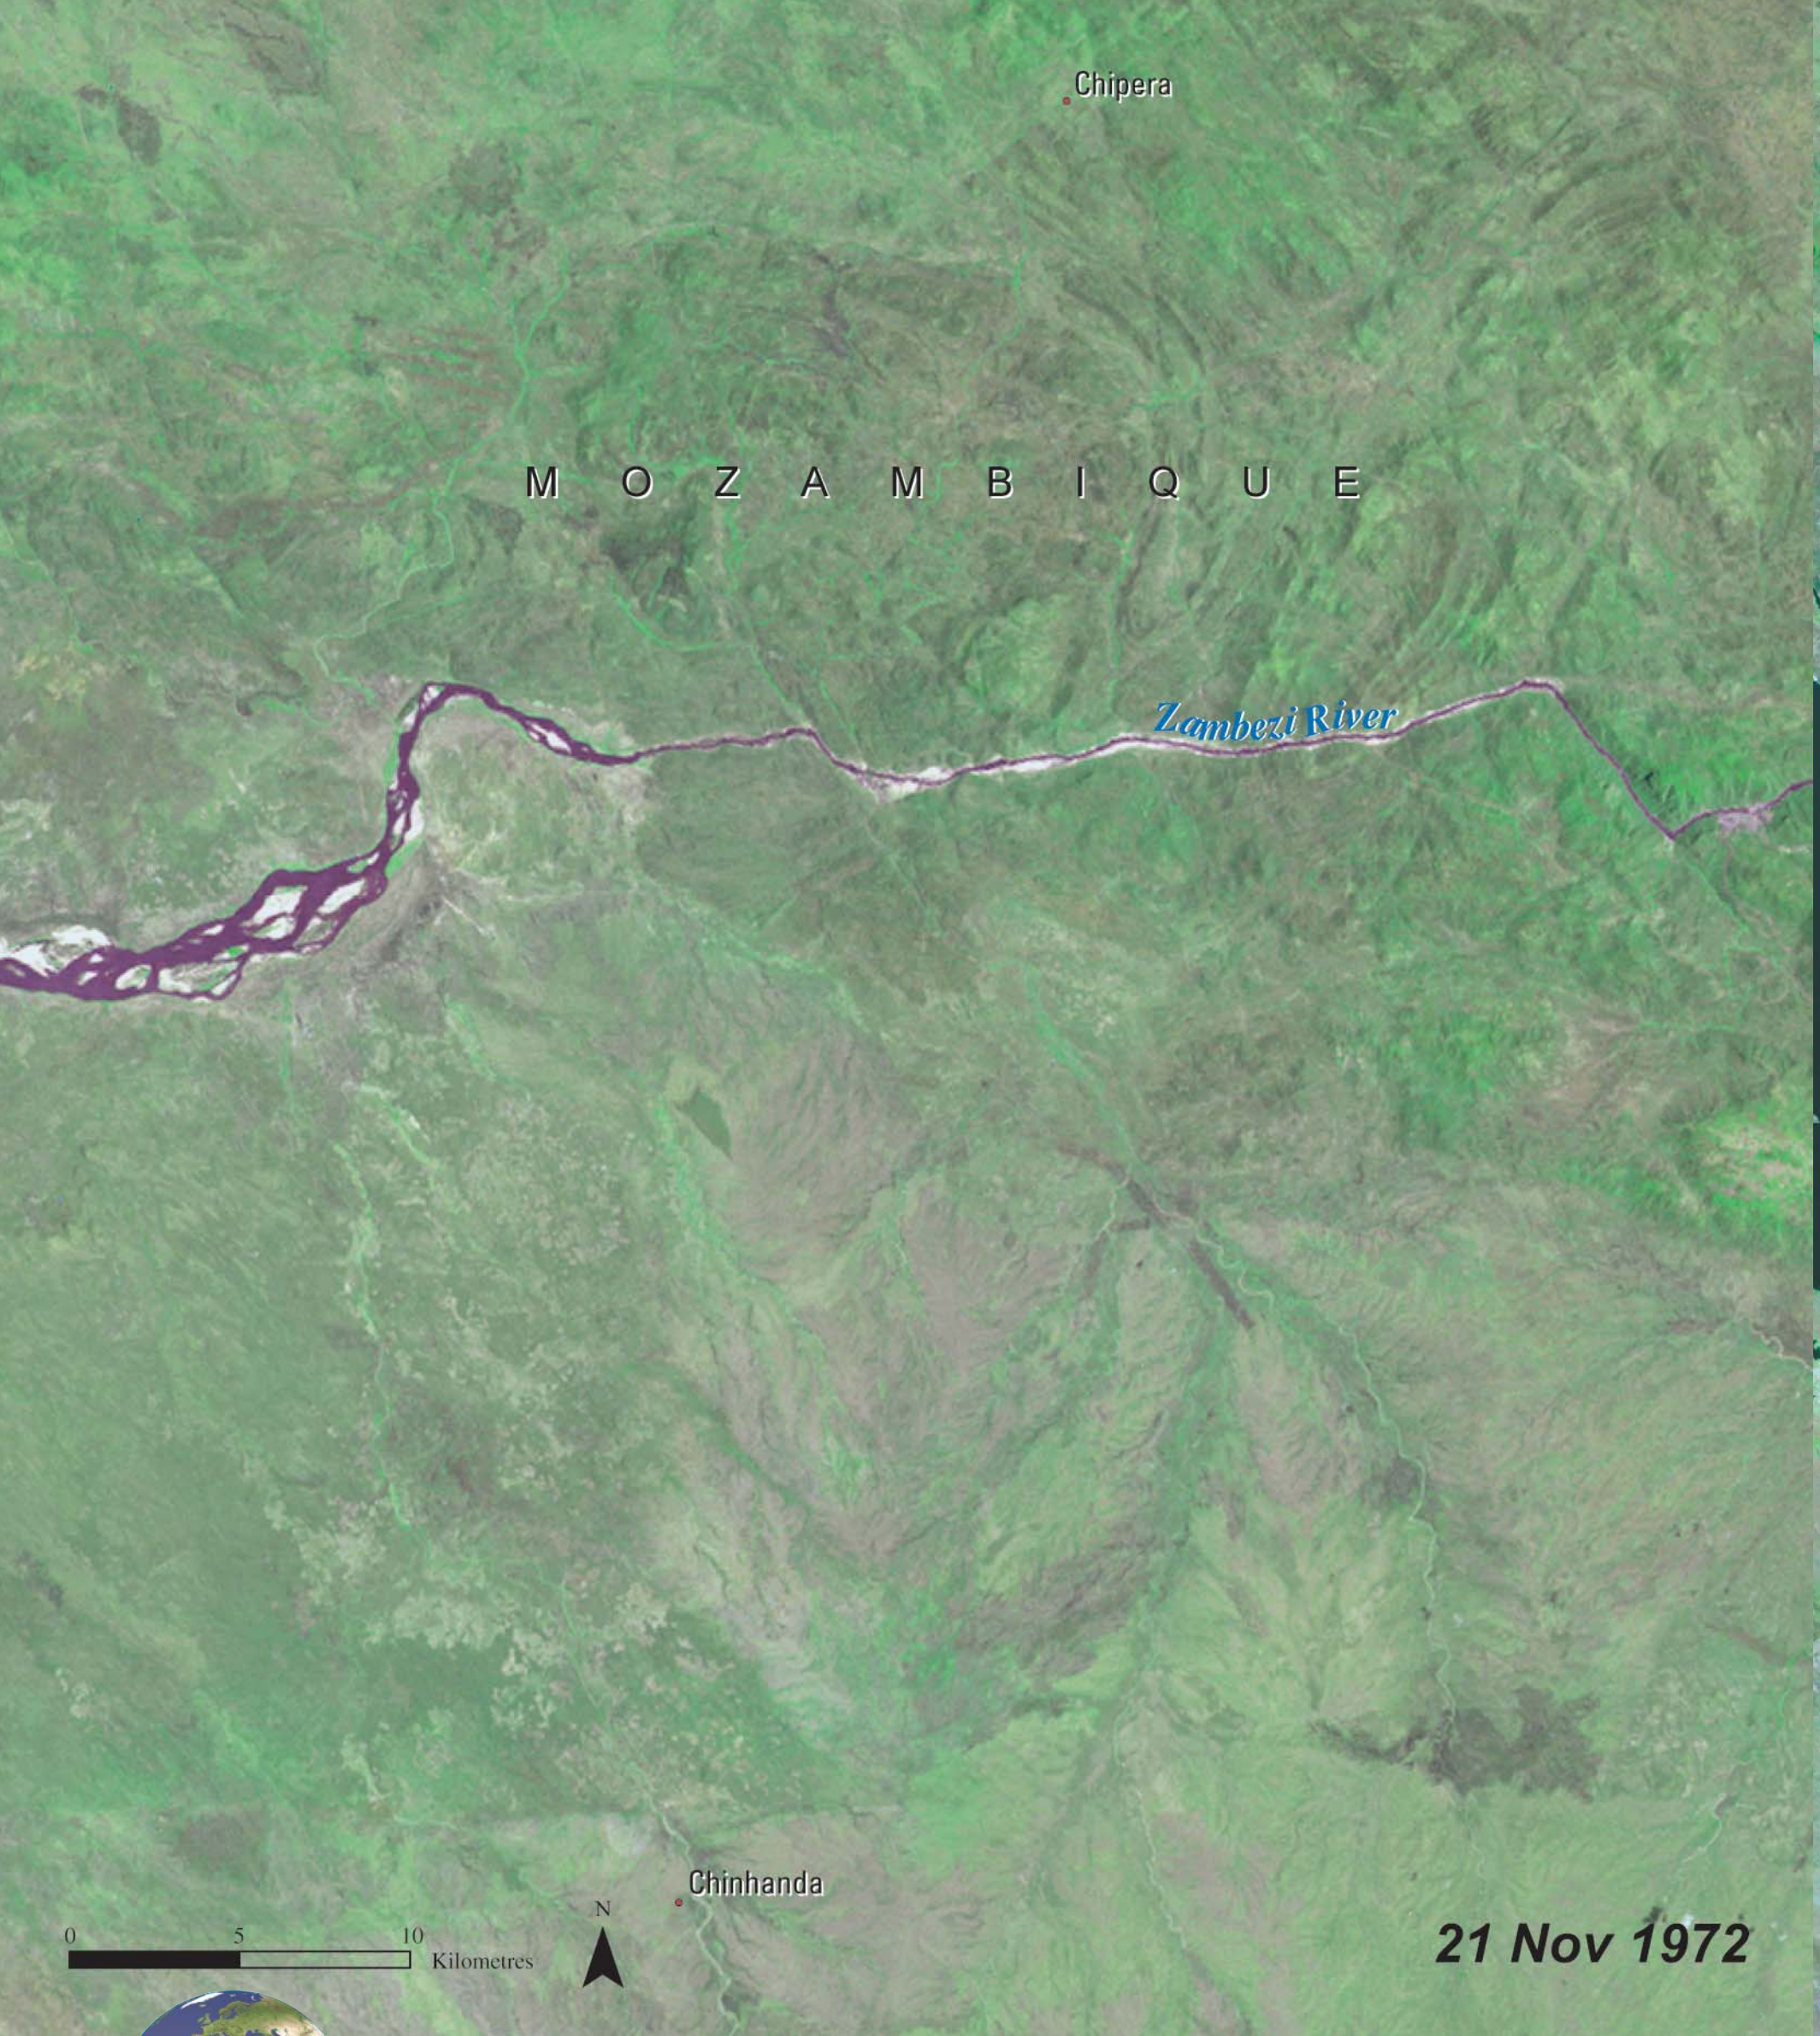
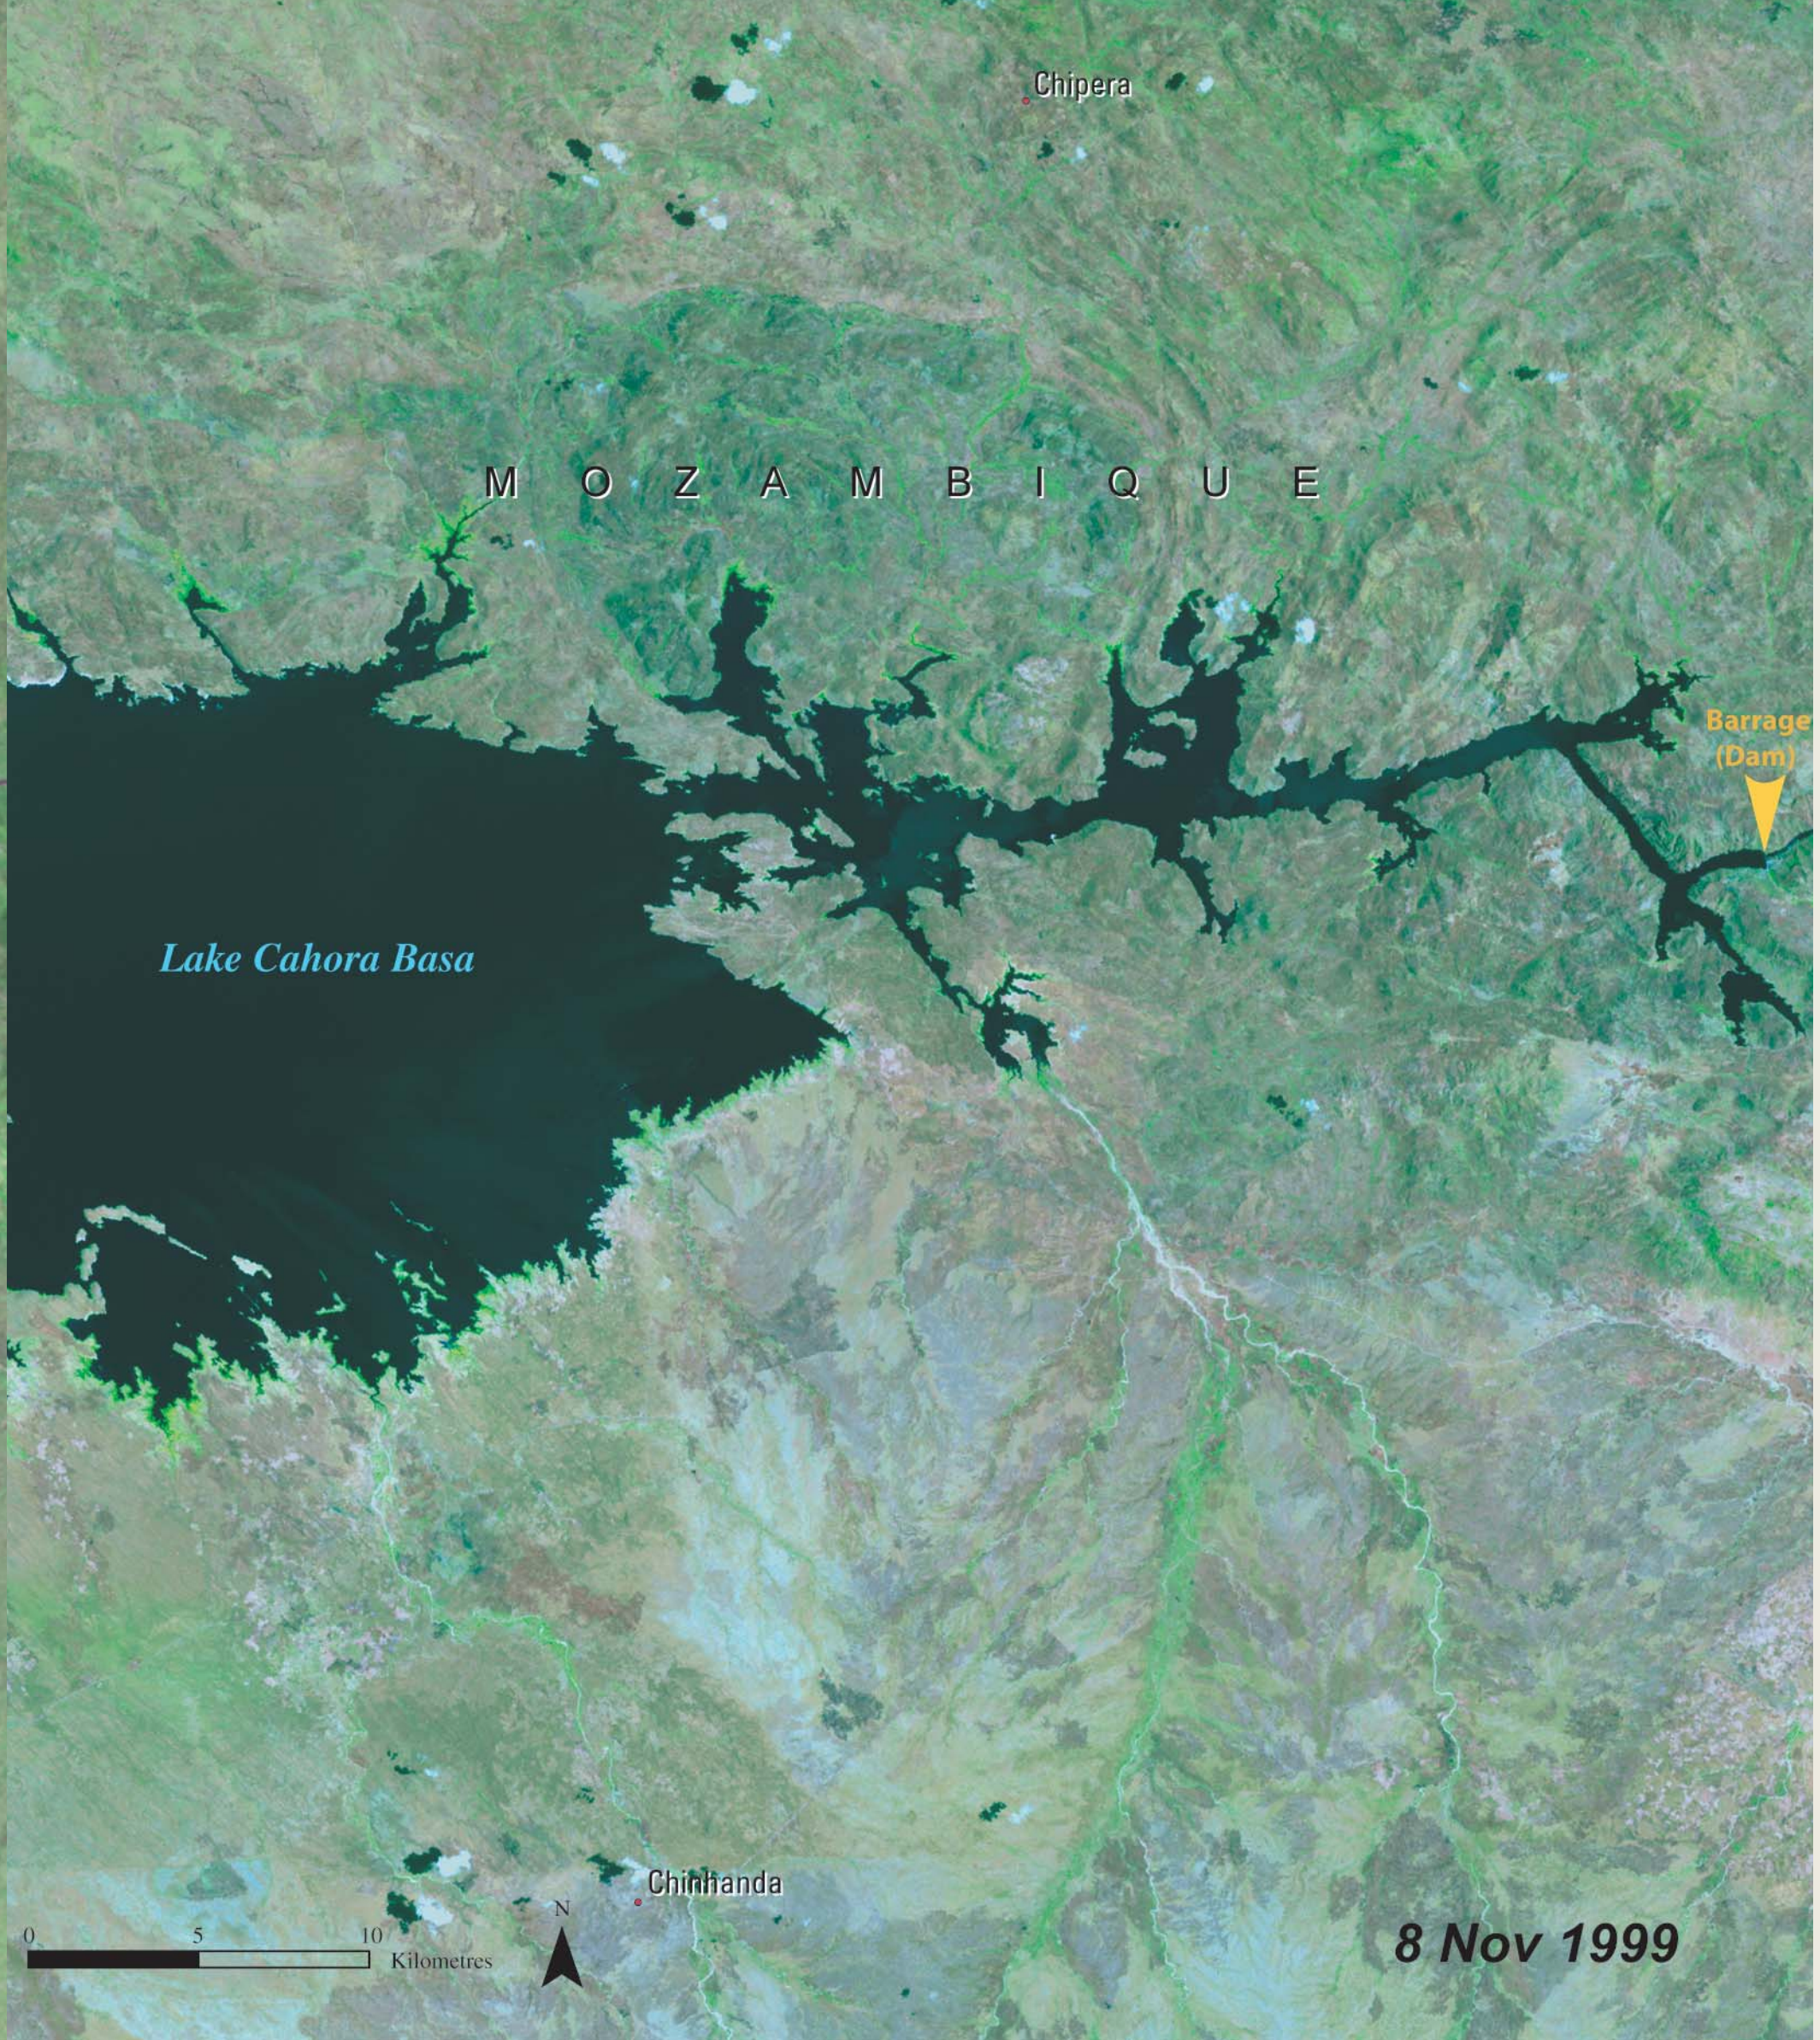
21 Nov 1972

Cahora Basa Reservoir in Tete Province of Mozambique is the site of the country's largest dam on the Zambezi River. These satellite images show spectacular changes in the Zambezi riverine system over the past three

decades. The 1972 image shows the Zambezi River a few years before the Cahora Basa Dam was constructed, while the 1999 image shows part of the enormous dam and the lake. The eastern/right tip of the river is visible in both images, entering into a narrow gorge, which provides an obvious location for a power-producing

barrage (dam) of this size. Although the construction of Cahora Basa was seen as a strategic move to meet the region's growing energy needs, it has also reduced the extent of annual flooding on the Zambezi River downstream—in turn reducing the size of the floodplains on which local communities grow their crops.
