Lake Cahora Basa

Challawa Gorge Reservoir

LAKE CHIVERO

LAKE DJOUDJ SENEGAL

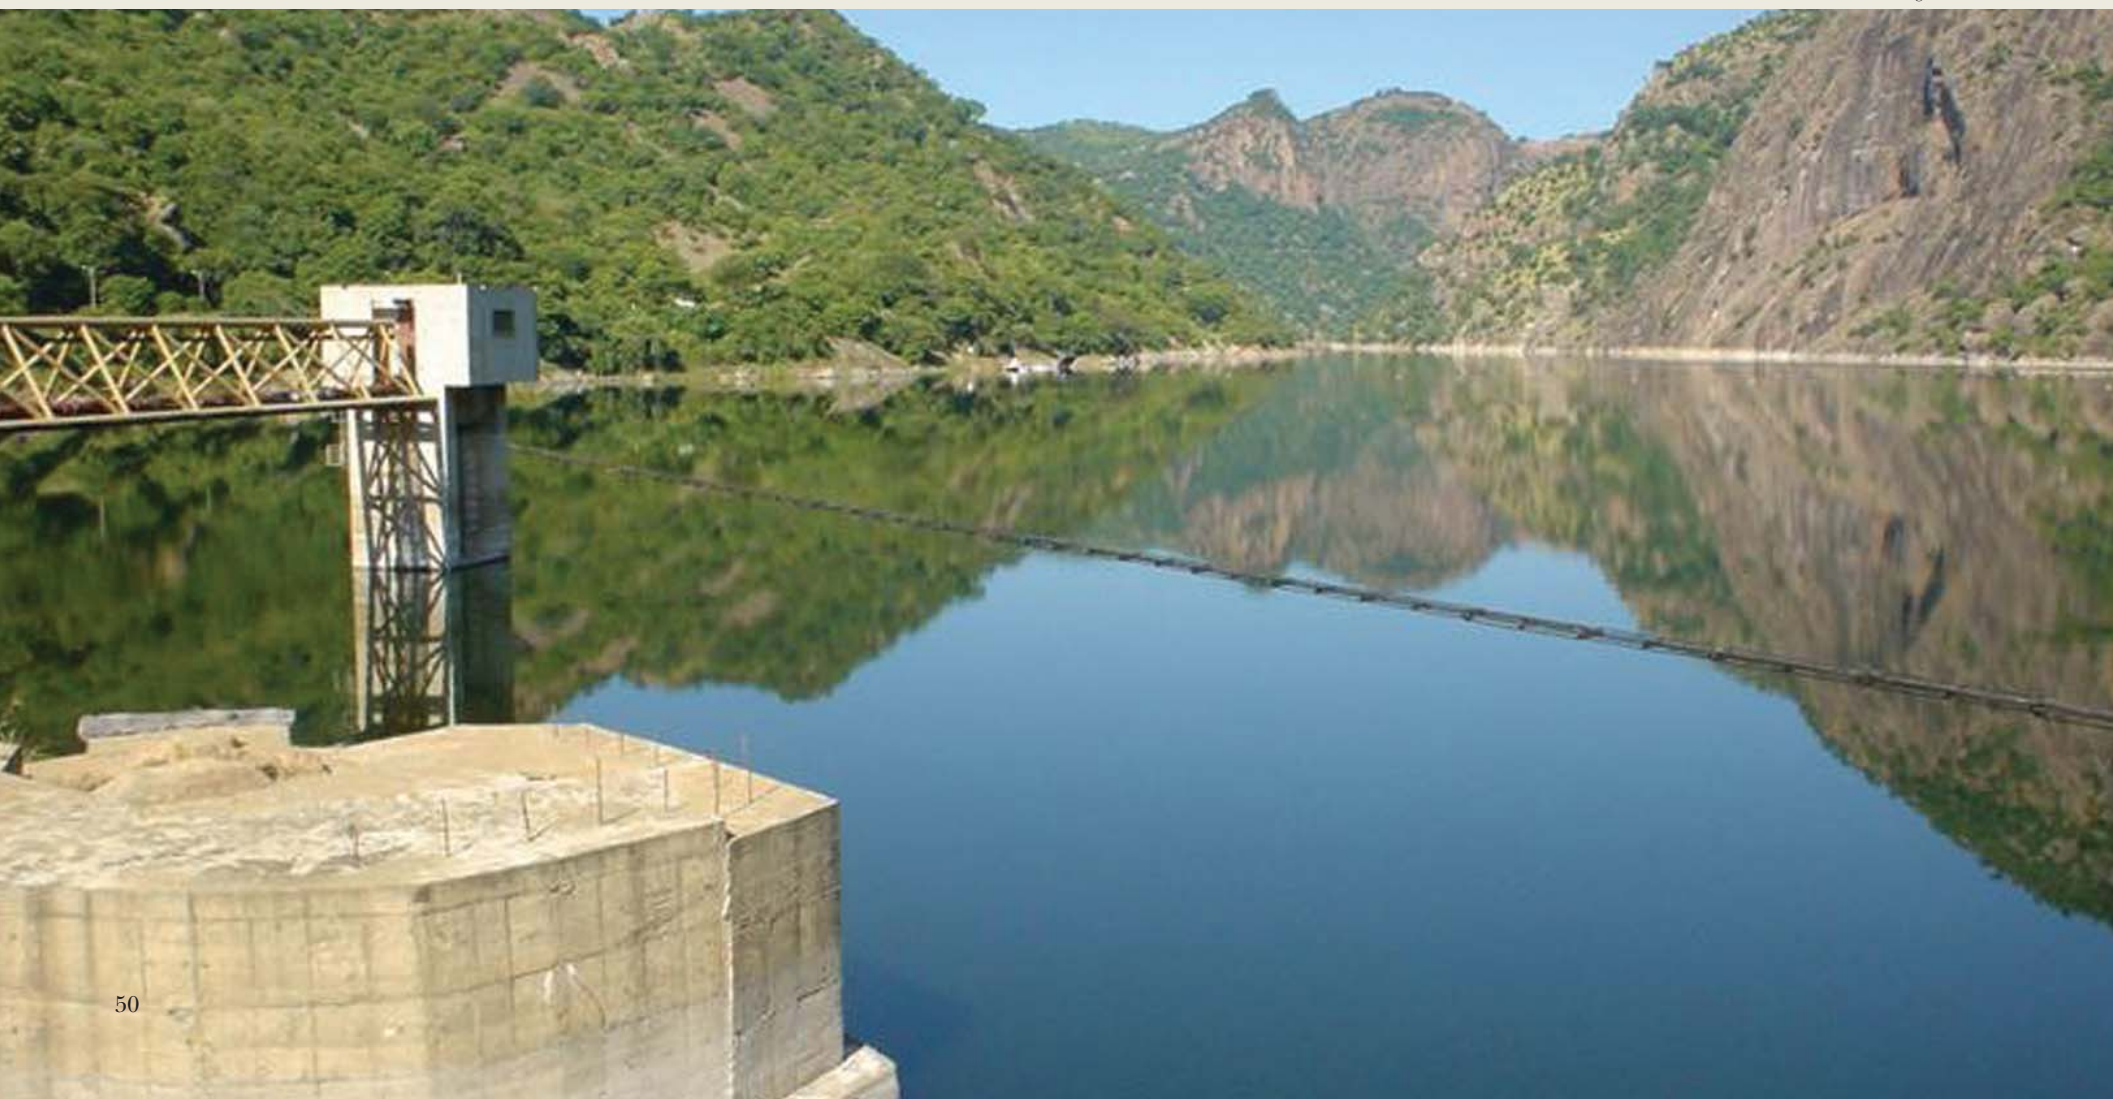
Reservoir behind the Cahora Basa Dam

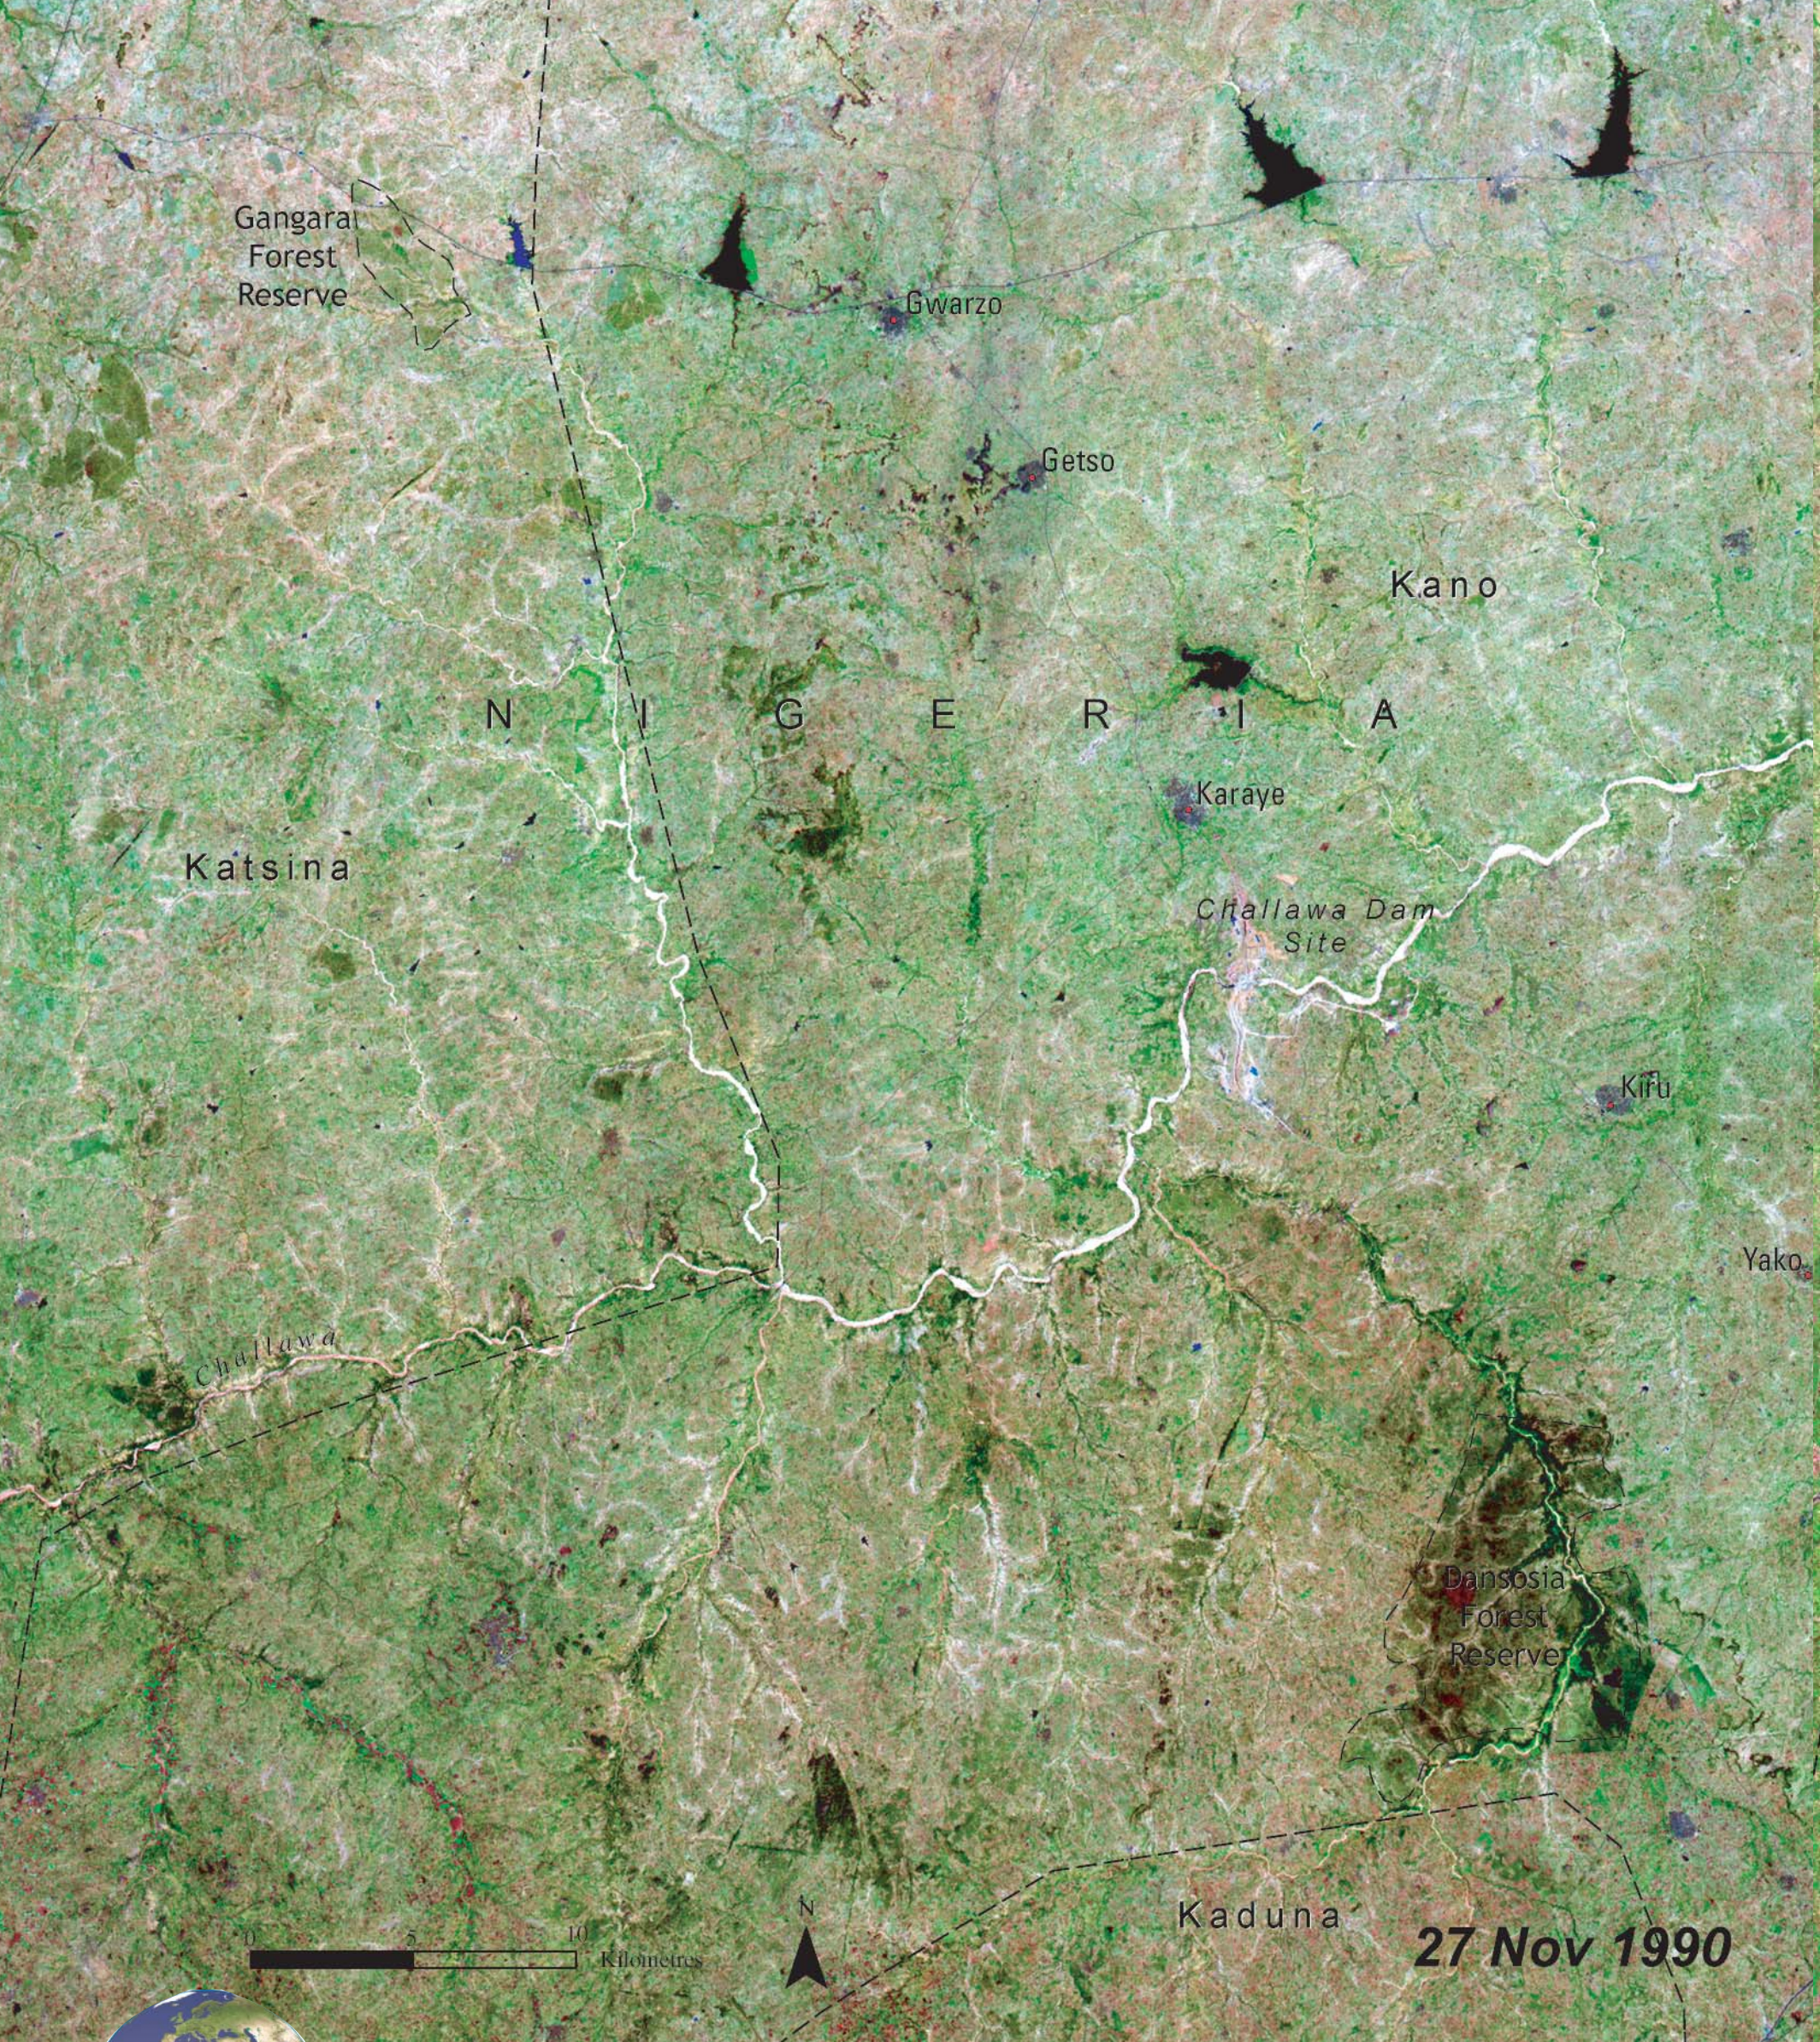
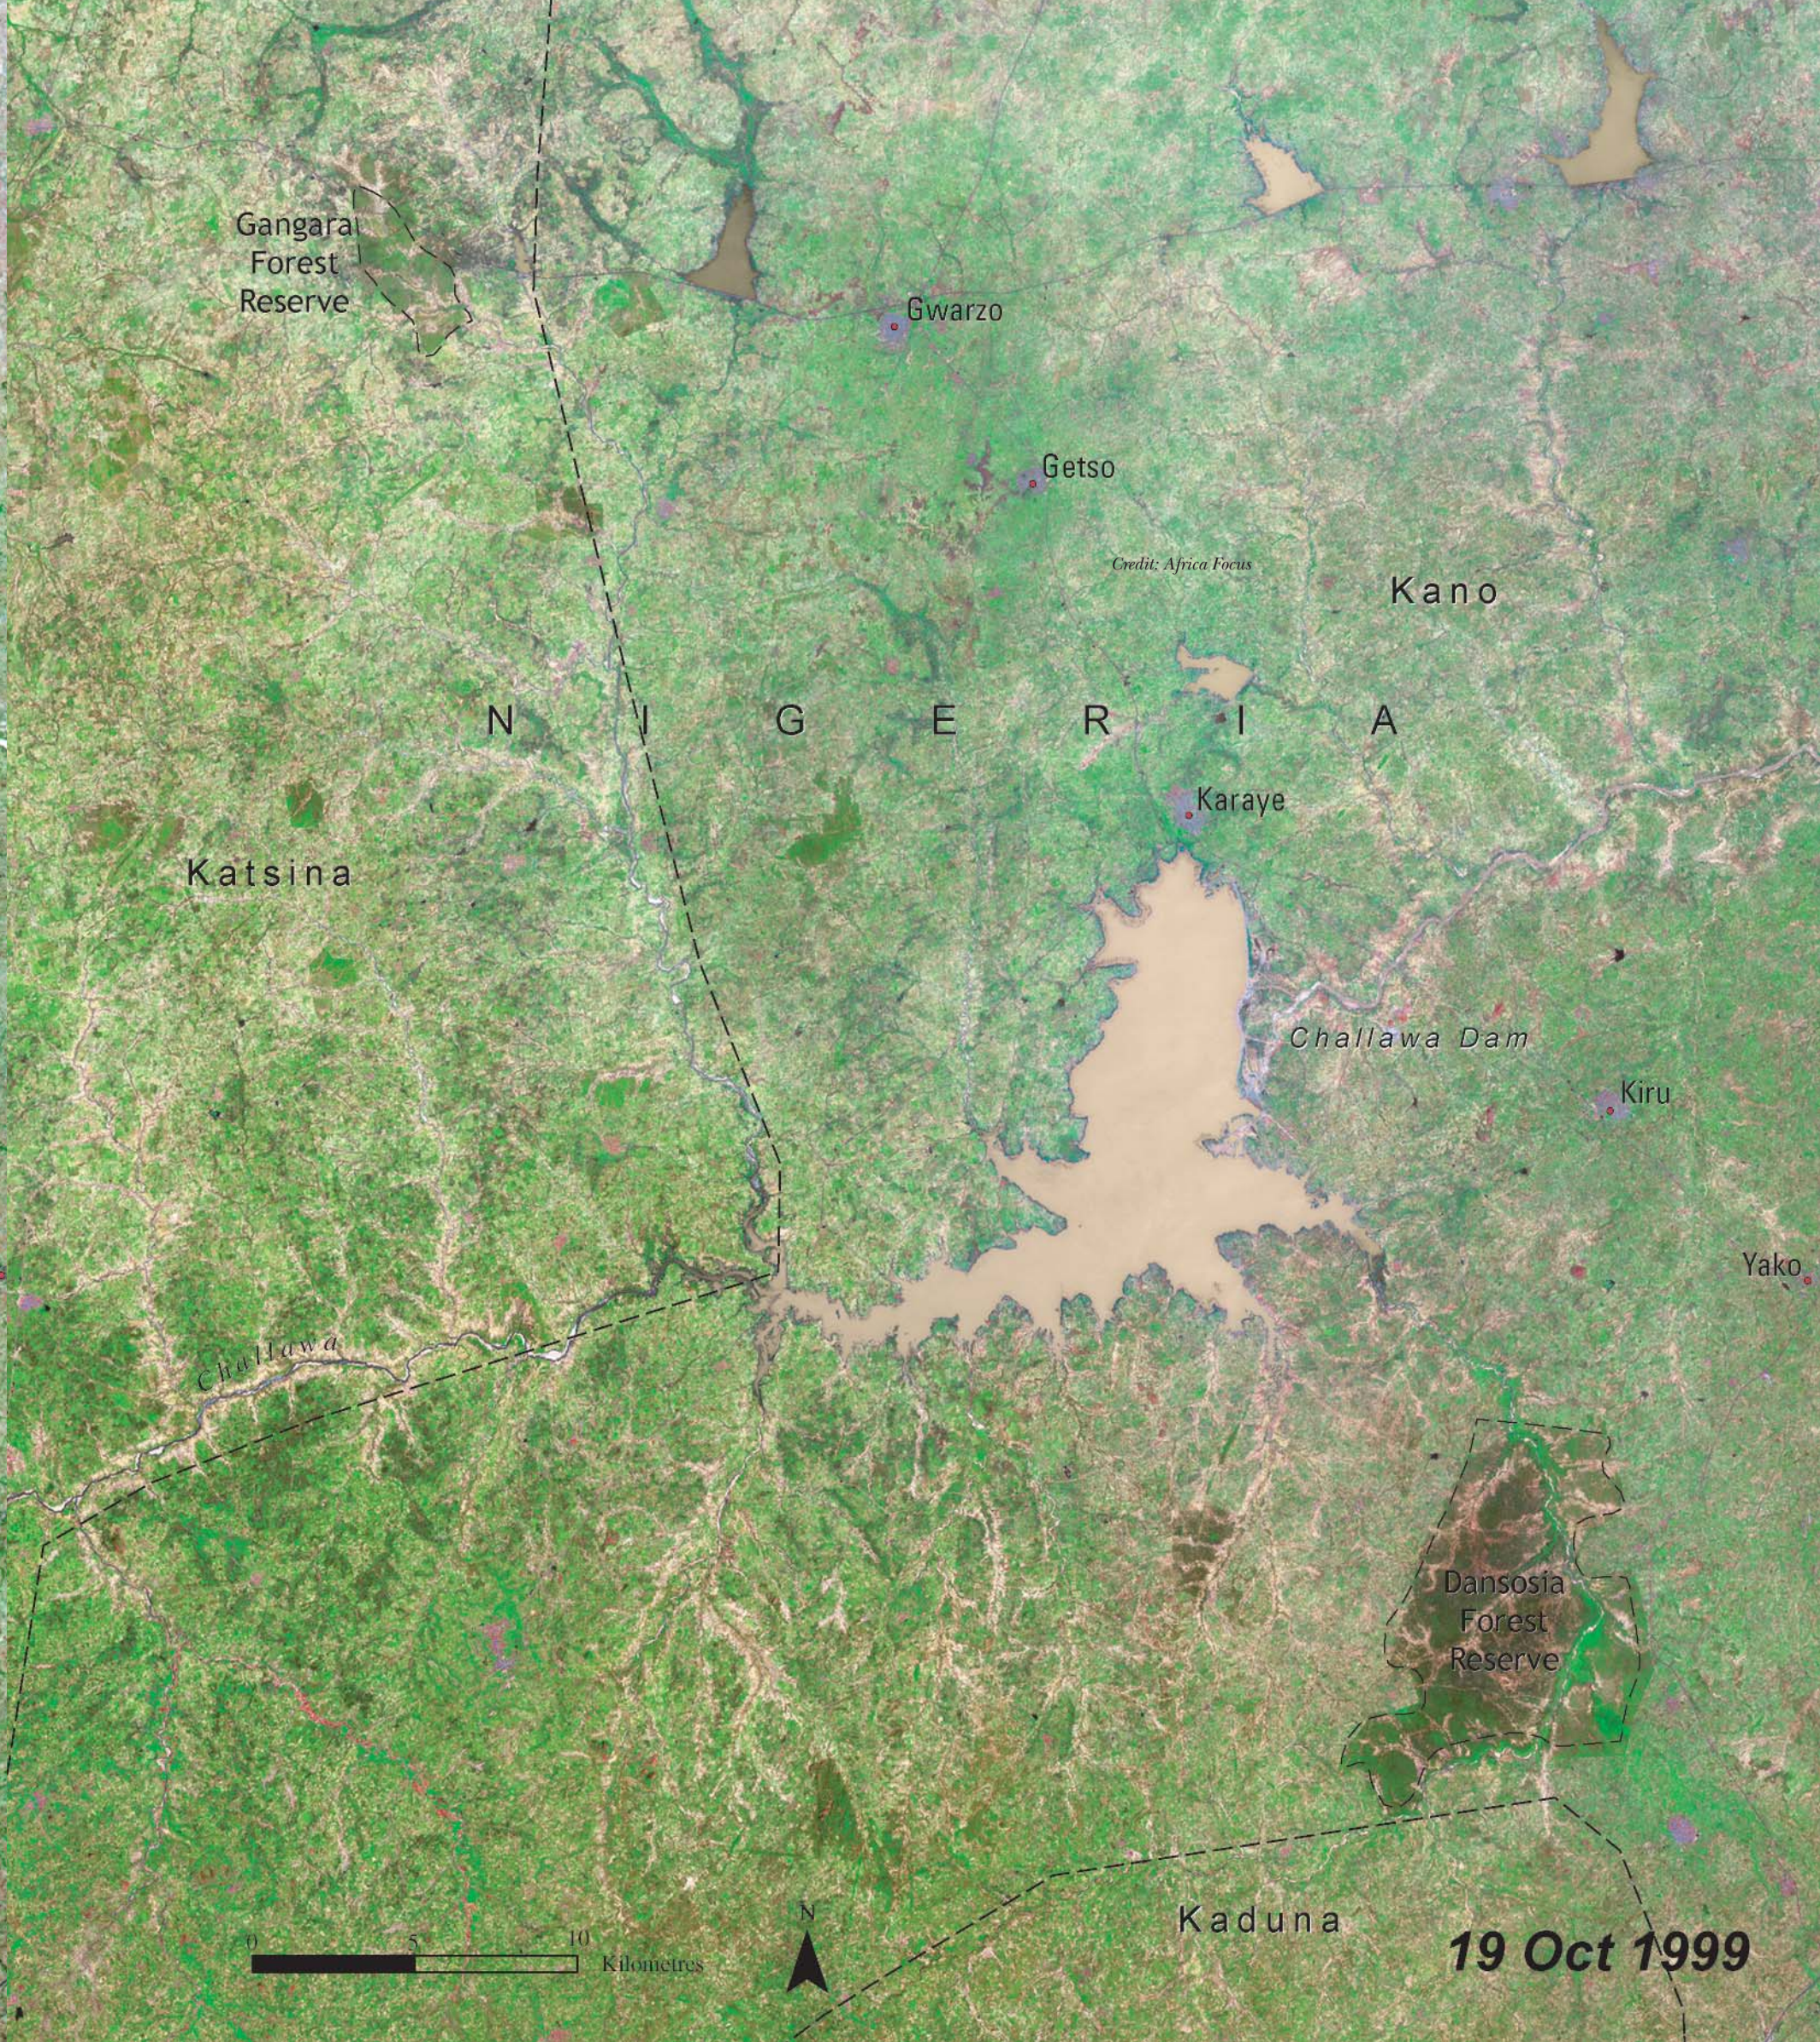
CHALLAWA DAM

The Challawa Gorge Dam, completed in 1993, is the second largest of the 23 dams along the rivers in Nigeria's Hadejia-Jama'are River Basin. Although the dam has improved the water supply for irrigation,

it has also ruptured the fragile natural balance along this stretch of water. When it rains heavily, the river can break its banks and flood farms and land upstream from the dam. Areas downstream, meanwhile, do not receive enough water to maintain the wetlands bordering the river. Under these conditions, the soil dries out and overgrazing occurs, which in turn leads to wind erosion of the

topsoil. These satellite images provide a comparison of the area before and after the dam's construction. The 1999 image shows the degree to which flooding upstream impacts the landscape, and how the lack of water downstream negatively affects riverine wetlands and cropland. The colour of the water in the flooded area is also indicative of high-sediment content.

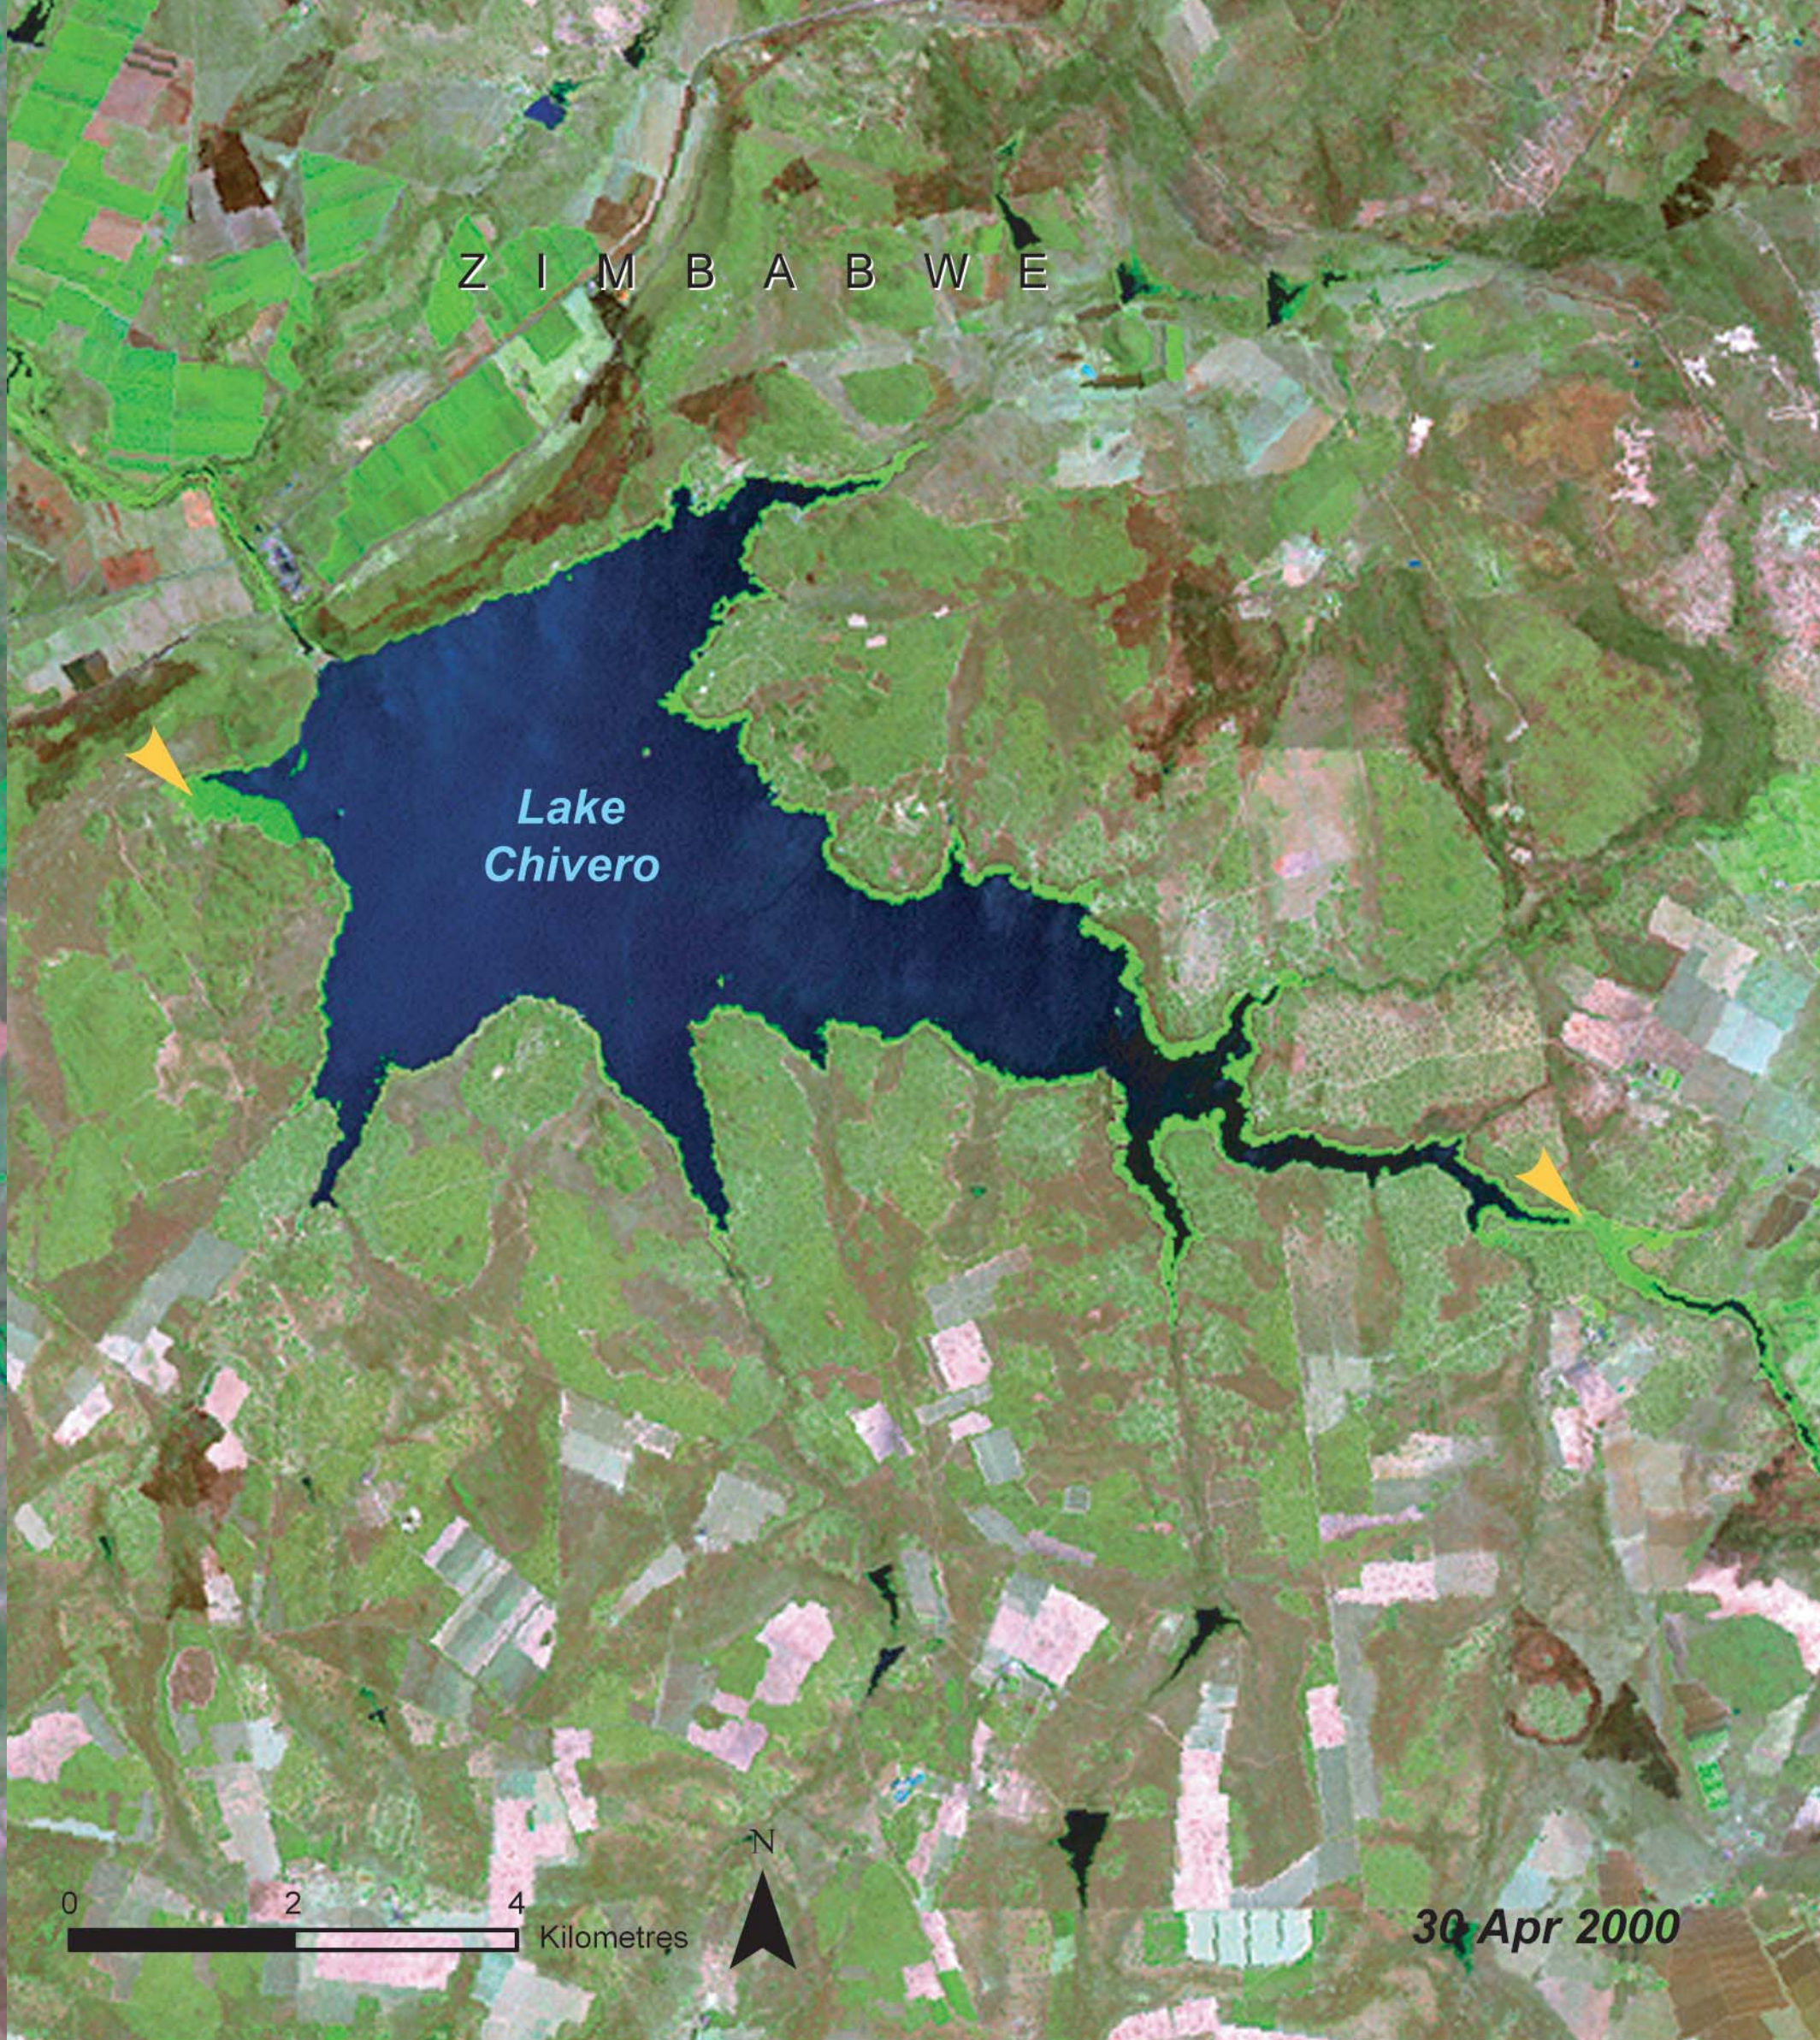
lake became progressively eutrophic, after a recovery period from a previous eutrophication phase in the mid 1960s. While these two images suggest an overall reduction of the presence of invasive water weeds in Lake Chivero between 1989 and 2000, there is evidence that this remains a persistent problem. The

weeds show up as green strands along the edges of the lake. Like most of Zimbabwe's freshwater bodies, freeing Lake Chivero from the weed menace will require long-term eradication strategies, continuous monitoring, and a comprehensive integrated water basin management programme.
