3.3 Water

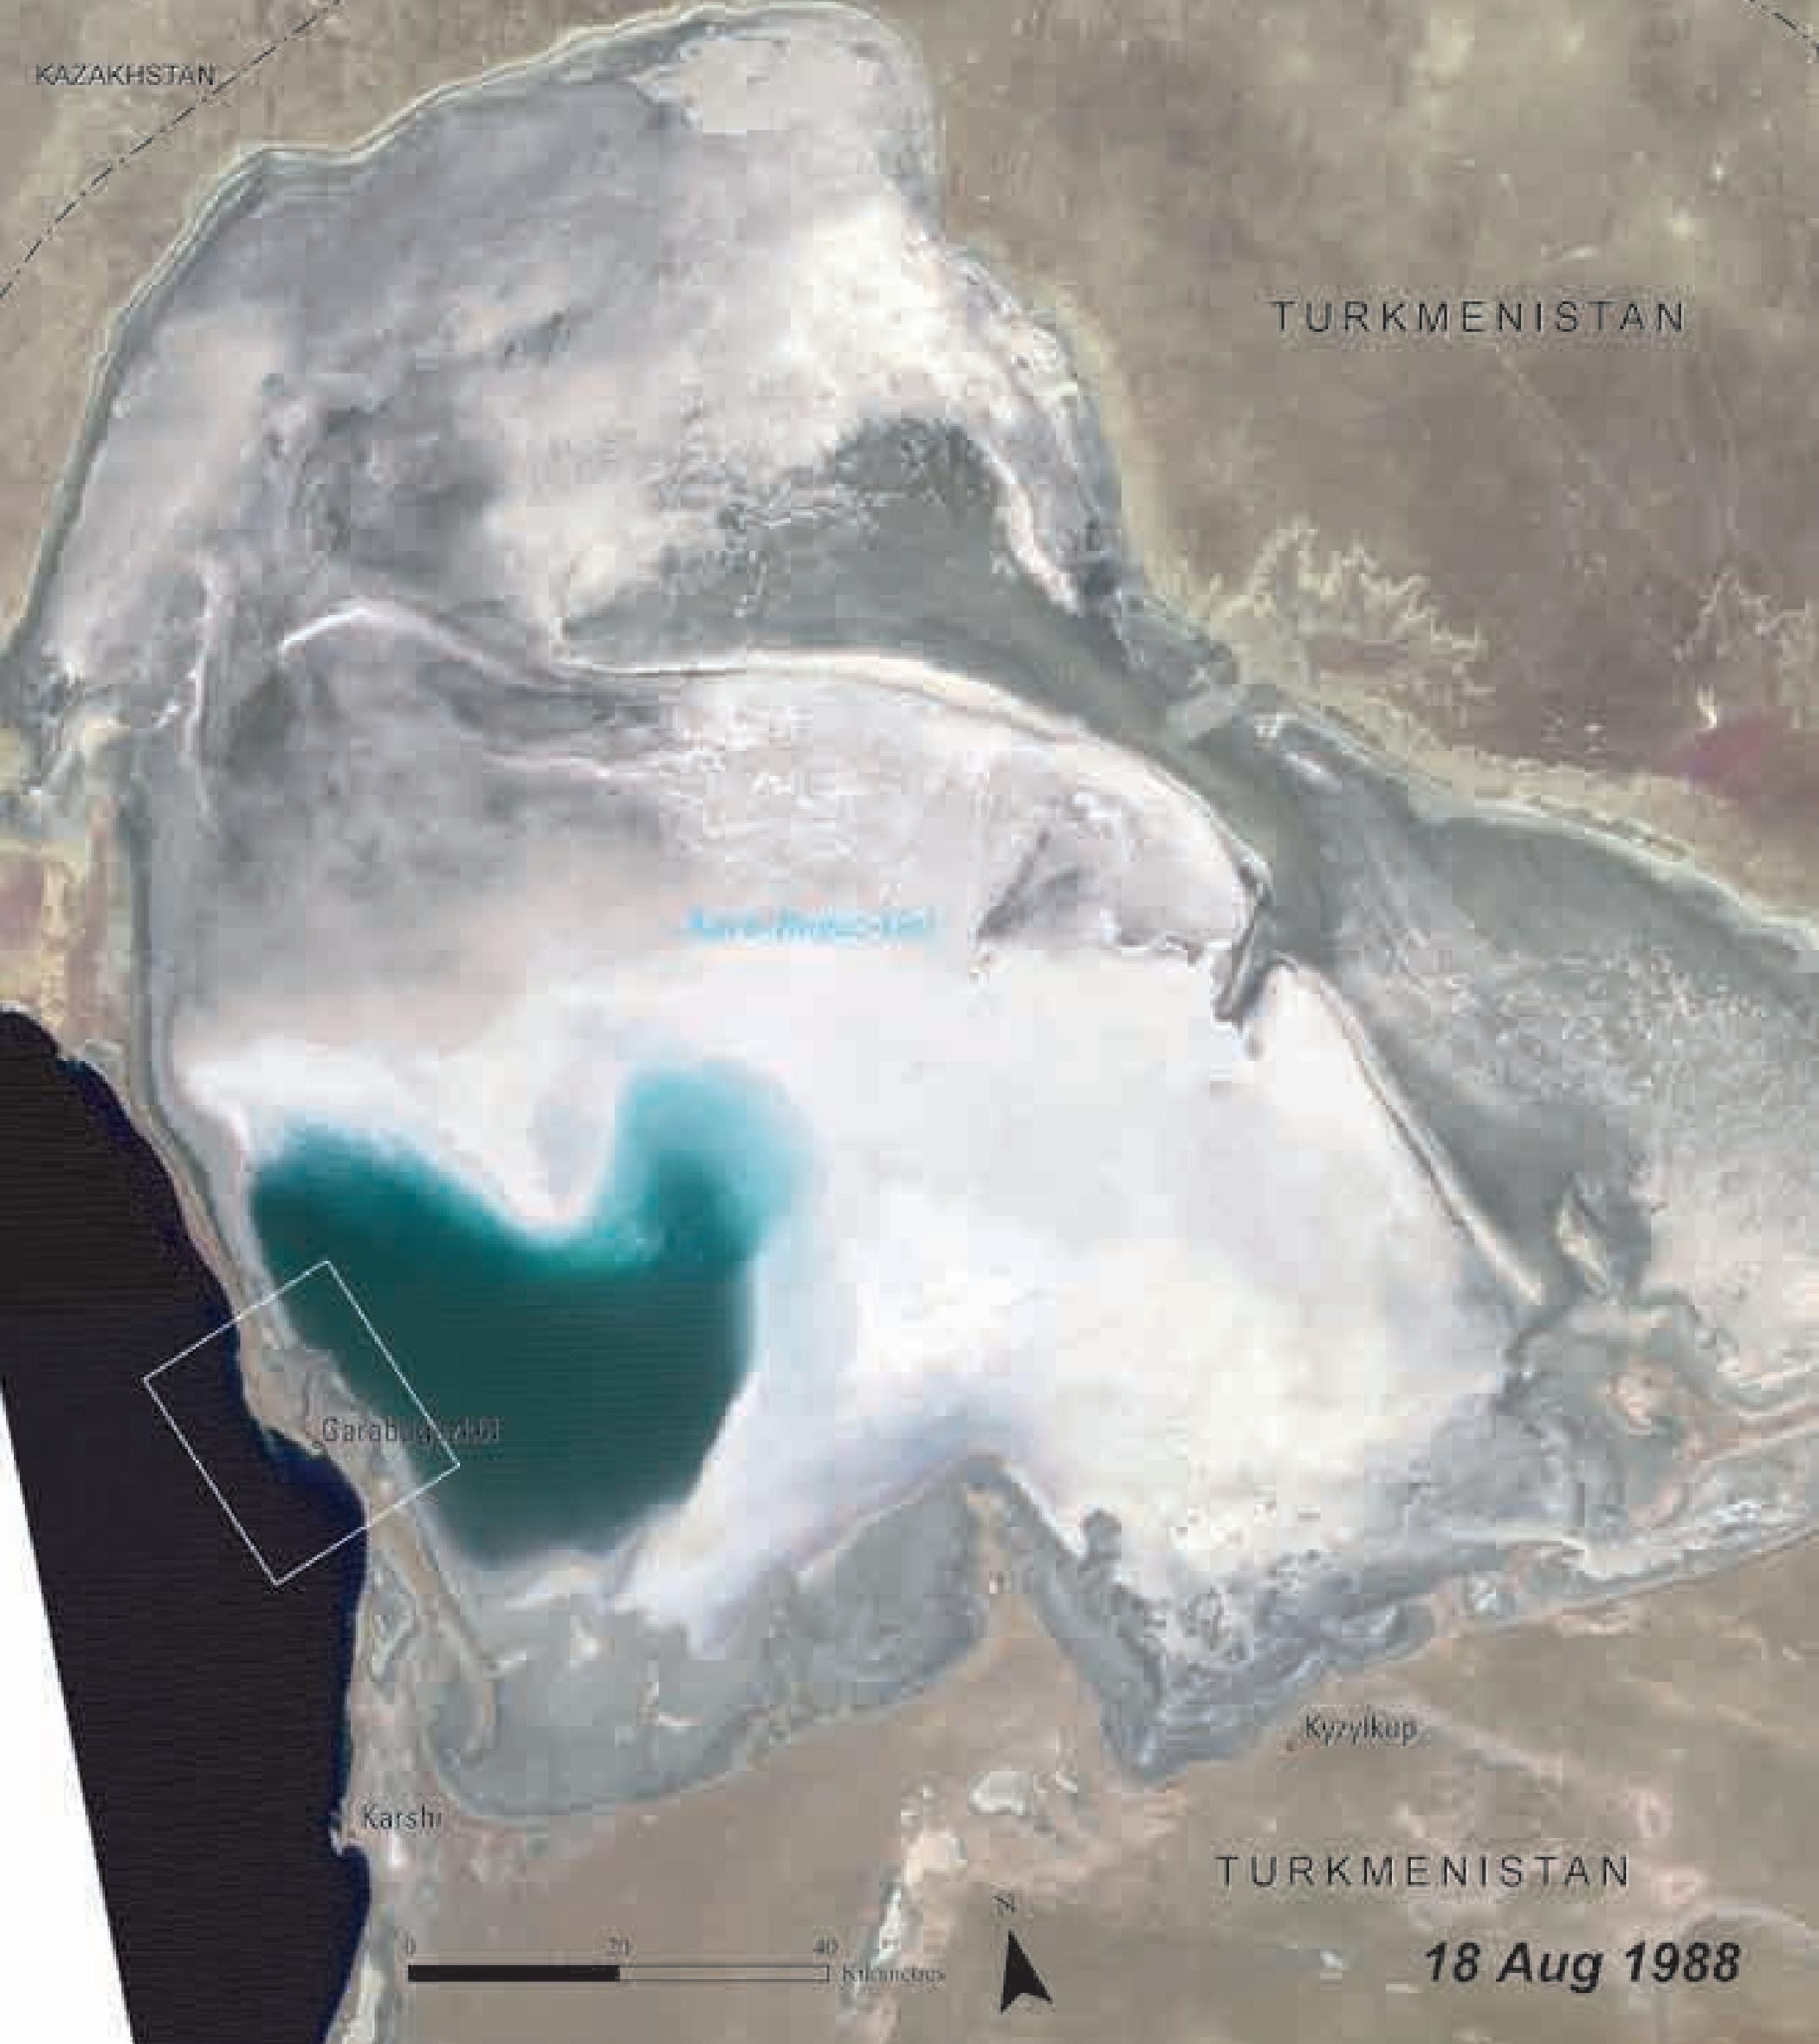
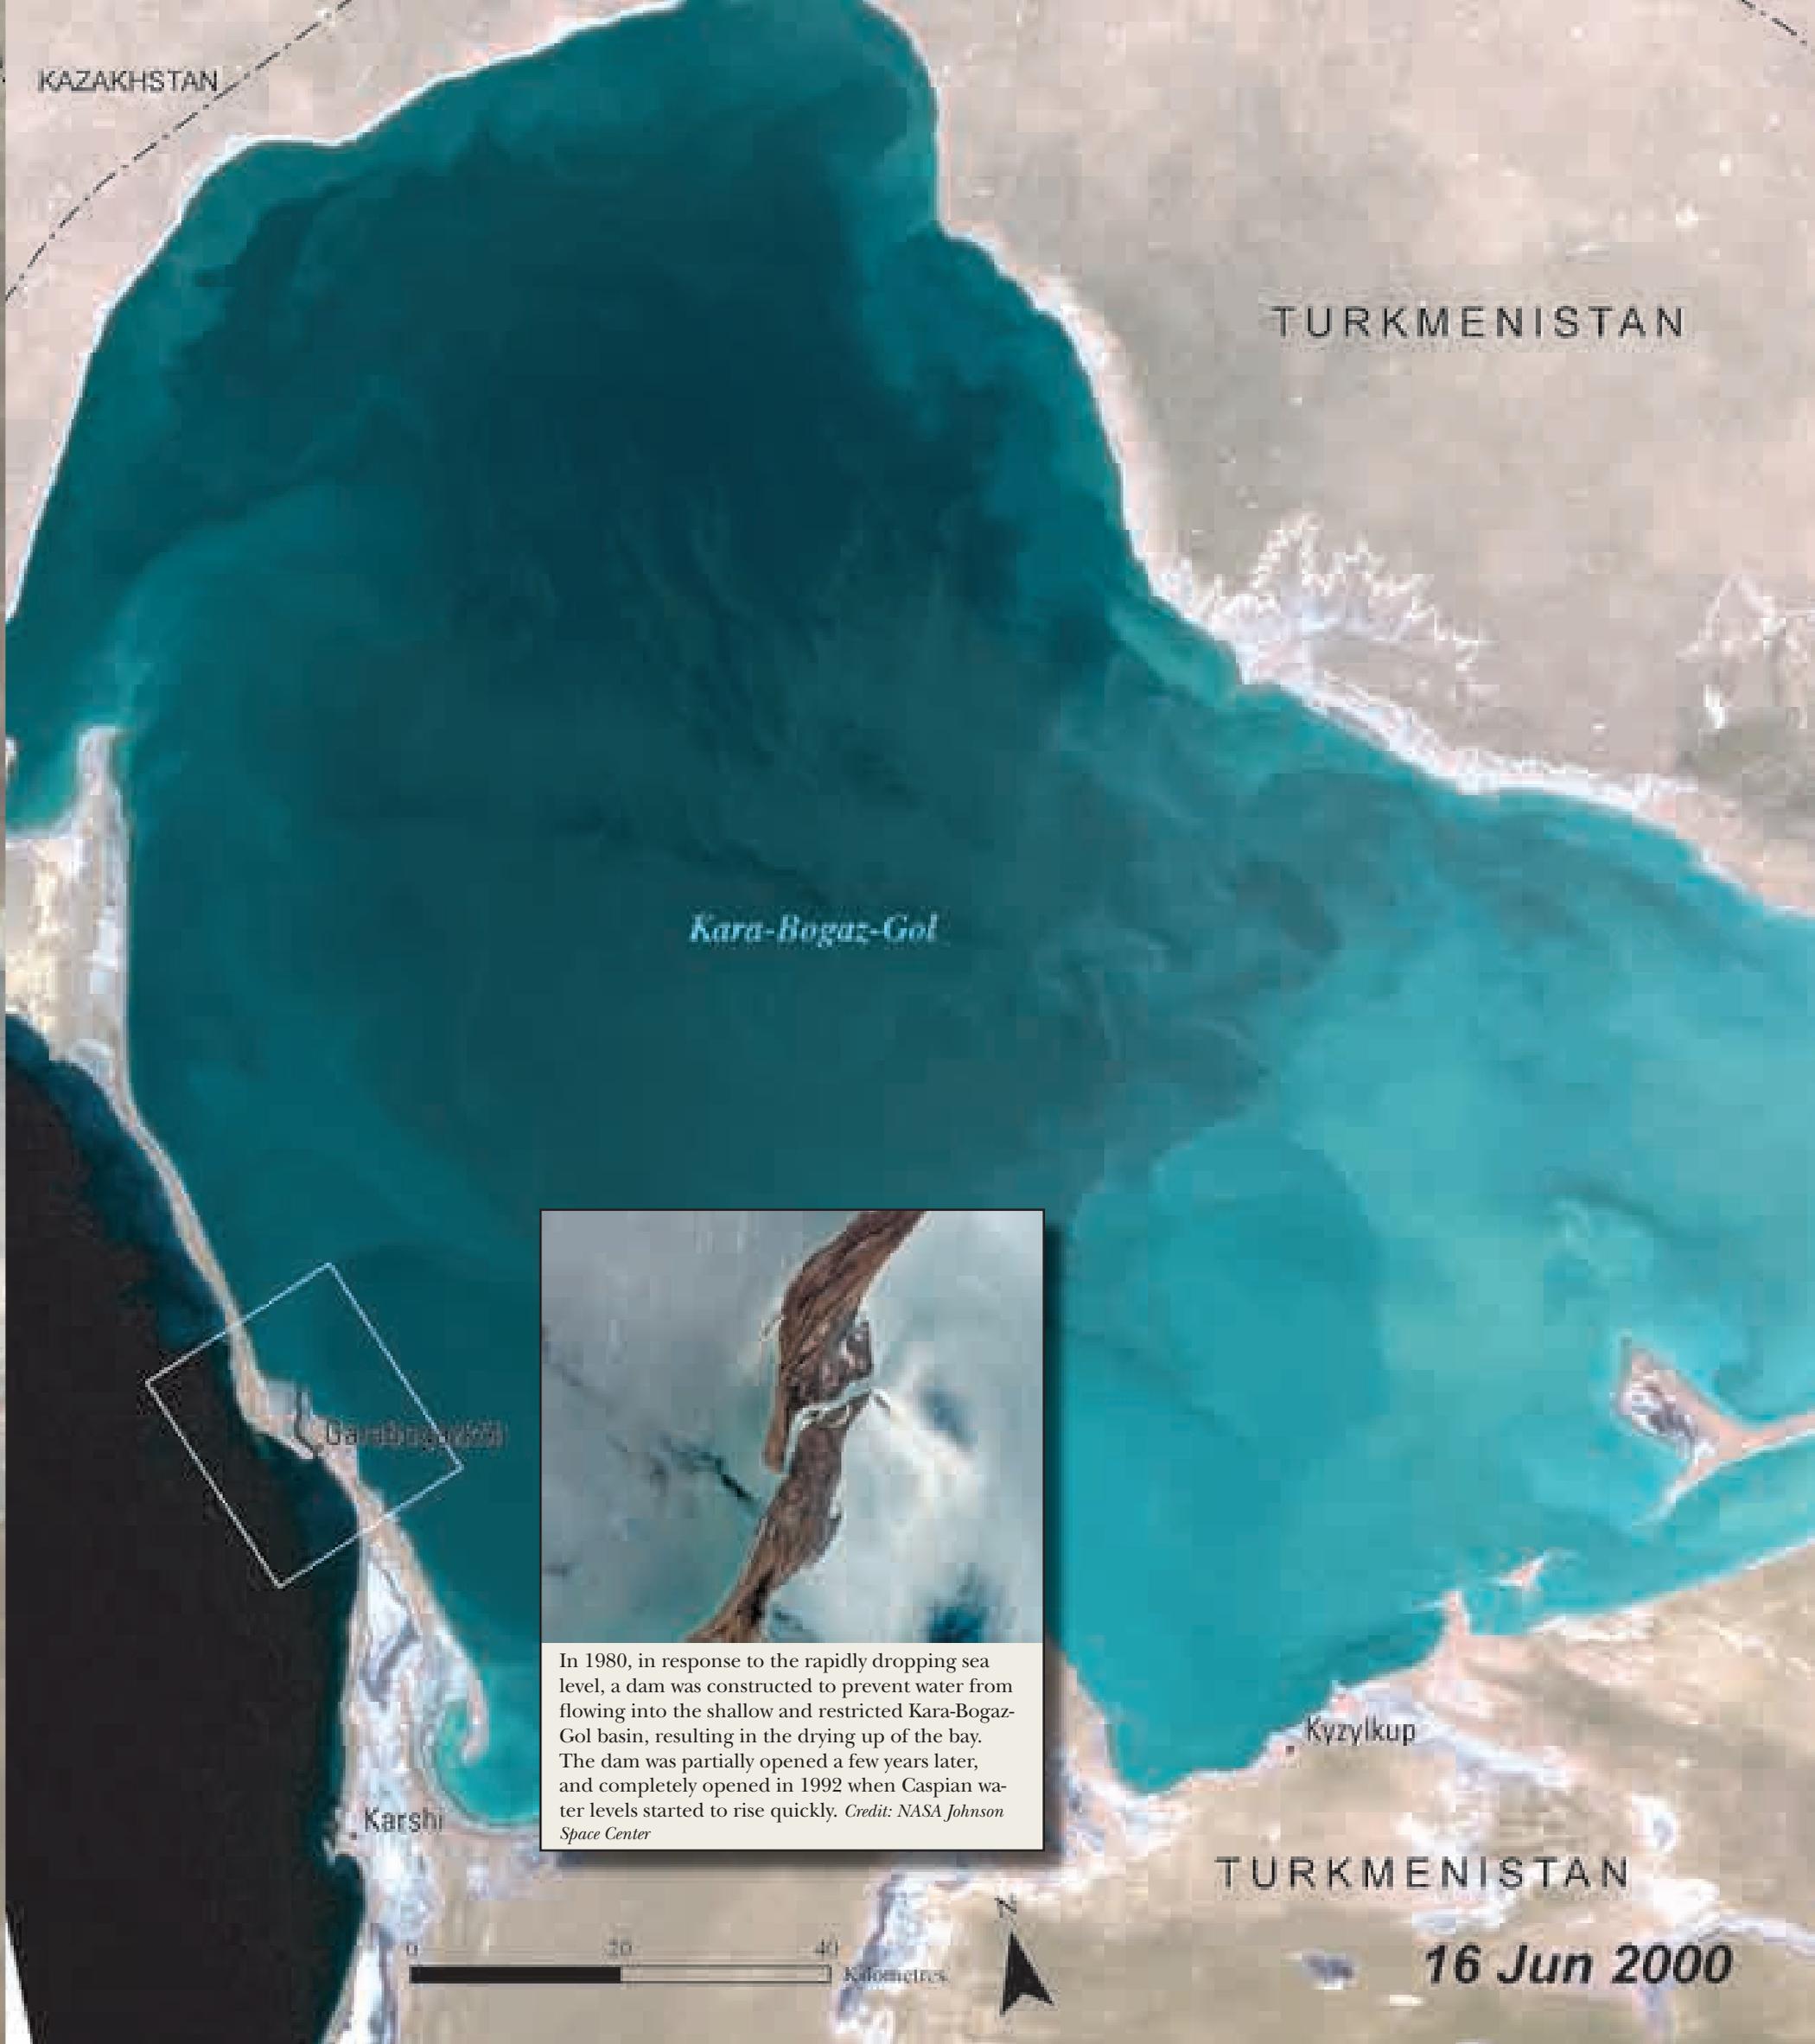
WATER KBG, TURKMENISTAN

In 1980, in response to the rapidly dropping sea level, a dam was constructed to prevent water from flowing into the shallow and restricted Kara-Bogaz-Gol basin, resulting in the drying up of the bay. The dam was partially opened a few years later, and completely opened in 1992 when Caspian water levels started to rise quickly. *Credit: NASA Johnson Space Center*

reportedly poisoning soil, and causing health problems for people living hundreds of kilometers downwind to the east. While the dam was in place, not only did the KBG's water level rapidly drop by 2 m (7 ft) or more, but the lagoon's shallow bottom also rose 0.5 m (2 ft), due to the accumulation of salts.

The dam was partially opened in 1985, and completely opened in 1992 when Caspian Sea water levels started to rise quickly. Today, sea levels are more than 2.6 m (9 ft) higher than the 1978 levels and water flows freely into the salty waters of the Kara-Bogaz-Gol.

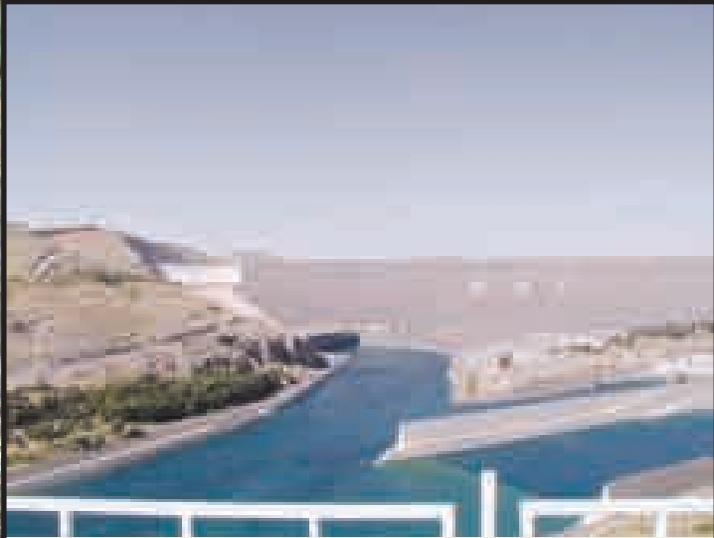
The power-generating station at the Ataturk Dam already provides 8.9 billion kilowatt hours of electricity—roughly 22 per cent of the electricity the country is expected to need by 2010.
Credit: Unknown/UNEP/USDA-FAS

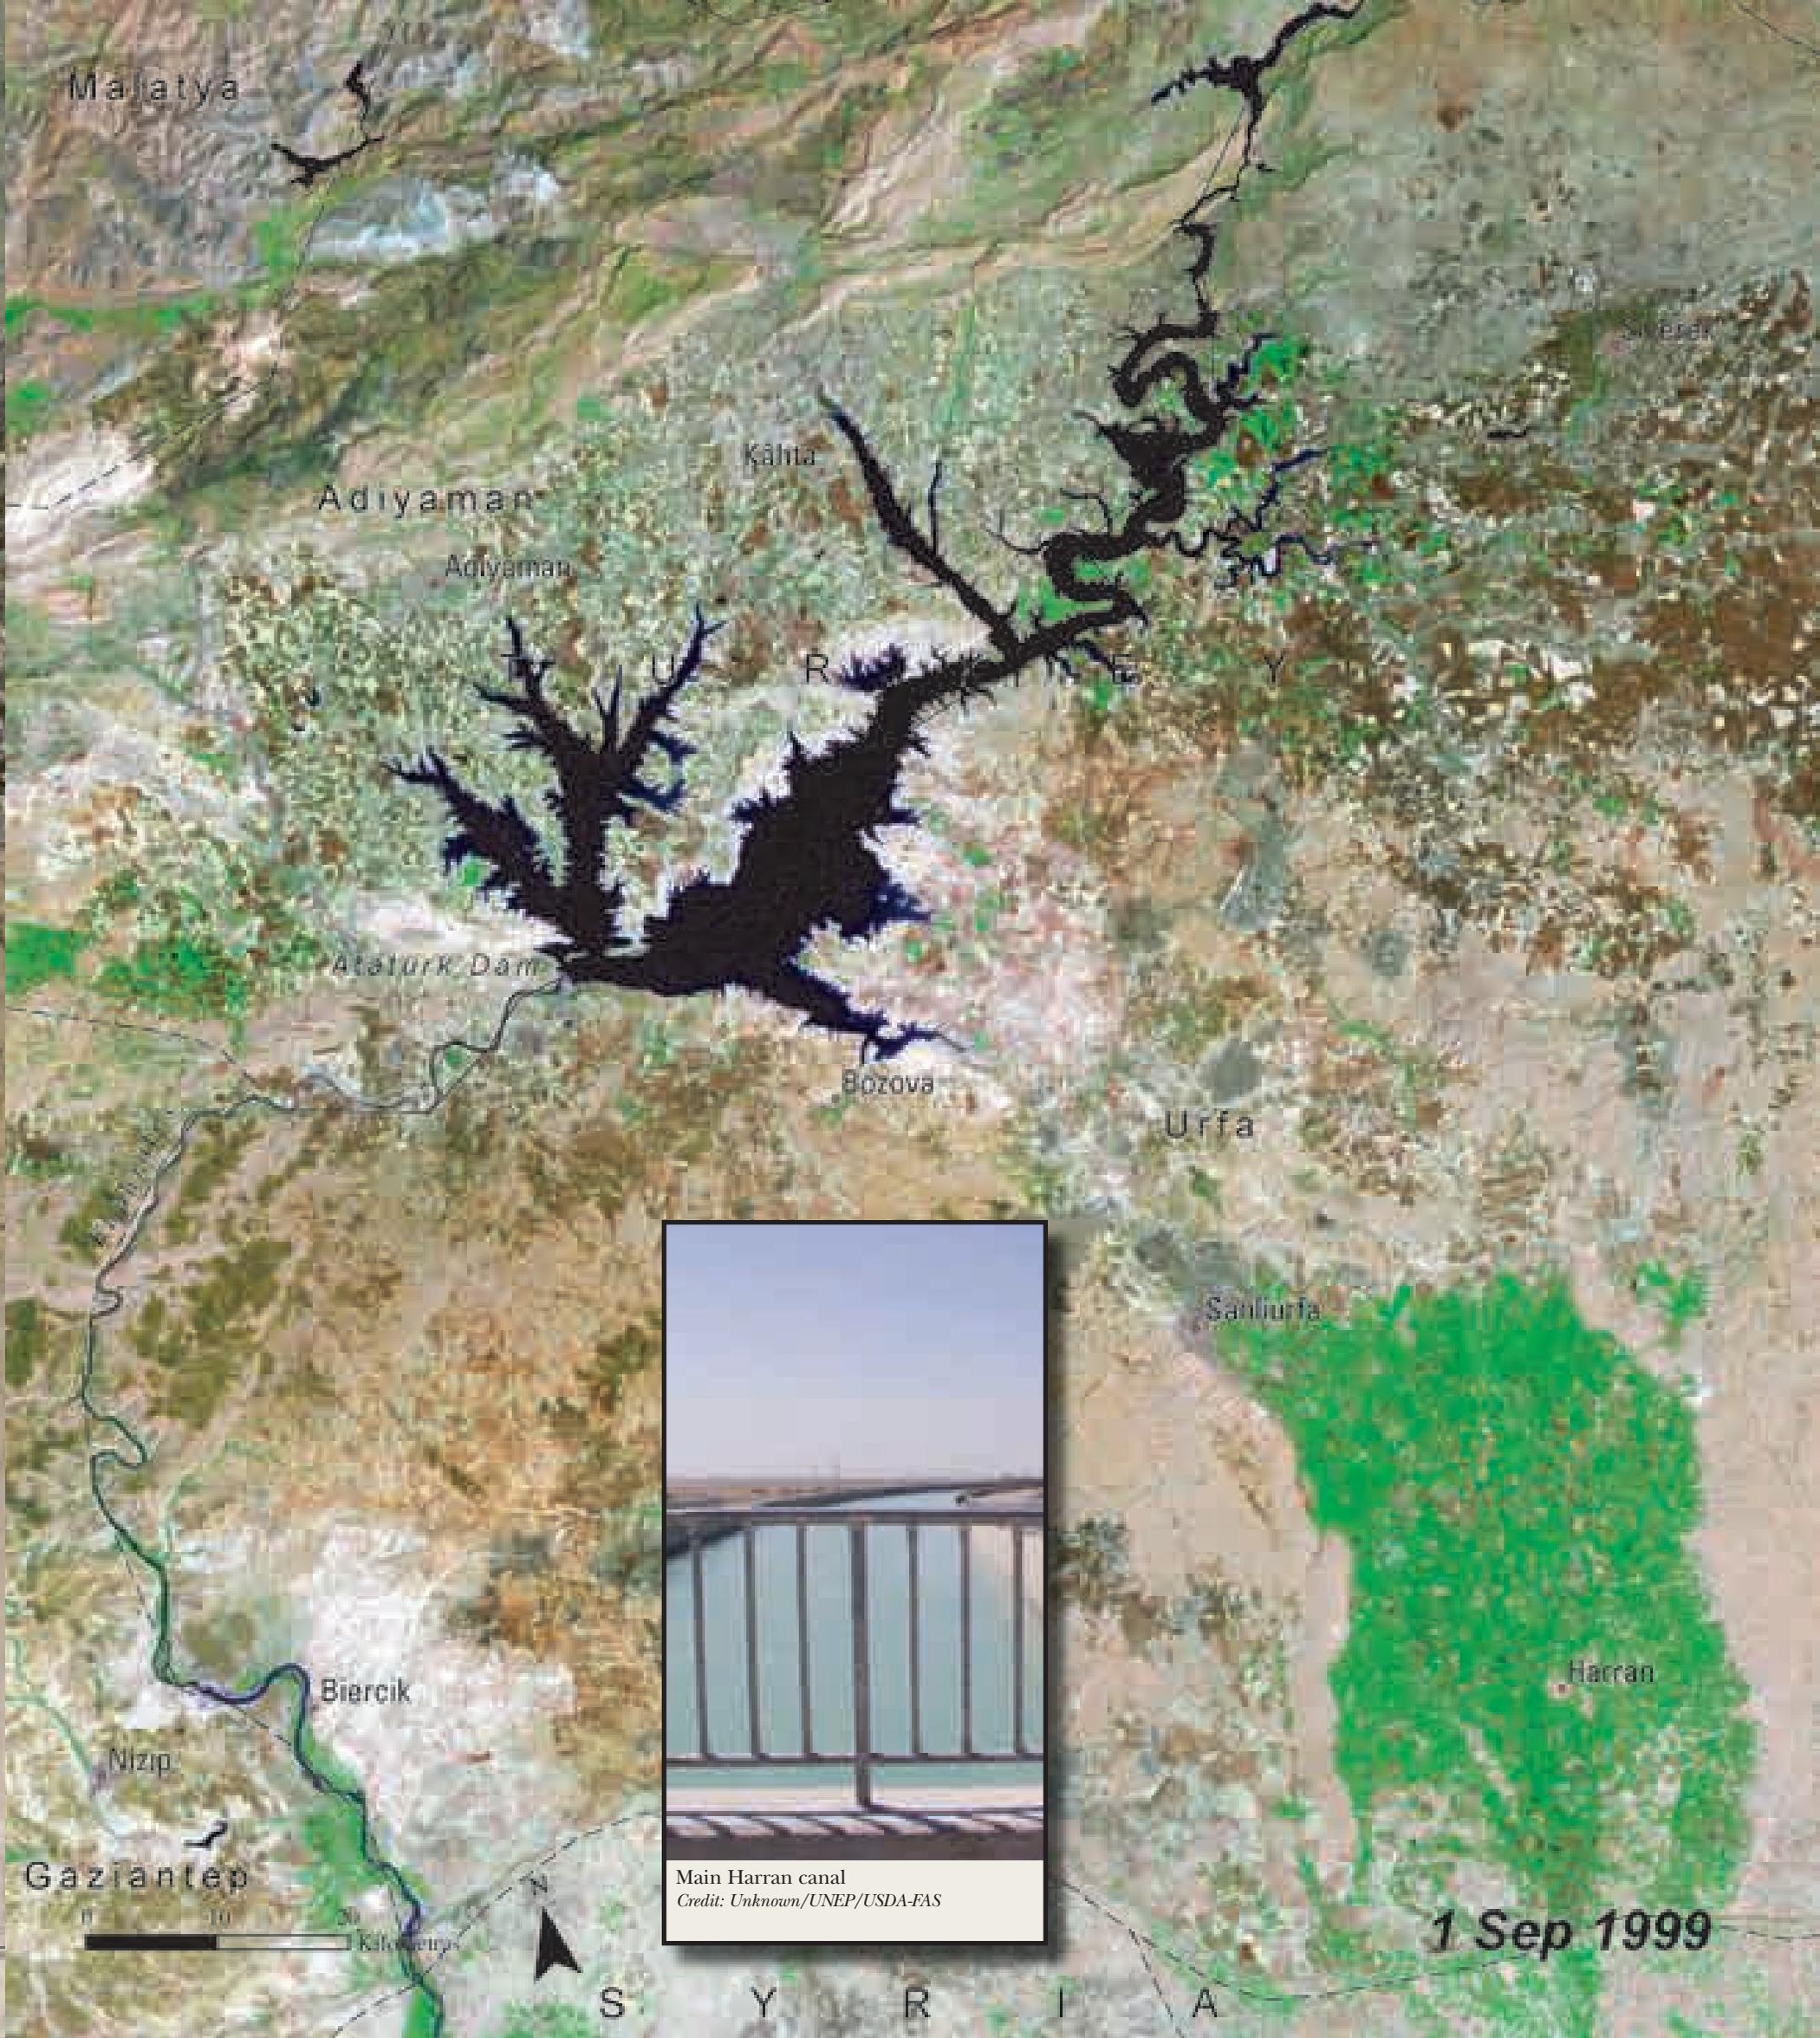
ATATÜRK DAM, TURKEY

In these two Landsat images, acquired in 1976 and 1999, respectively, the transformation of the region around the dam is strikingly apparent. The dam's

reservoir reached capacity in 1992 and has supplied sufficient water for irrigation to turn a once-arid landscape into a green one. This is especially obvious in the lower right-hand corner of the 1999 image, where irrigated fields completely surround the town of Harran. The development of the Harran region could not have occurred without the Atatürk Dam project, especially since the town is many kilometres from the river.

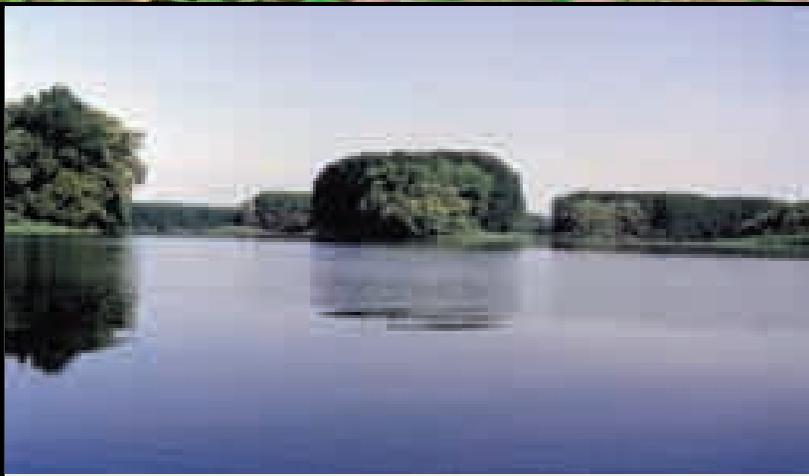
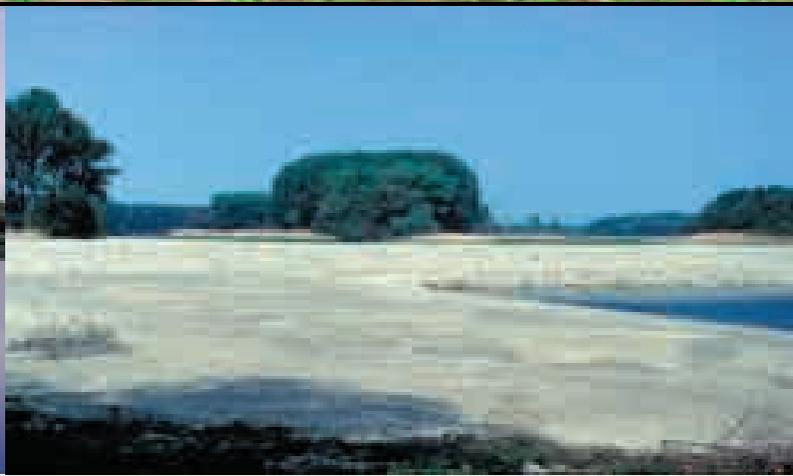
Former Danube river bottom exposed as water is redirected into the diversion canal.

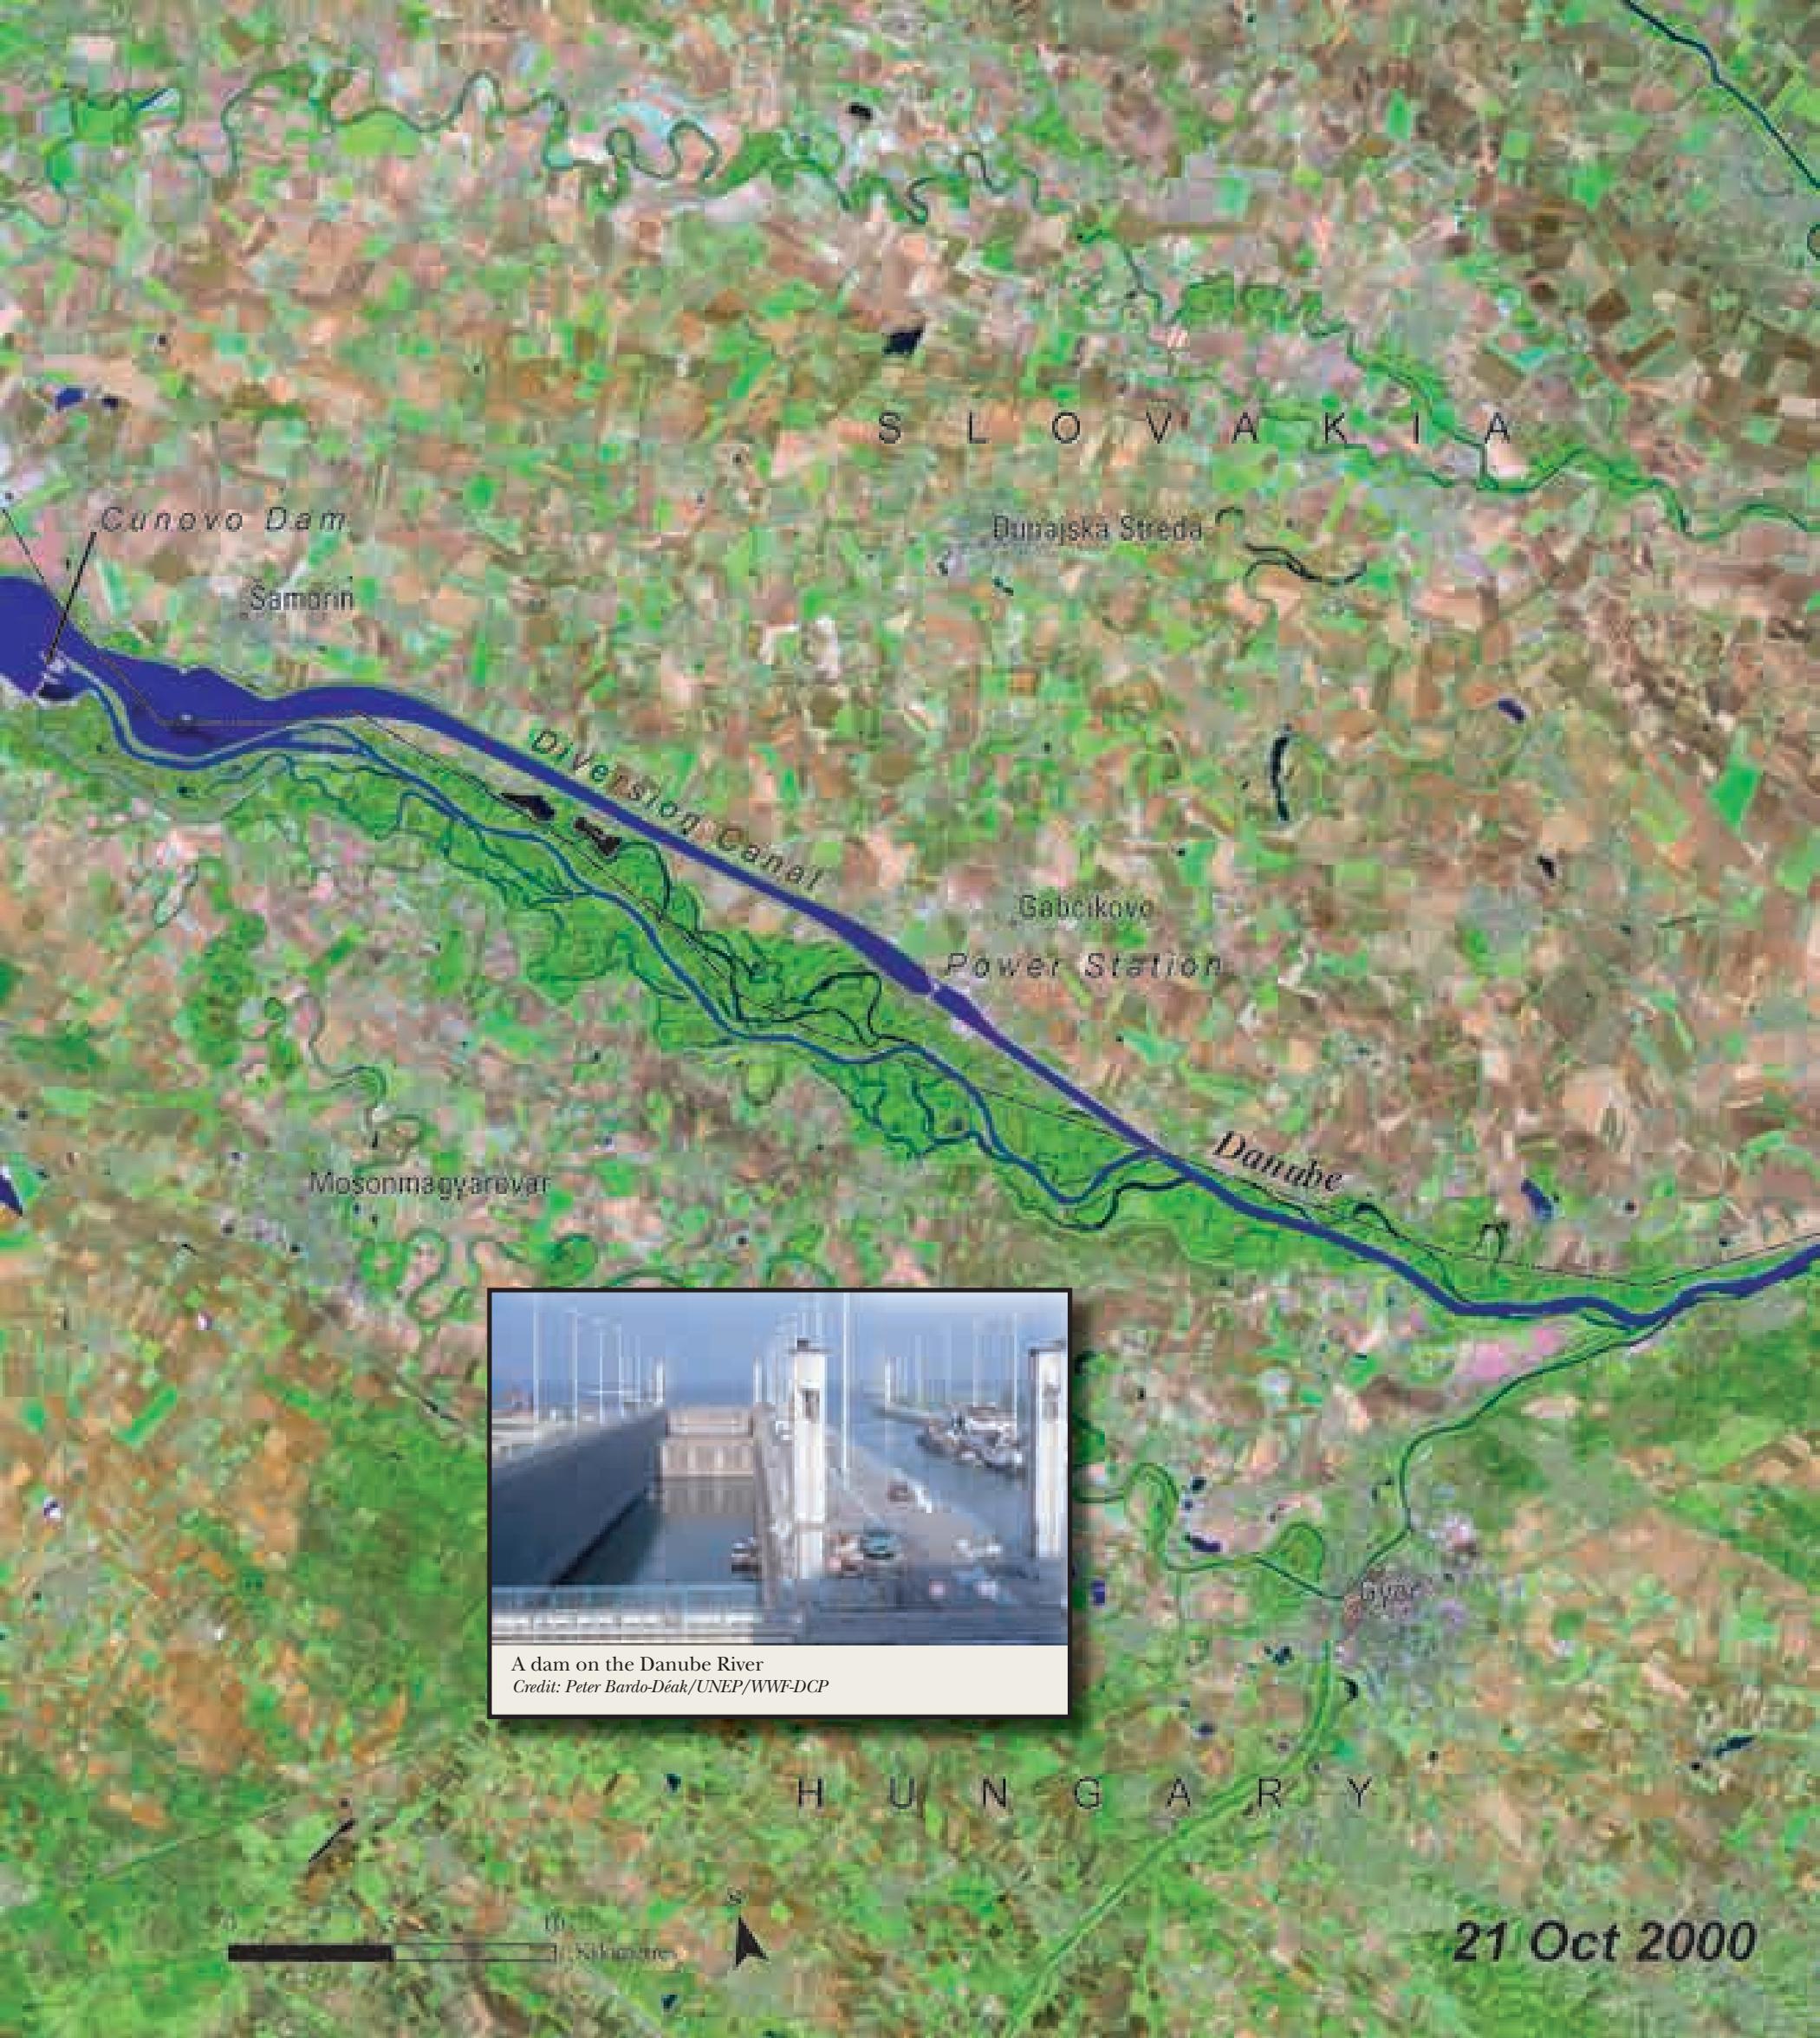
WATER GABCIKOVA, SLOVAKIA

This pair of images from 1973 and 2000 reveal the striking changes the massive re-channelling of river water has brought to the region. The dam altered the hydraulic regime of the Danube River valley from a natural water-

way to a controlled patchwork of channels and islands. The diversion of water by the dam brought an end to the natural, beneficial flooding that added moisture and nutrients to the soil. It also reduced the ability of wetlands and marshes to filter surface water and trap sediments. Consequently, water quality and soil nutrients levels in the region have declined. Generation of electricity has come with significant environmental cost.

Cunovo Dam began operation in Slovakia in October 1992. The dam diverted 80 to 90 per cent of Danube River water down a diversion canal to support a hydroelectric power station.

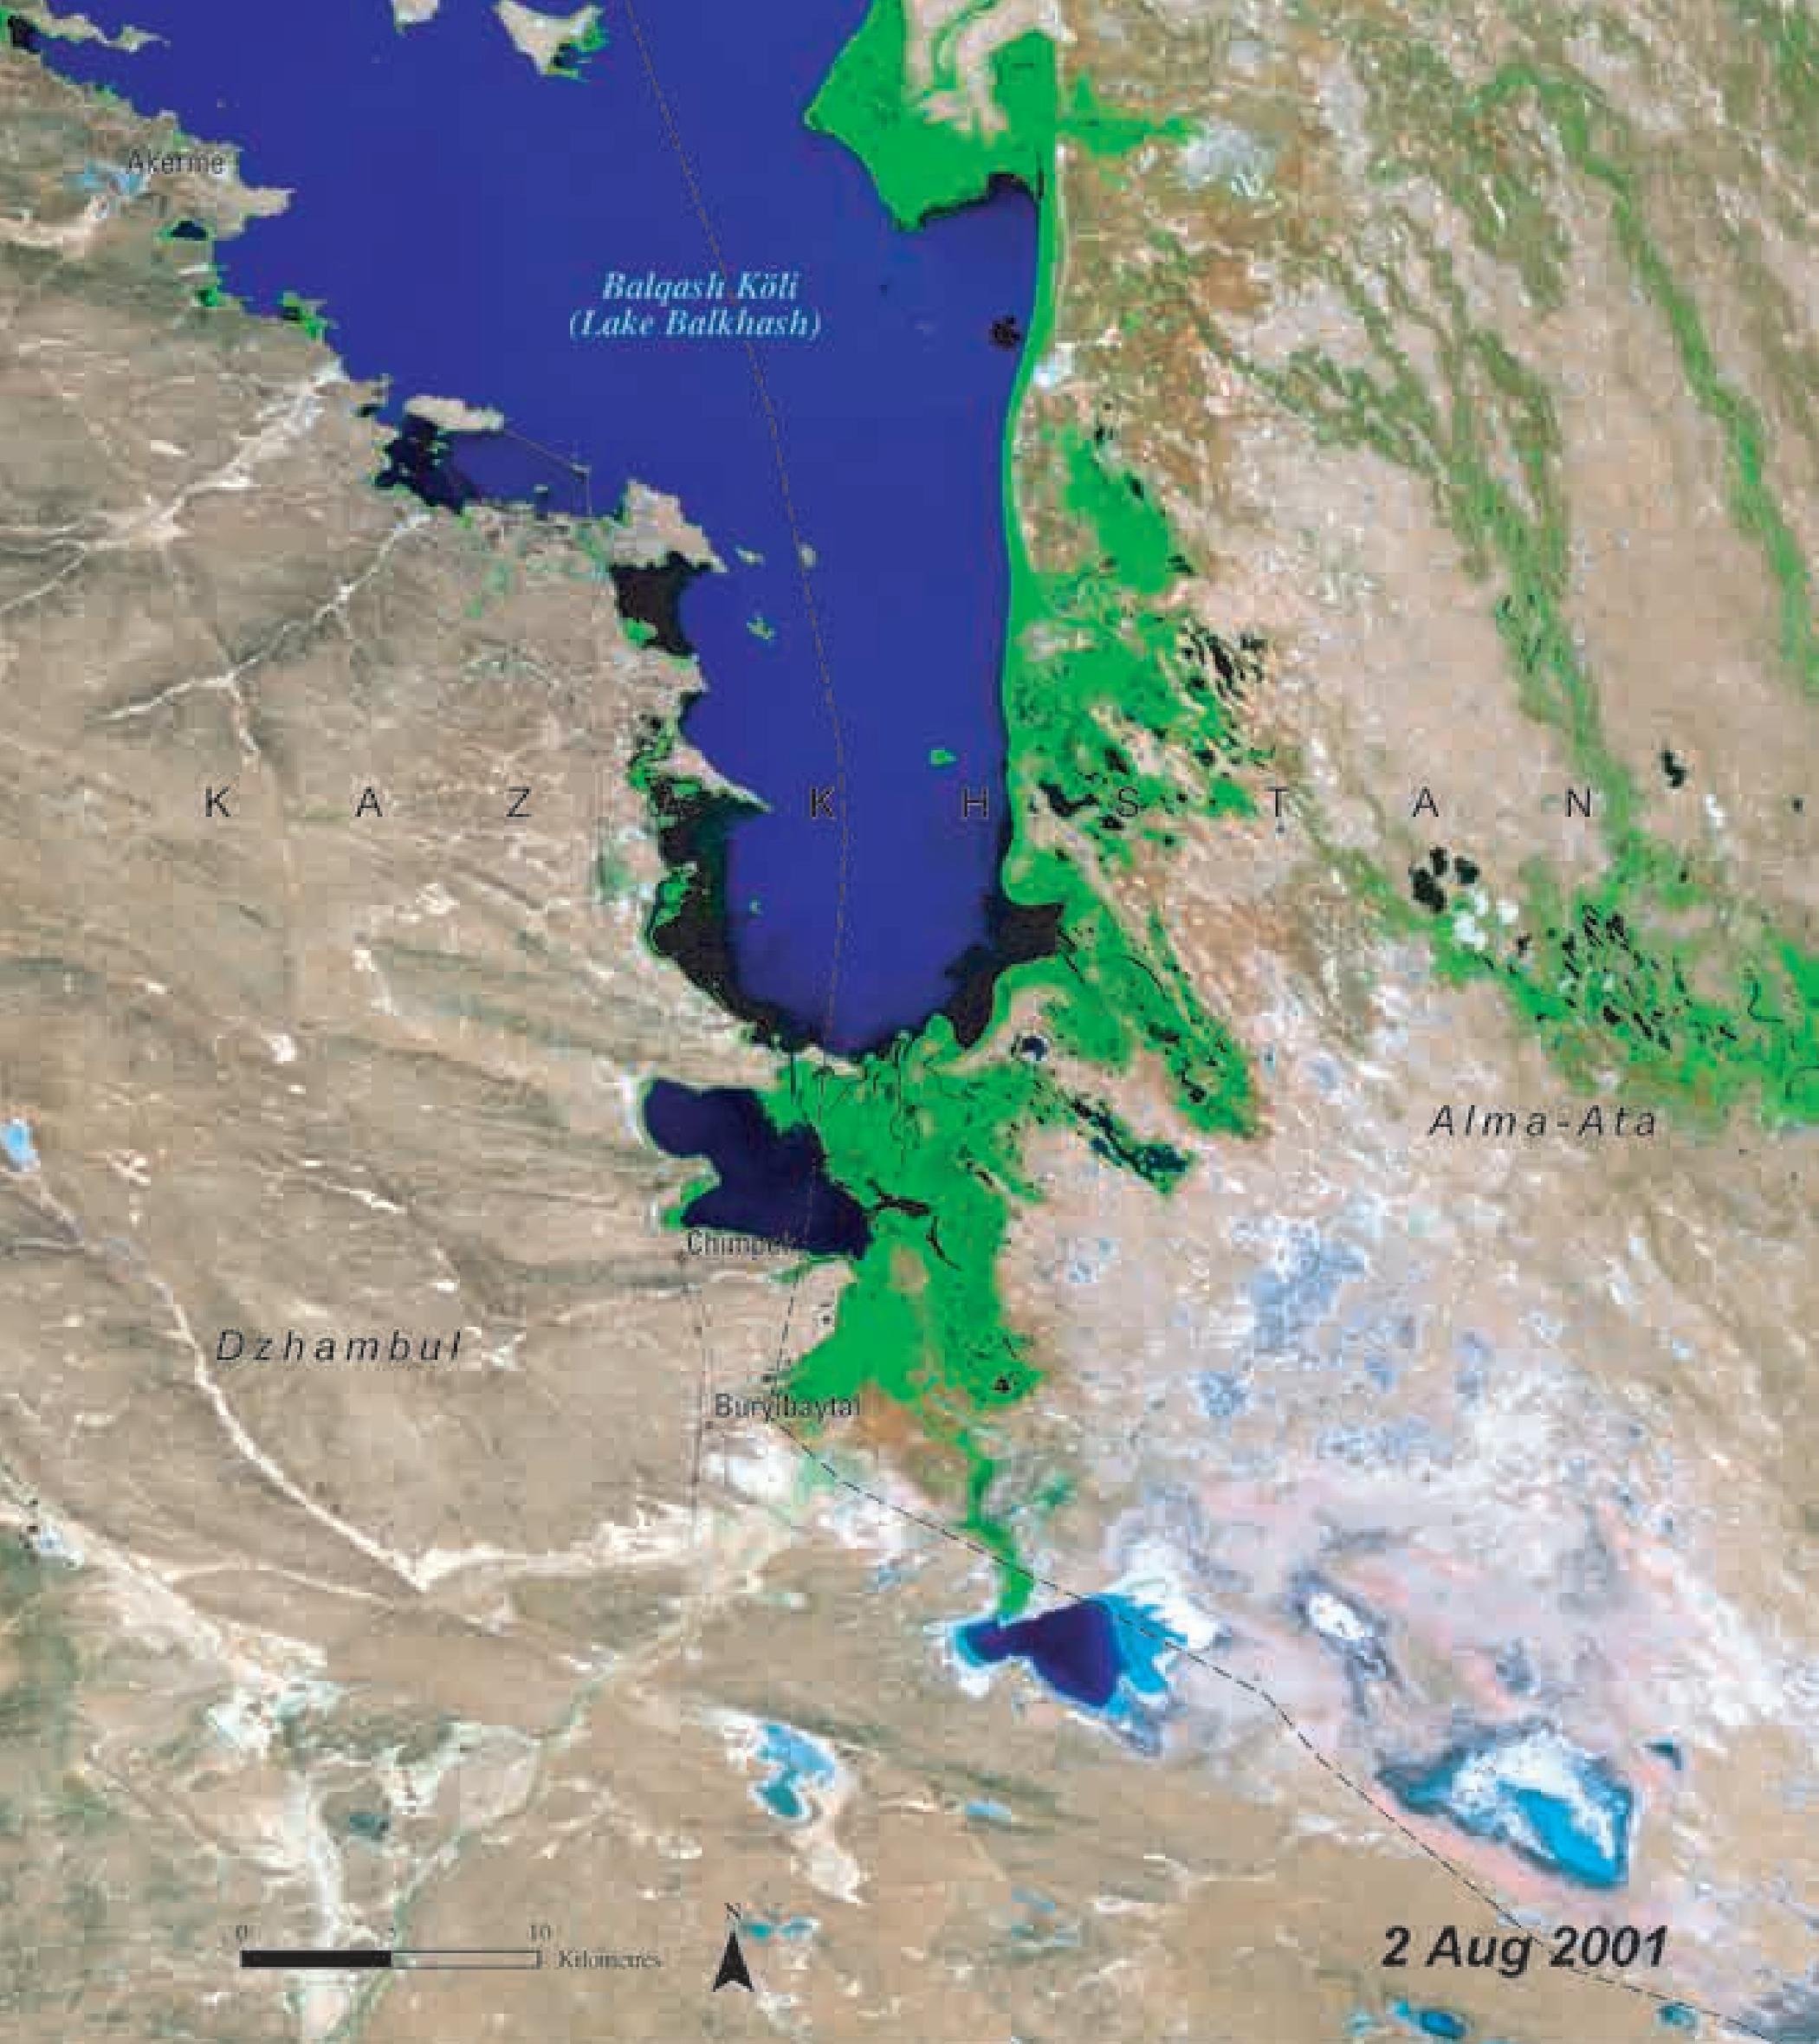
WATER
LAKE BALKHASH, **K**AZAKHSTAN

These two satellite images reveal an alarming drop in the lake's water levels in just over twenty years. Smaller, neighboring lakes, to the southeast of Balkhash, have become detached from the main water body; they have dramatically decreased in size and appear to be drying up.
