3.3 Water

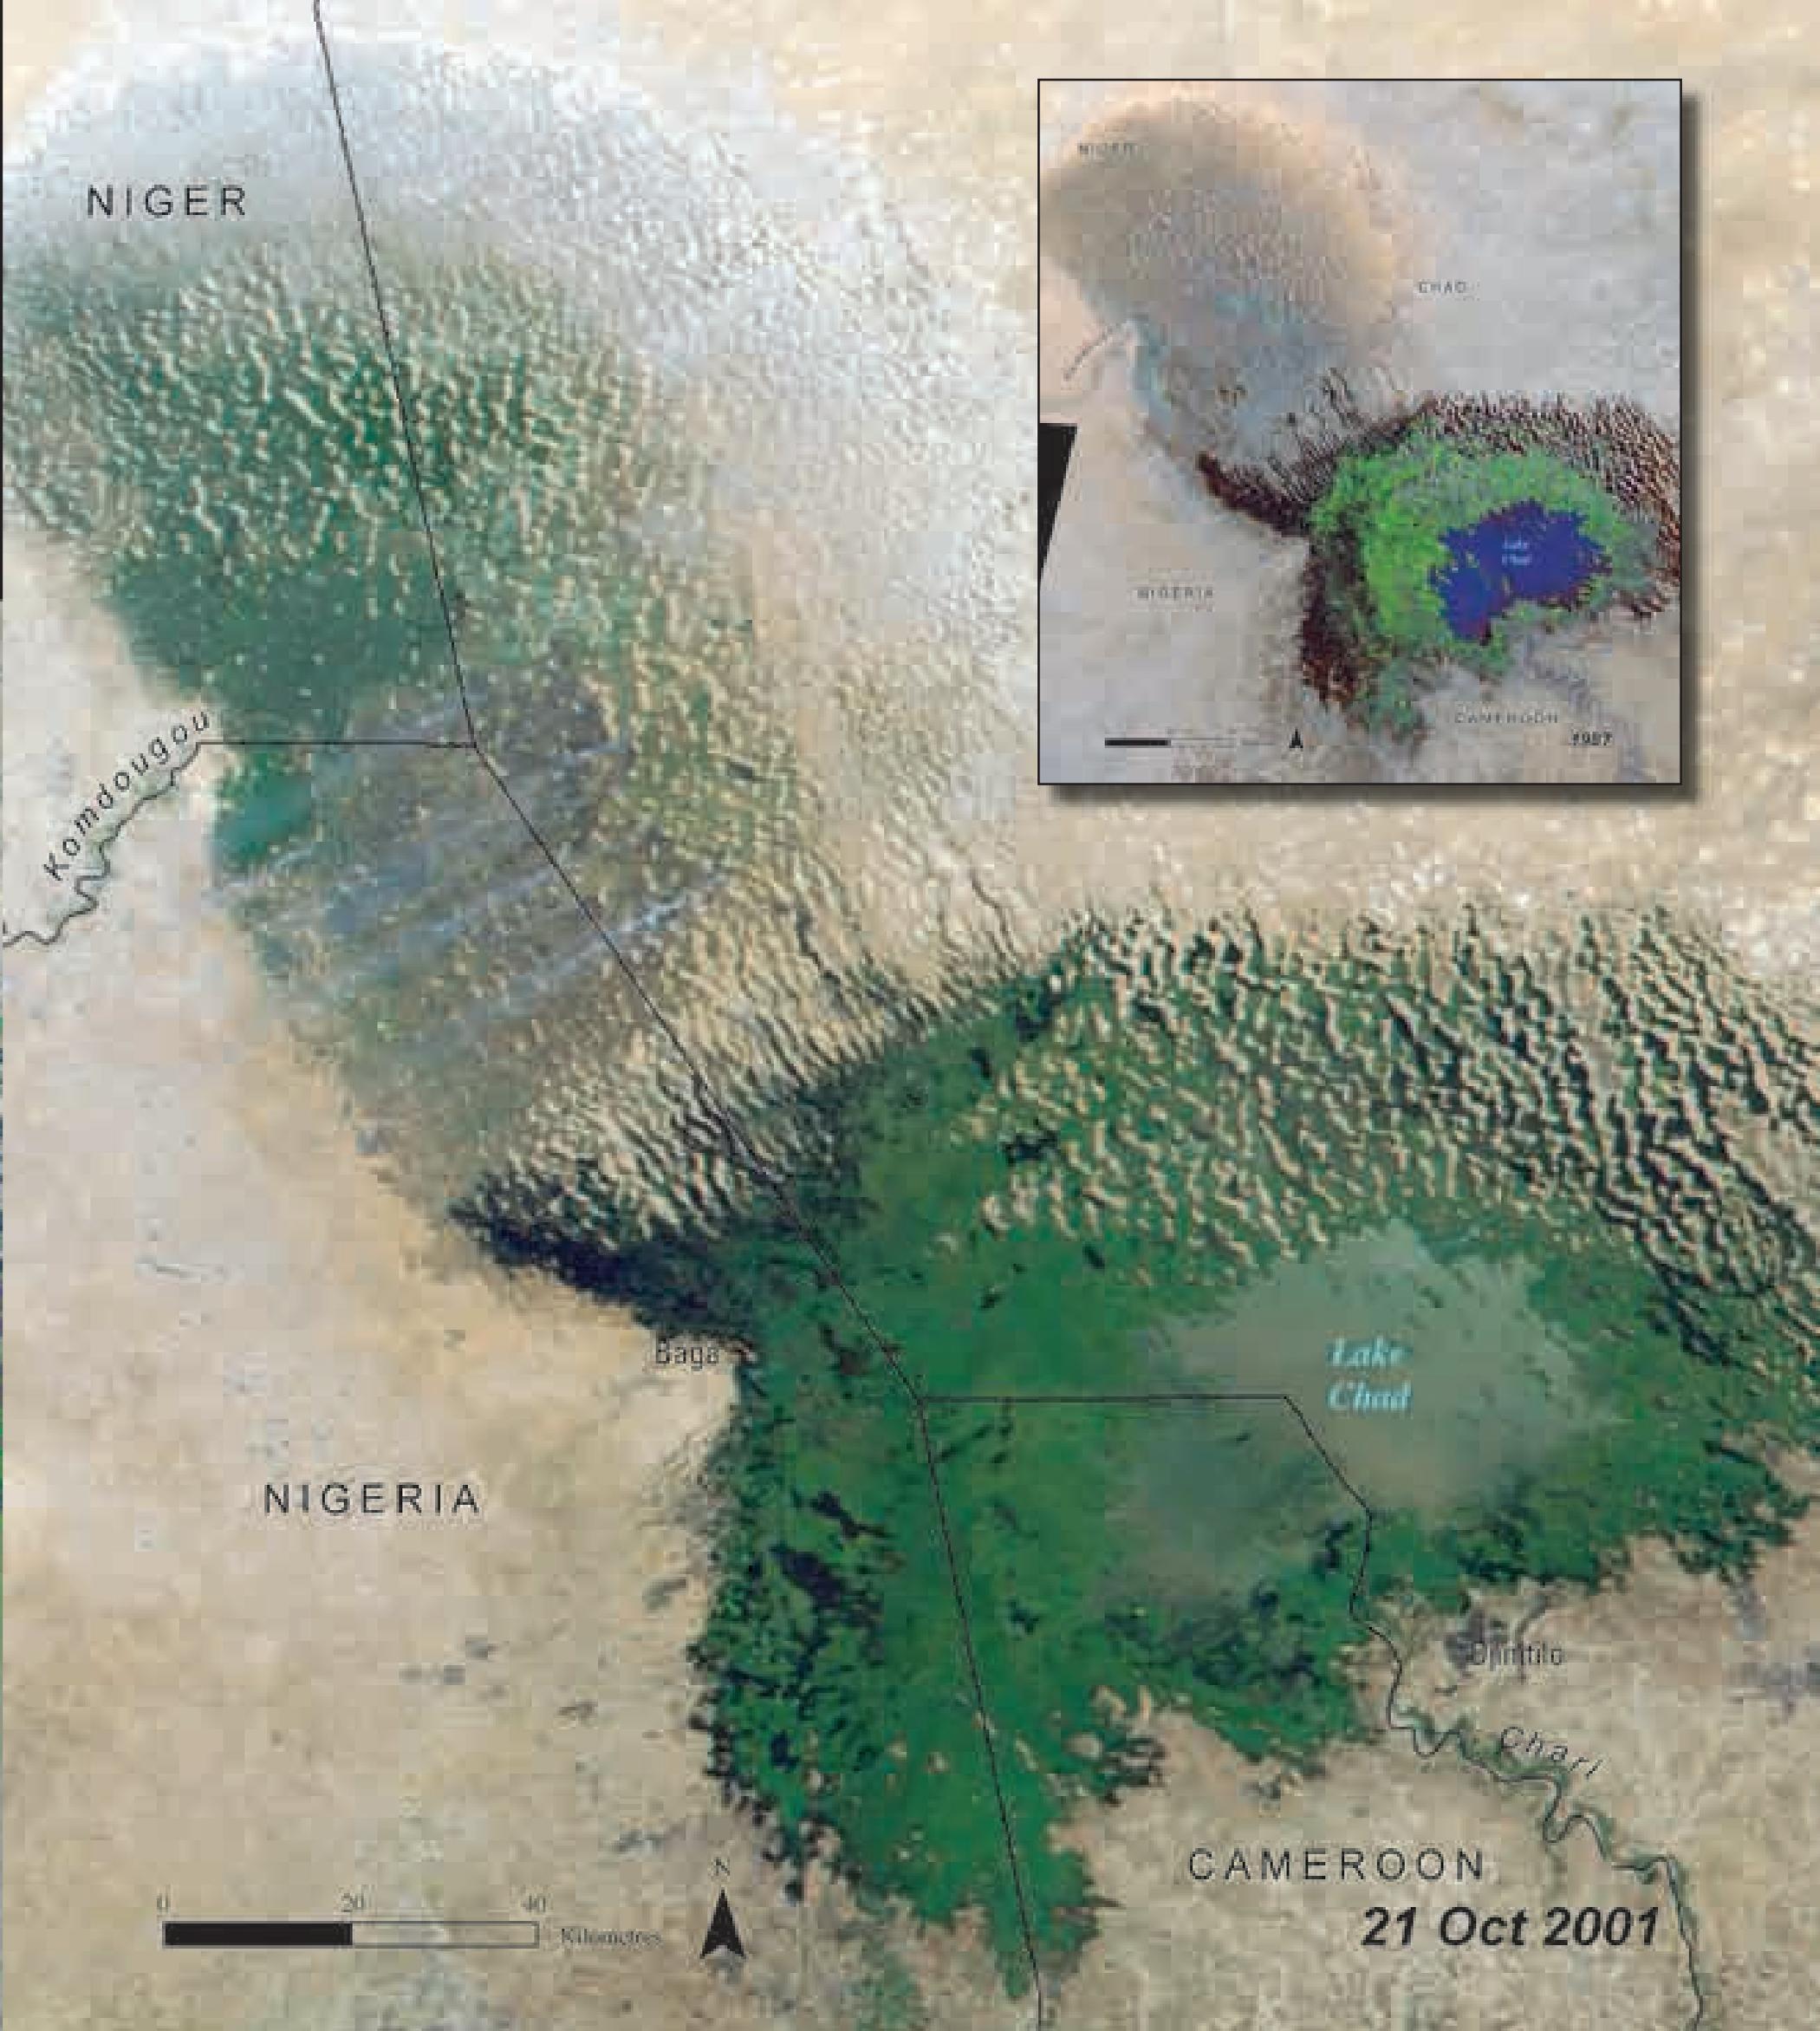
LAKE CHAD, AFRICA

This image set displays a continued decline in lake surface area from 22 902 km² (8 843 square miles) in 1963 to a meager 304 km² (117 square miles) in 2001.

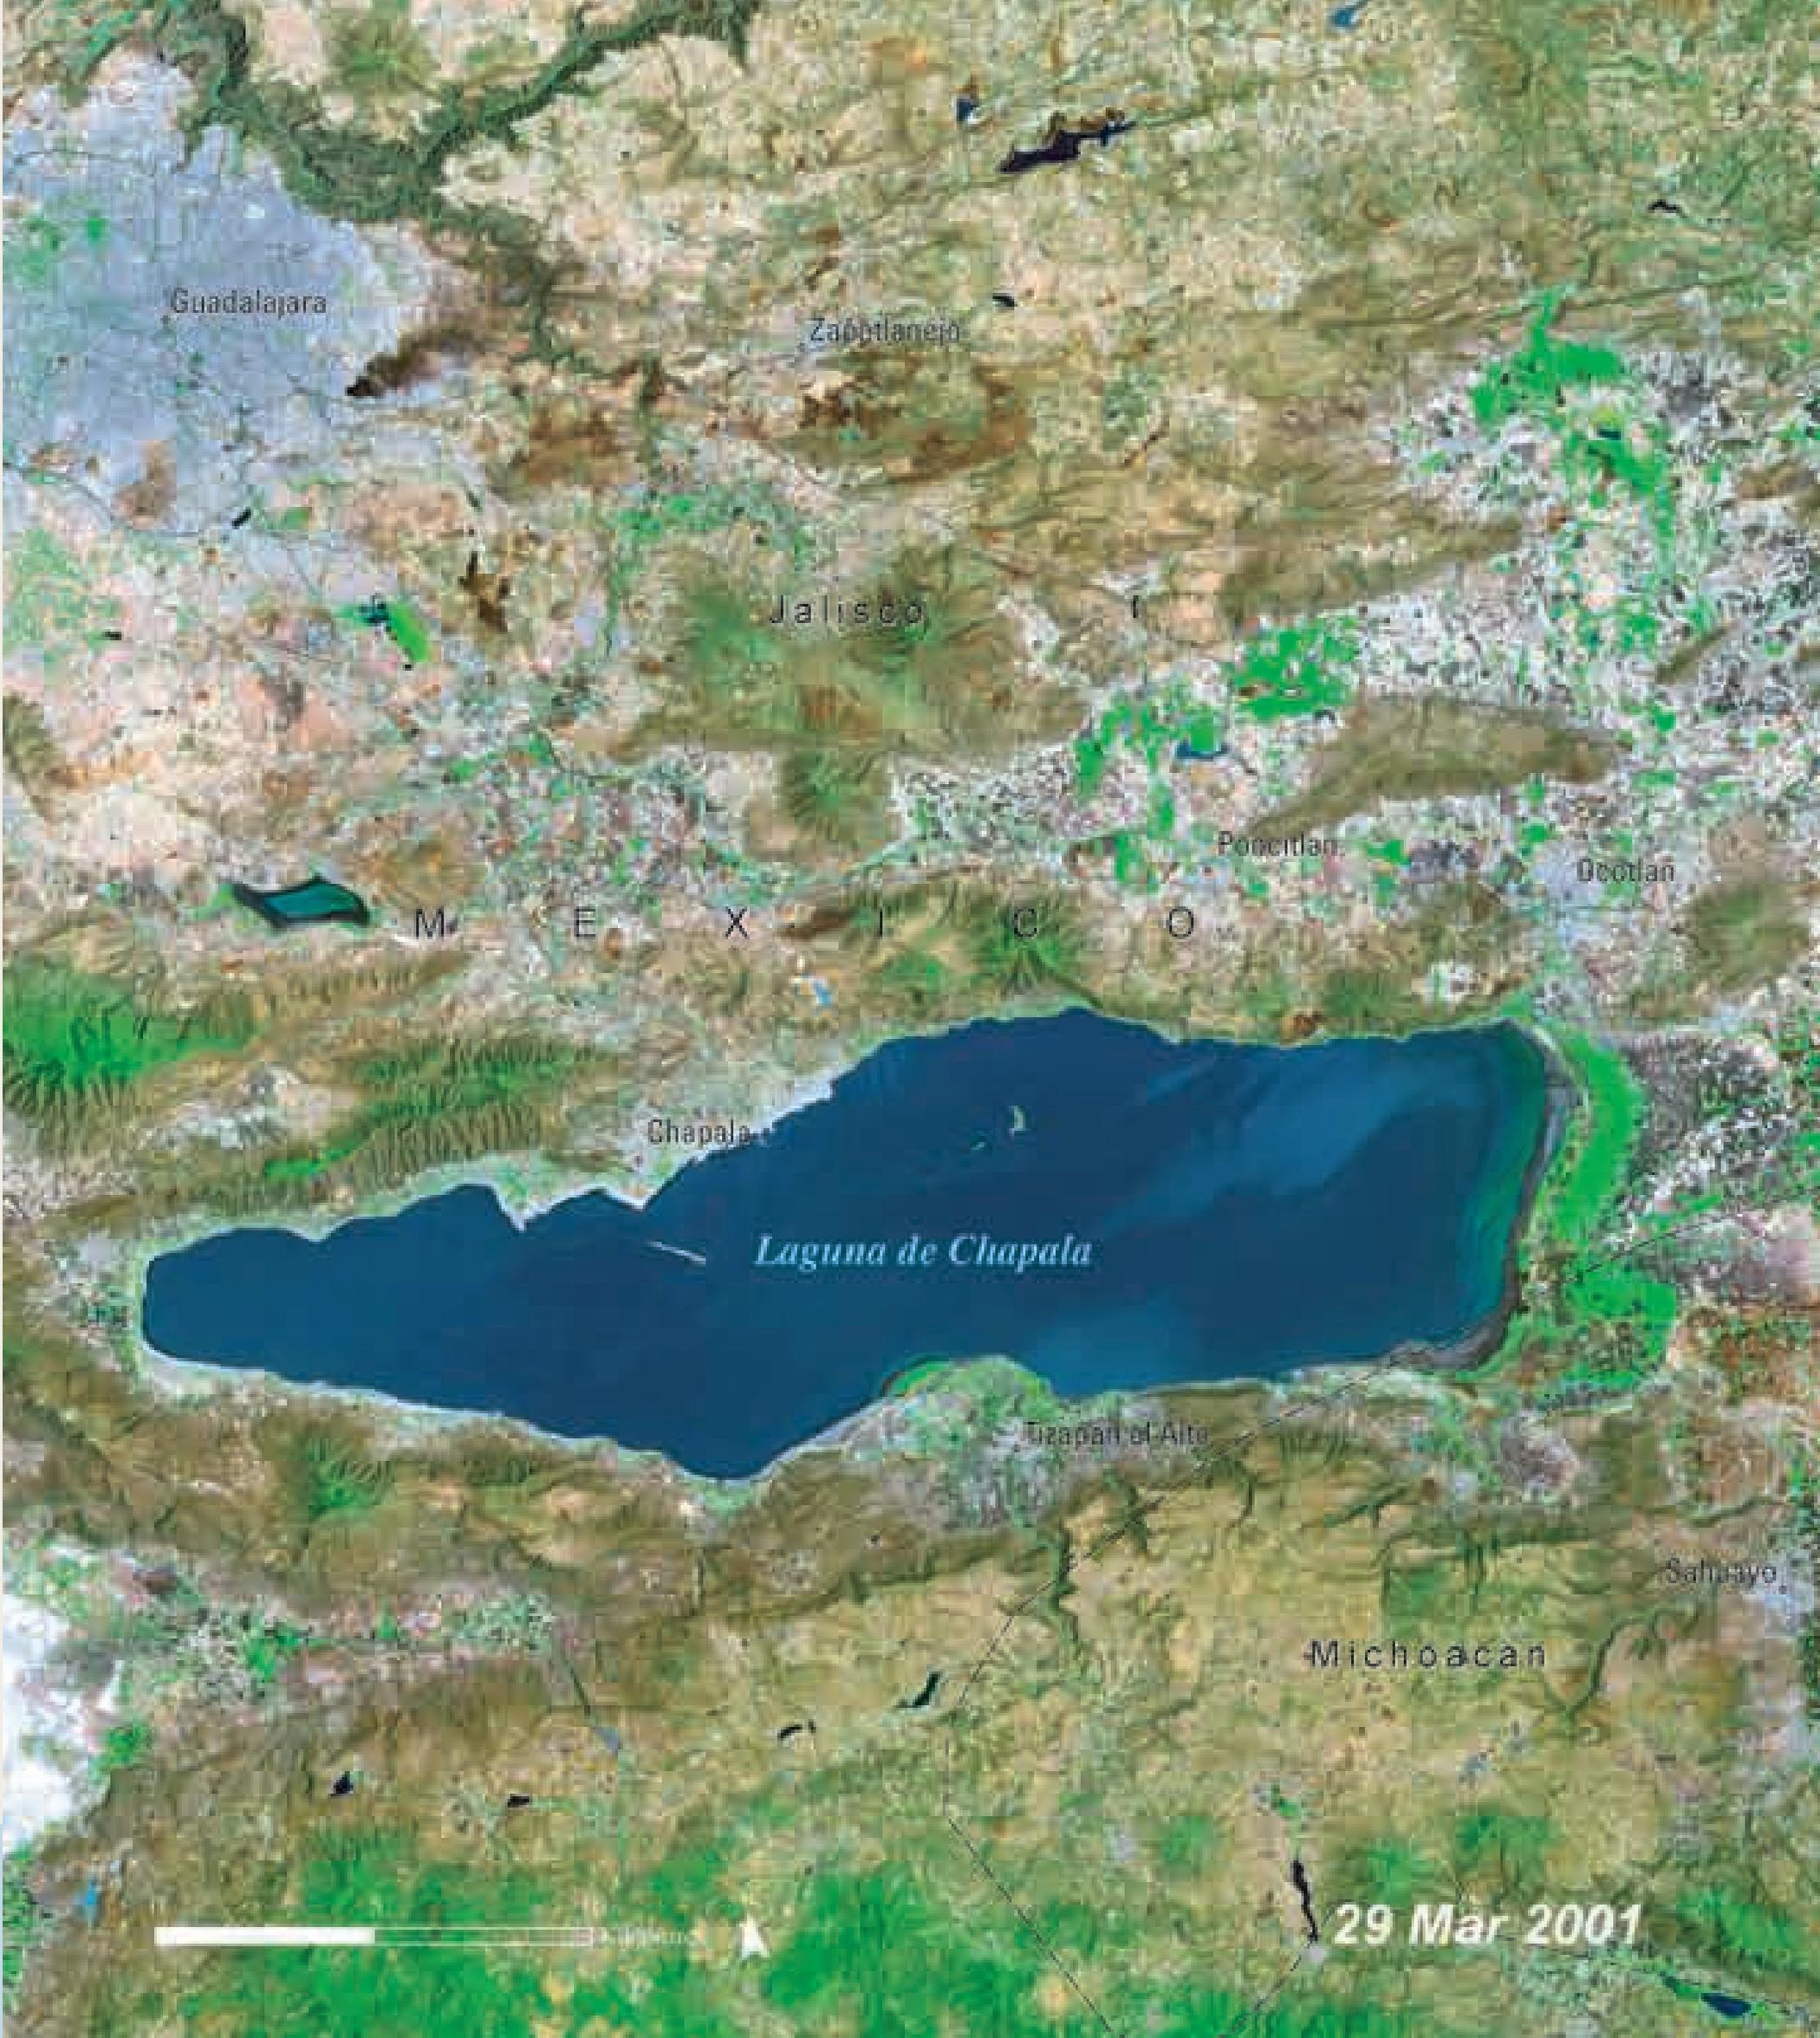
LAKE CHAPALA, MEXICO

Some of these changes are visible in this pair of satellite images, including alterations in the contours of the shoreline, obvious extensions of land near

various townships around the lake, and the appearance of remarkably large areas of reclaimed land at the lake's eastern end. Like all arid areas, the land around Lake Chapala is prone to salinization. If the lake continues to shrink, researchers predict both a decrease in water availability and an increase in the salt content of the region's soil.

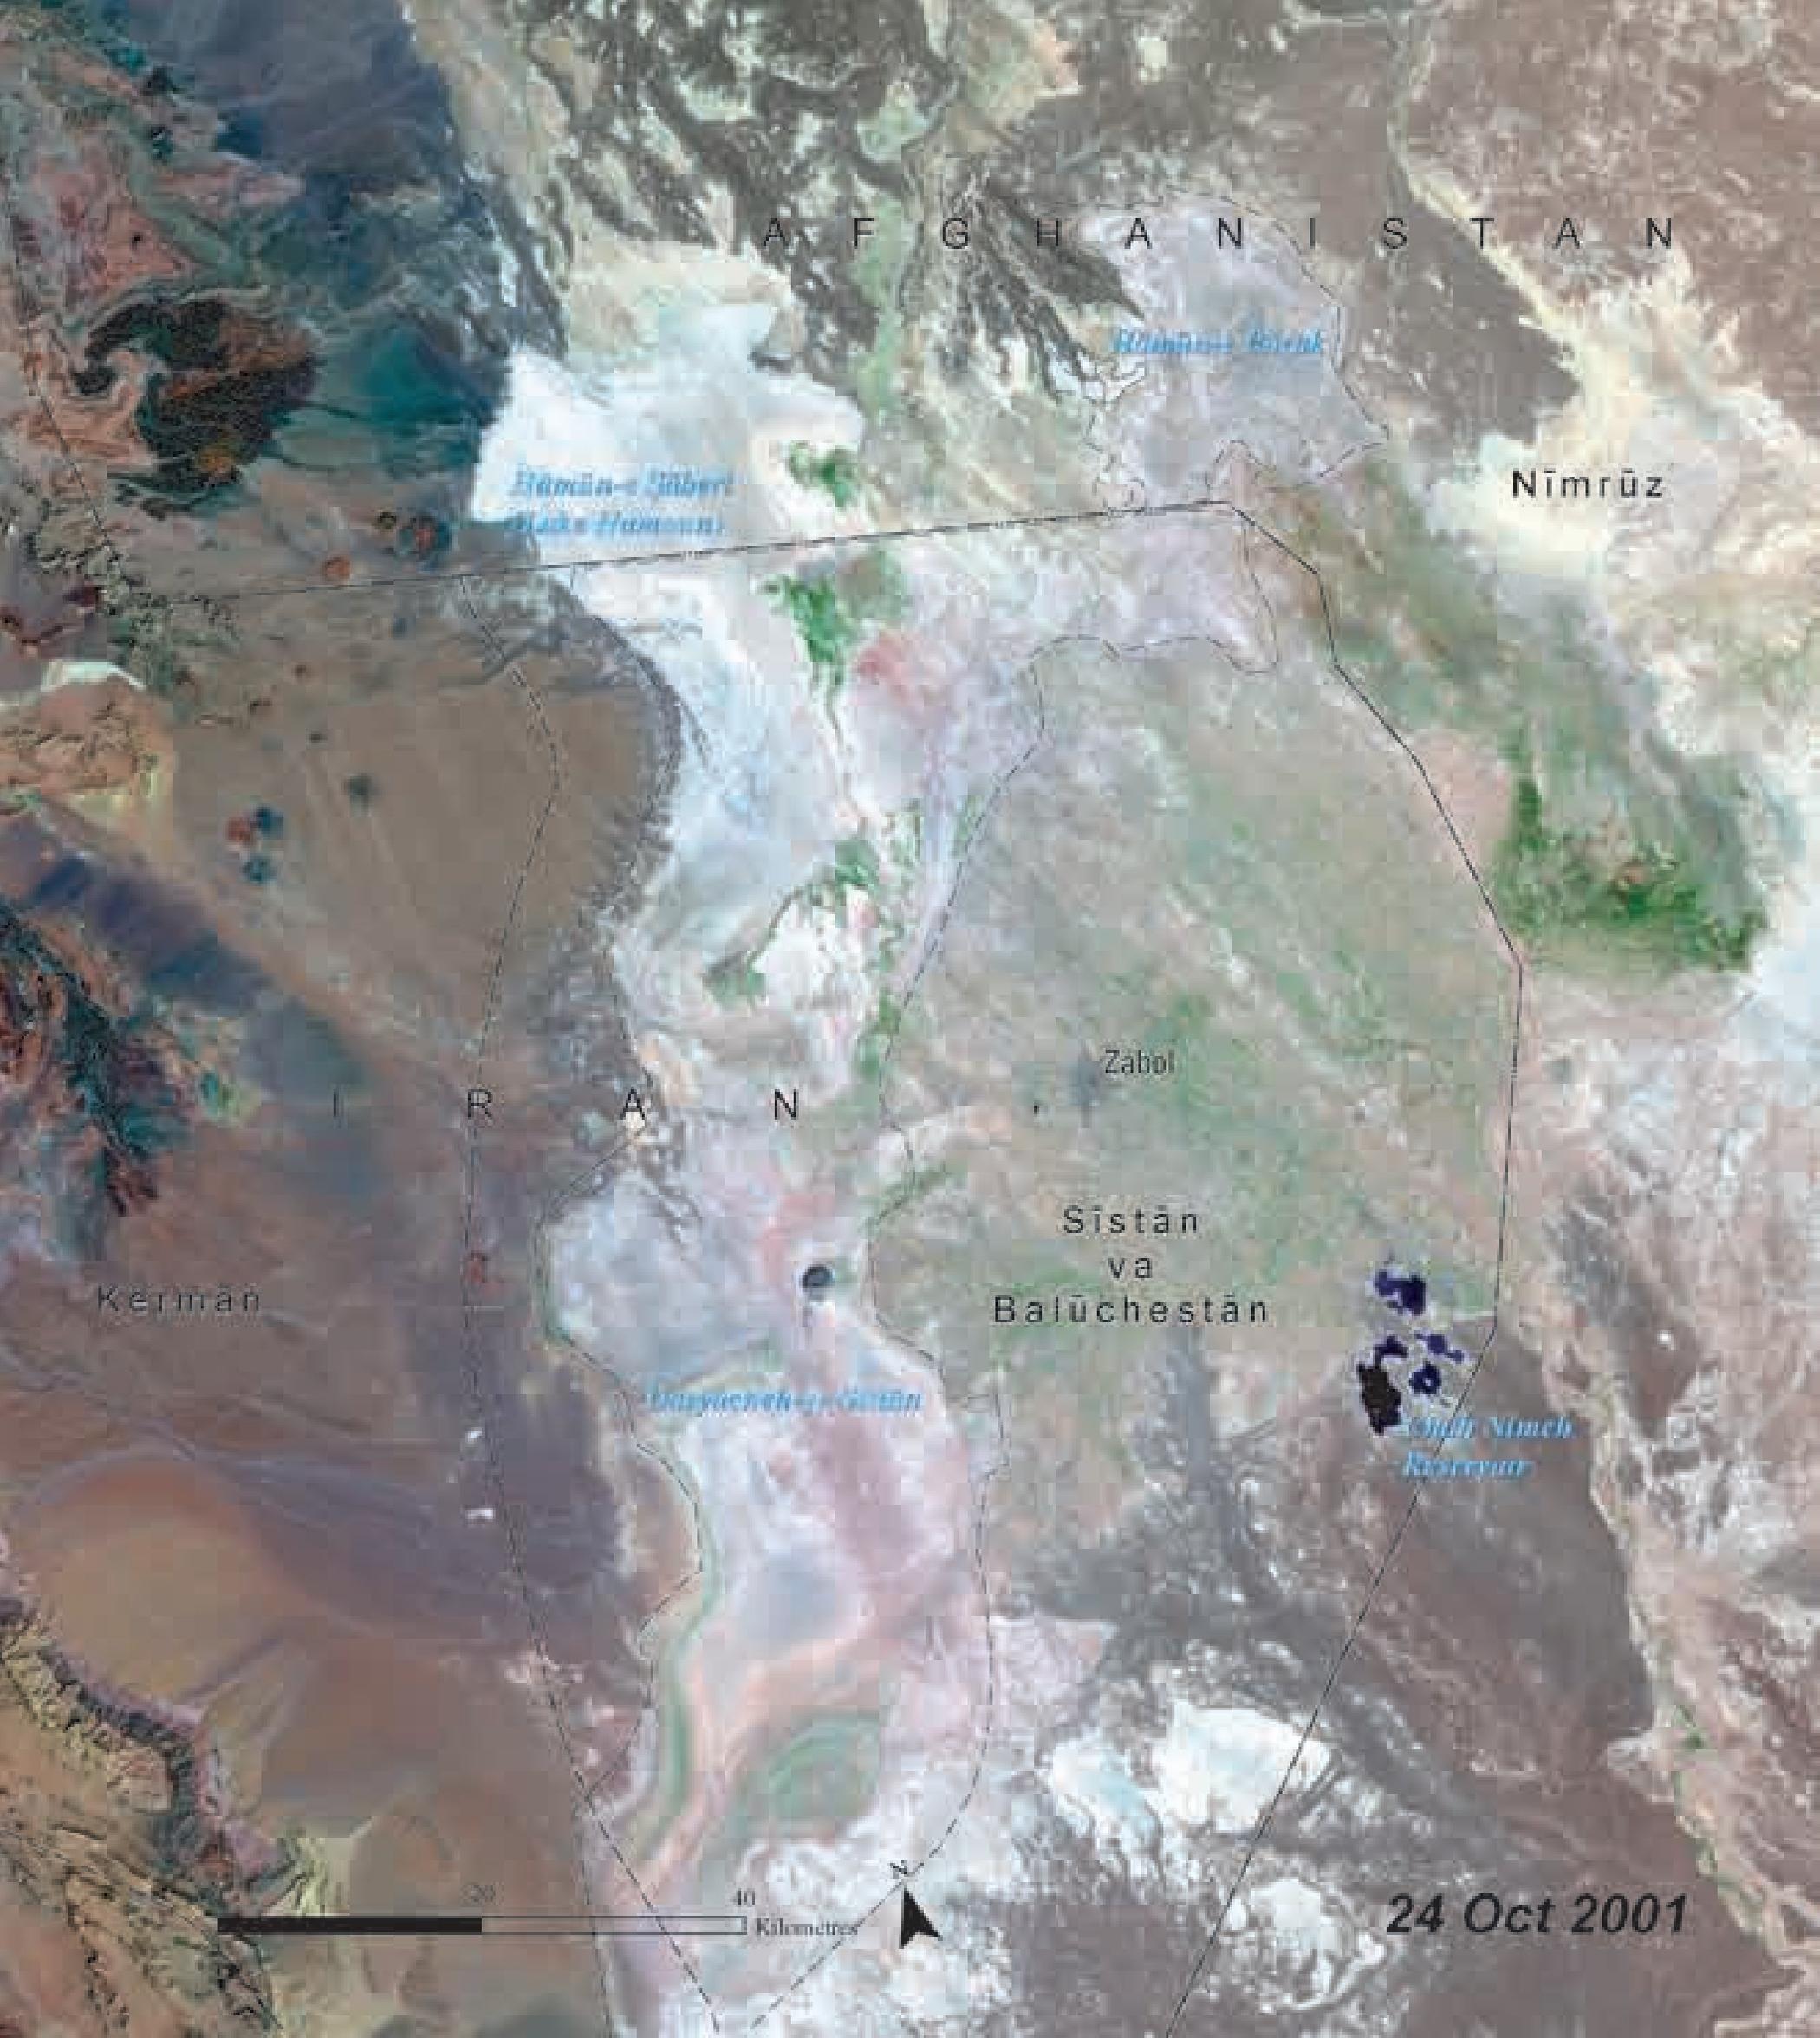
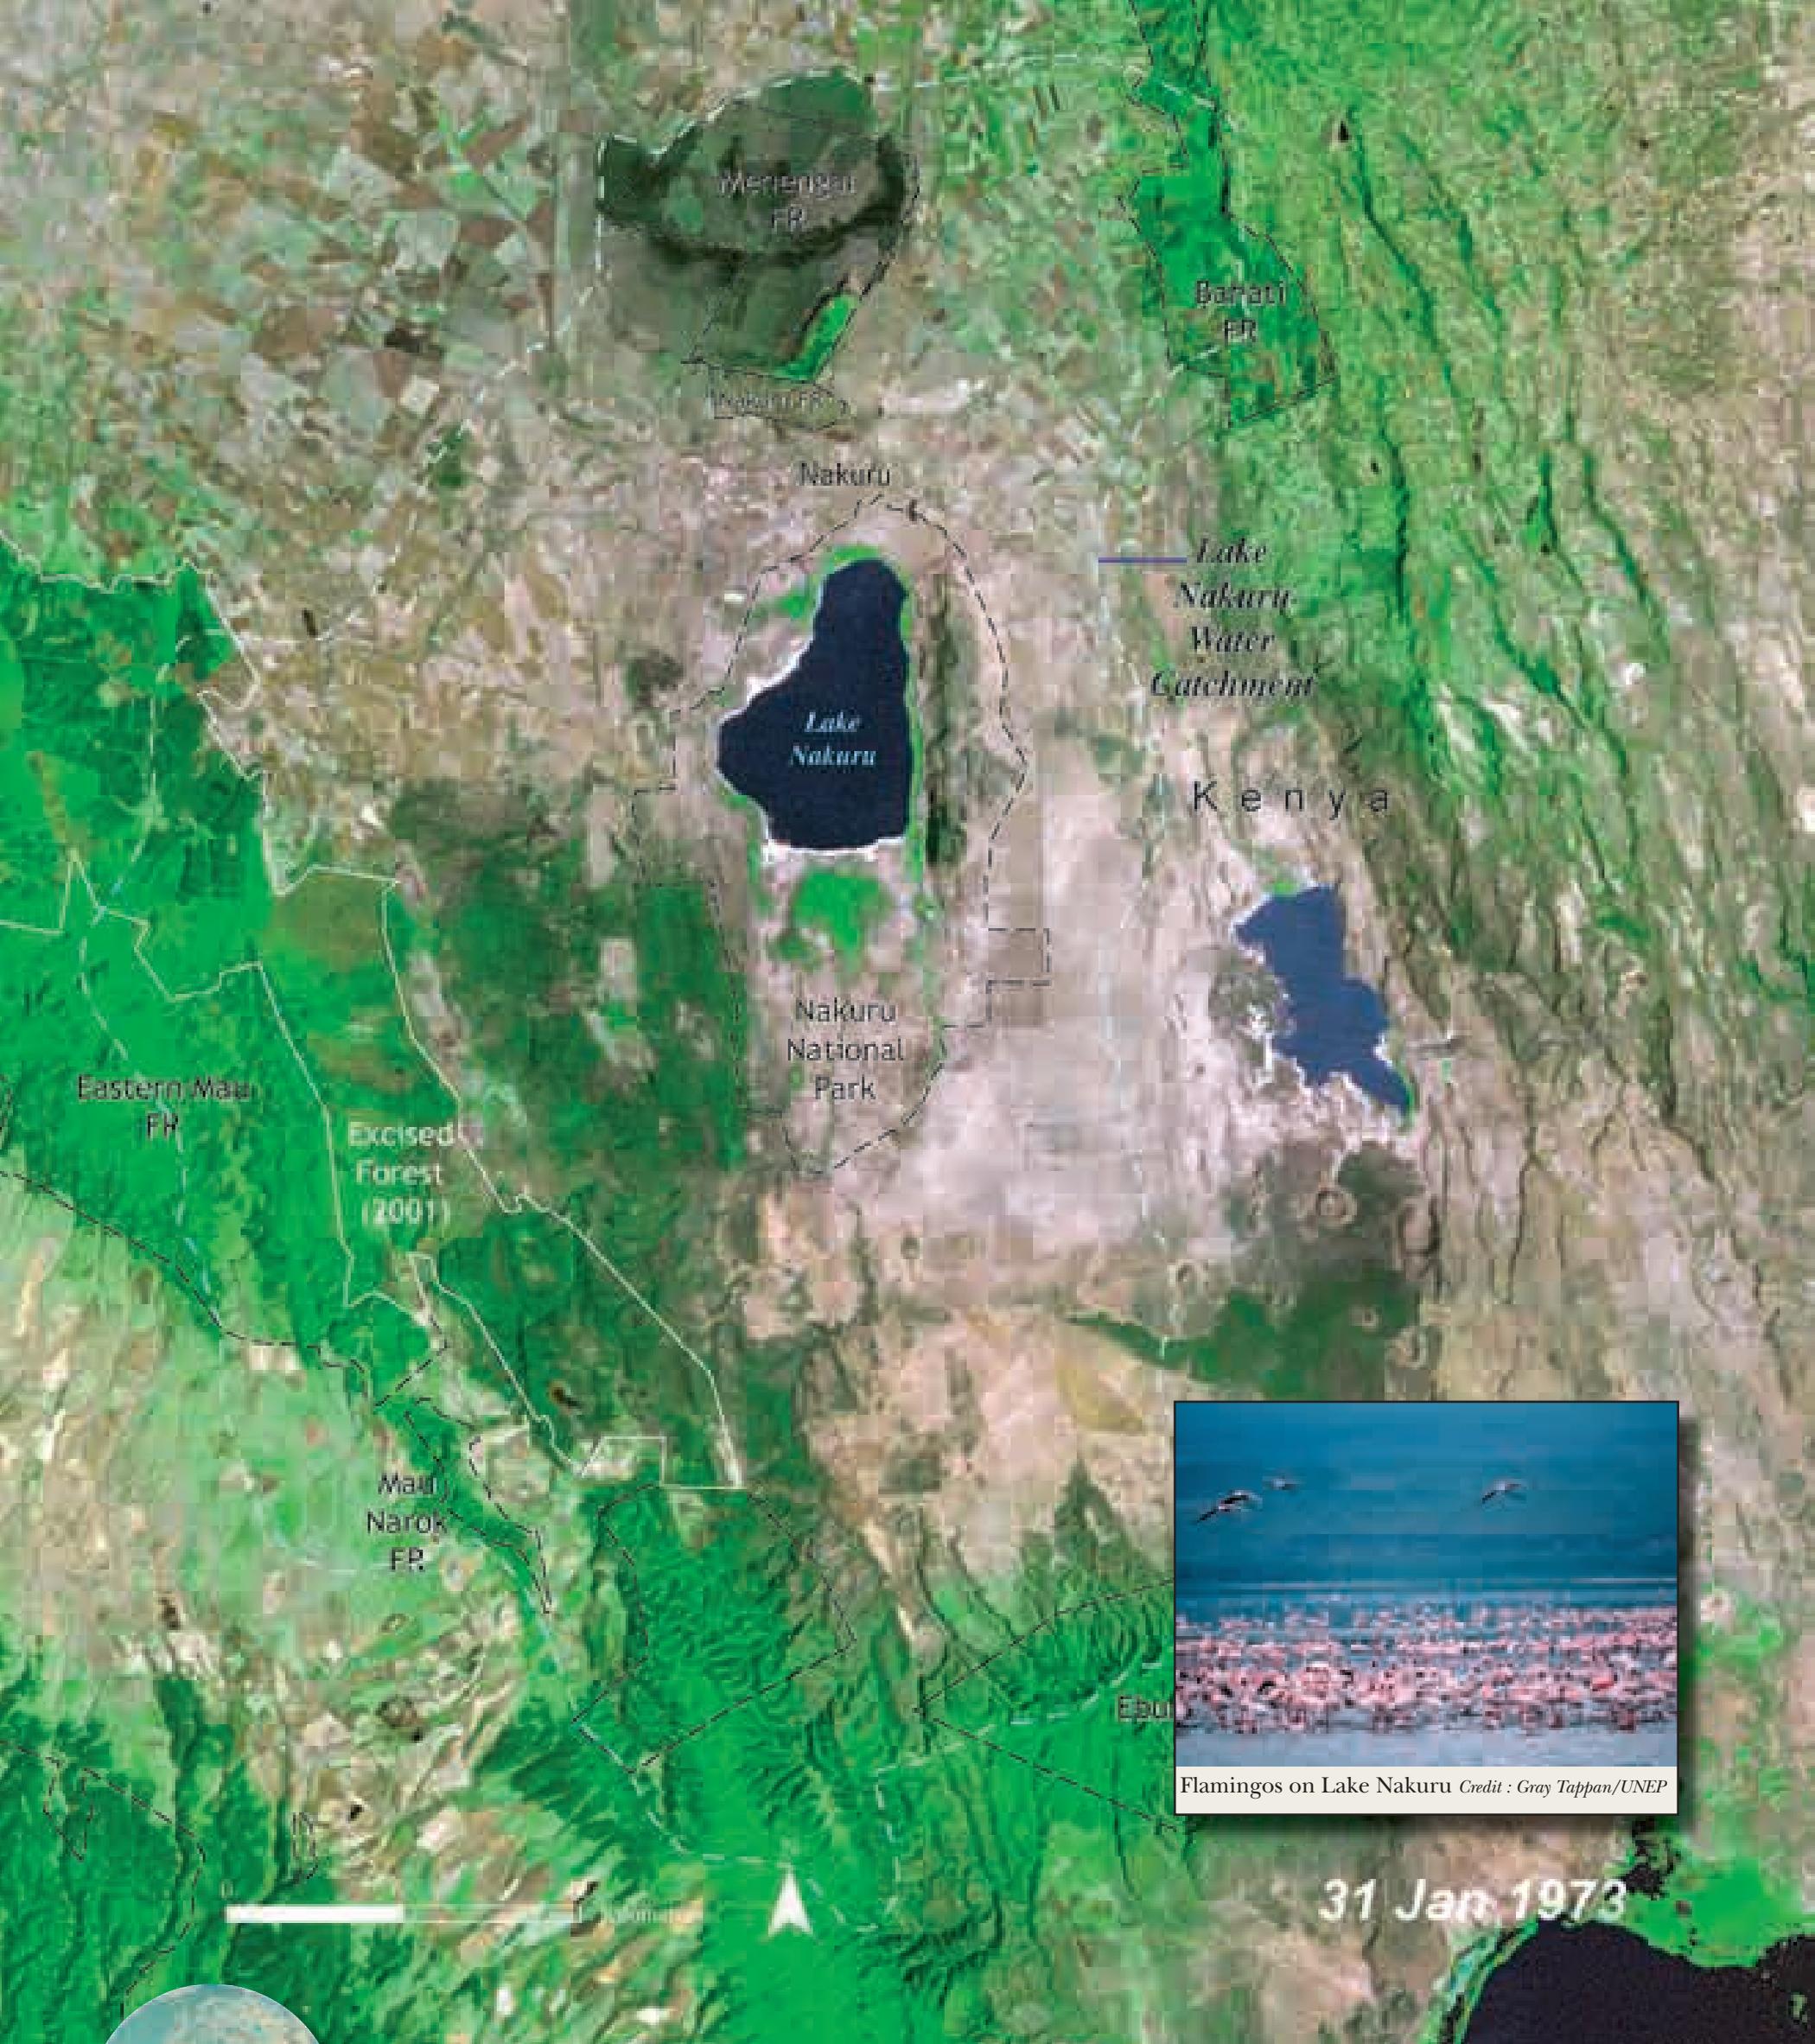
LAKE HAMOUN, IRAN

2001, however, the lake all but dried up and disappeared, as can be seen in the 2001 satellite image above.

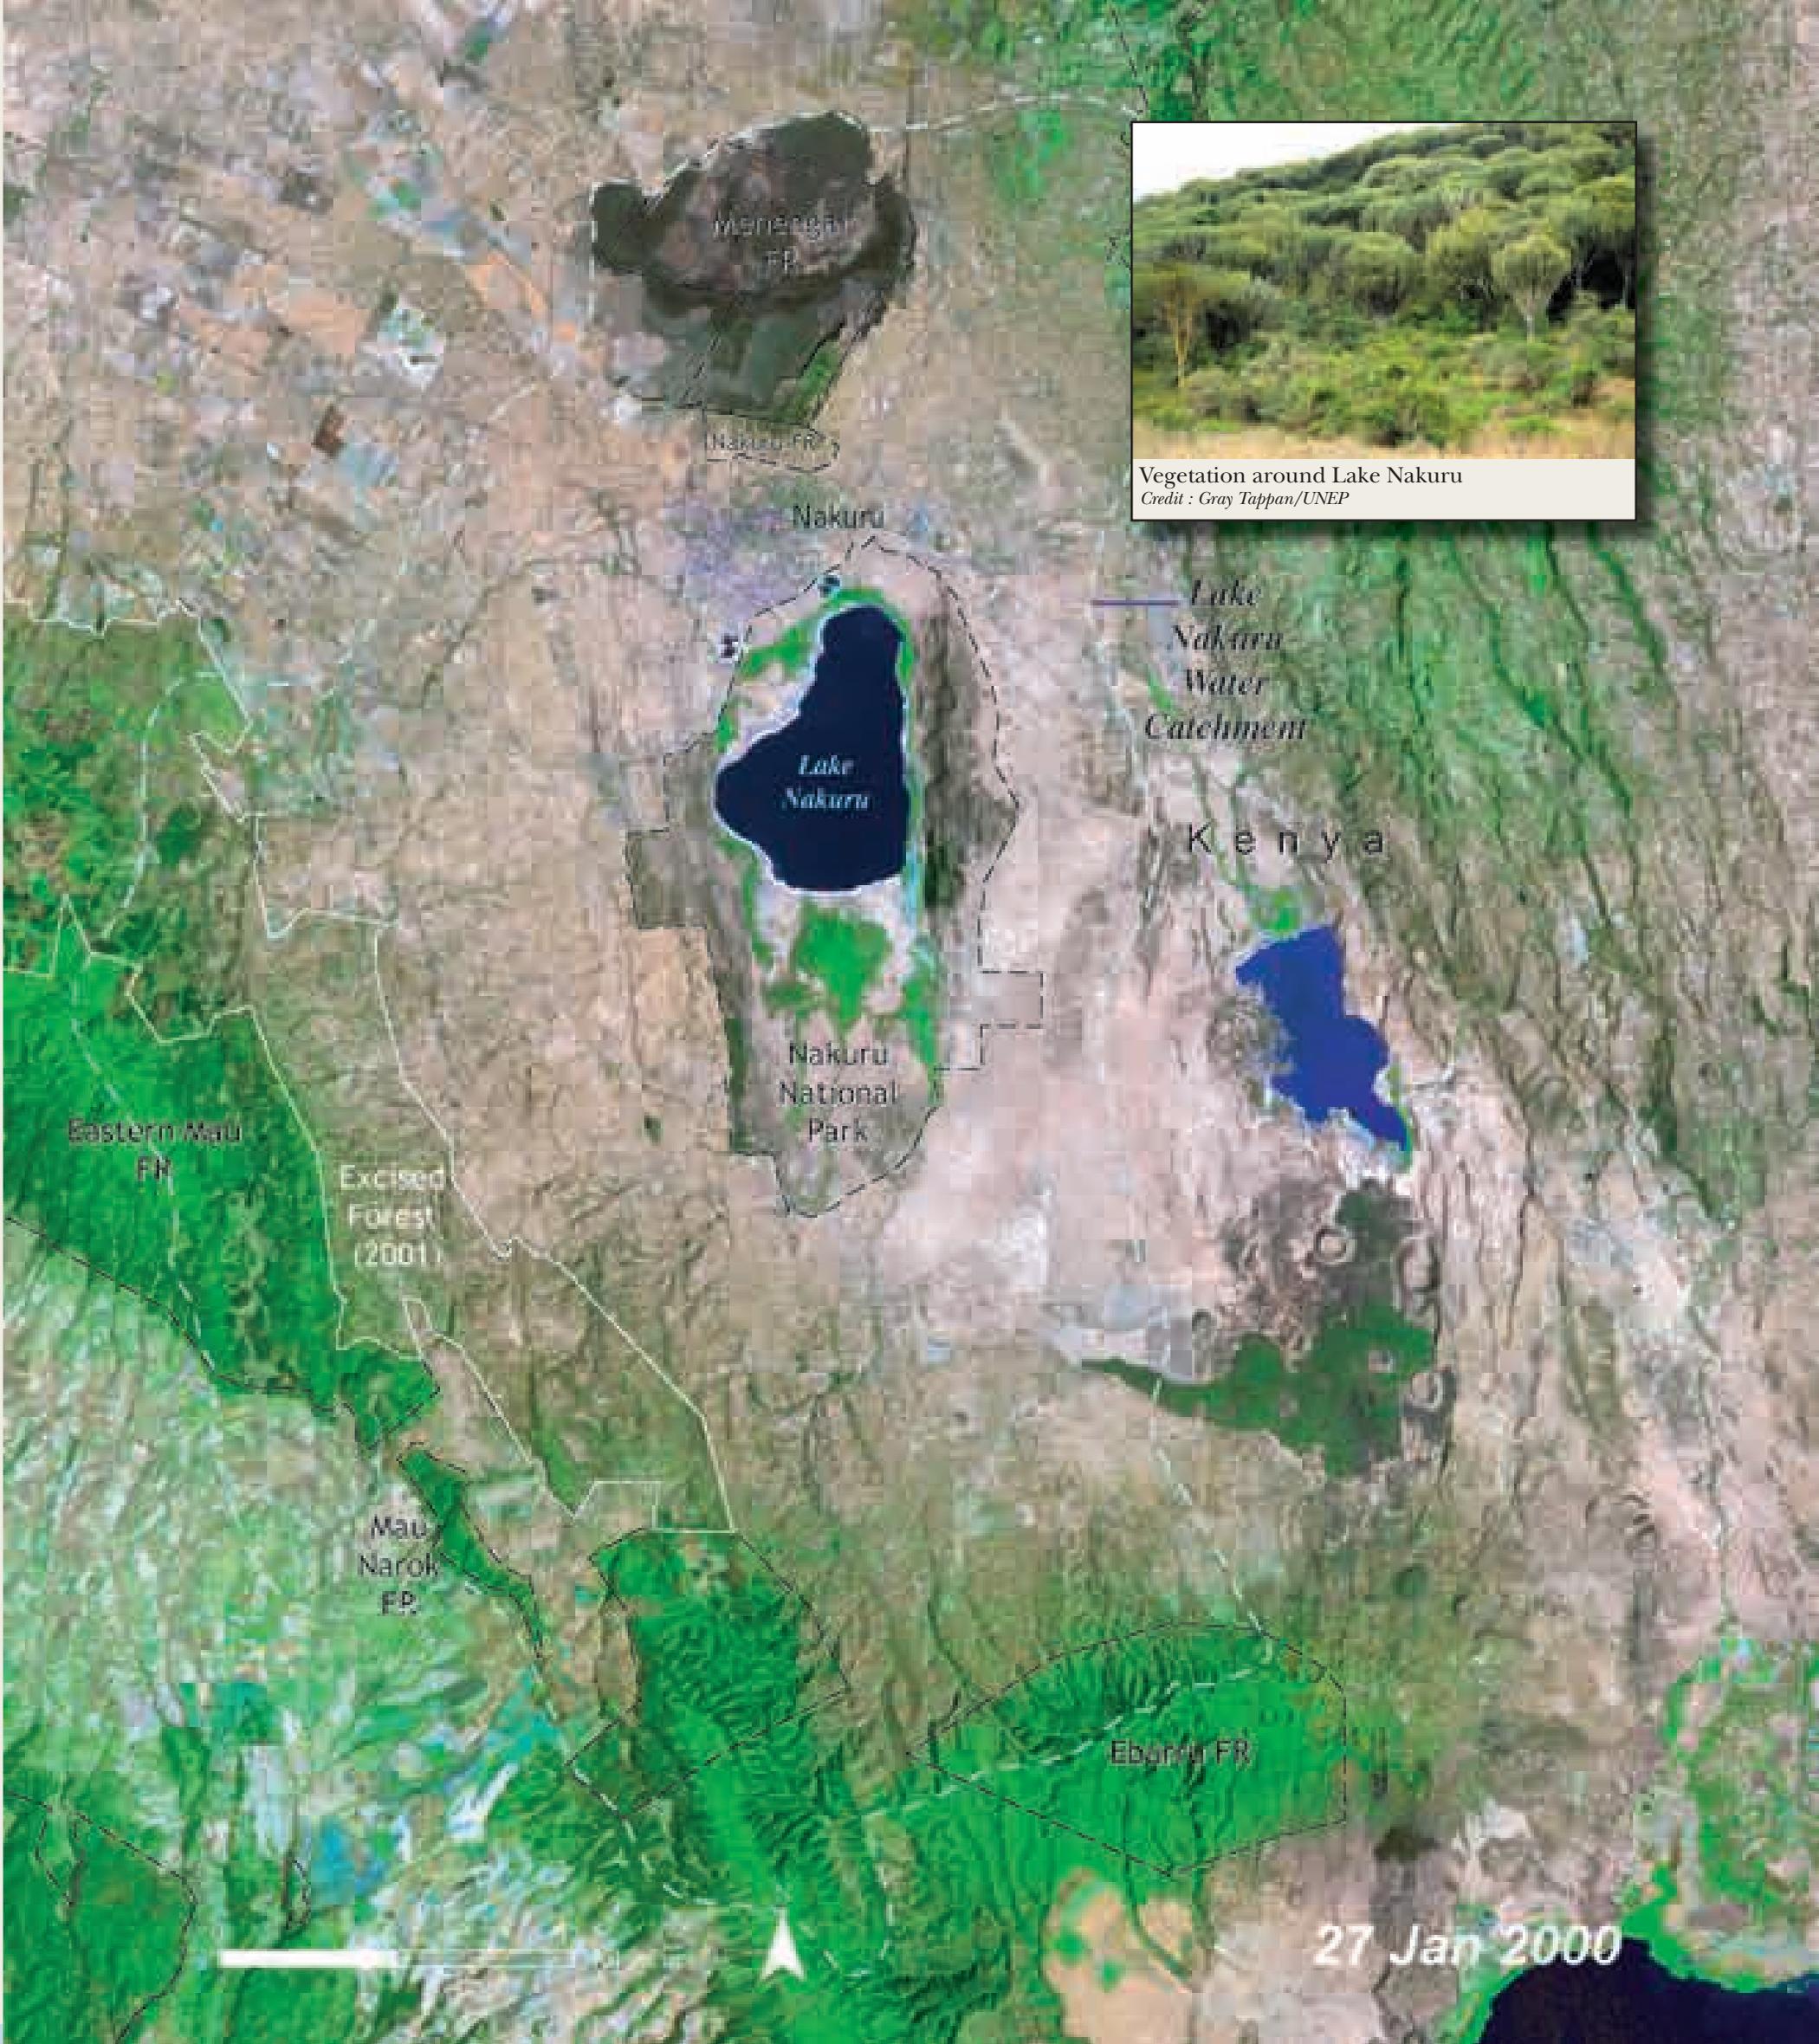
LAKE NAKURU, KENYA

The threat of land cover degradation in the catchments of the lake is likely to increase flow fluctuation and decrease water quality. These images show

the land cover degradation in the lake's catchment between 1973 and 2000.

In 2001, the Government of Kenya announced its intention to excise 353 km² (136 square miles) of forest in the Eastern Mau Forest Reserve (area with white boundary in the 2000 image). As a result, most of the forest cover in the upper catchment of the main rivers that feed Lake Nakuru will disappear.

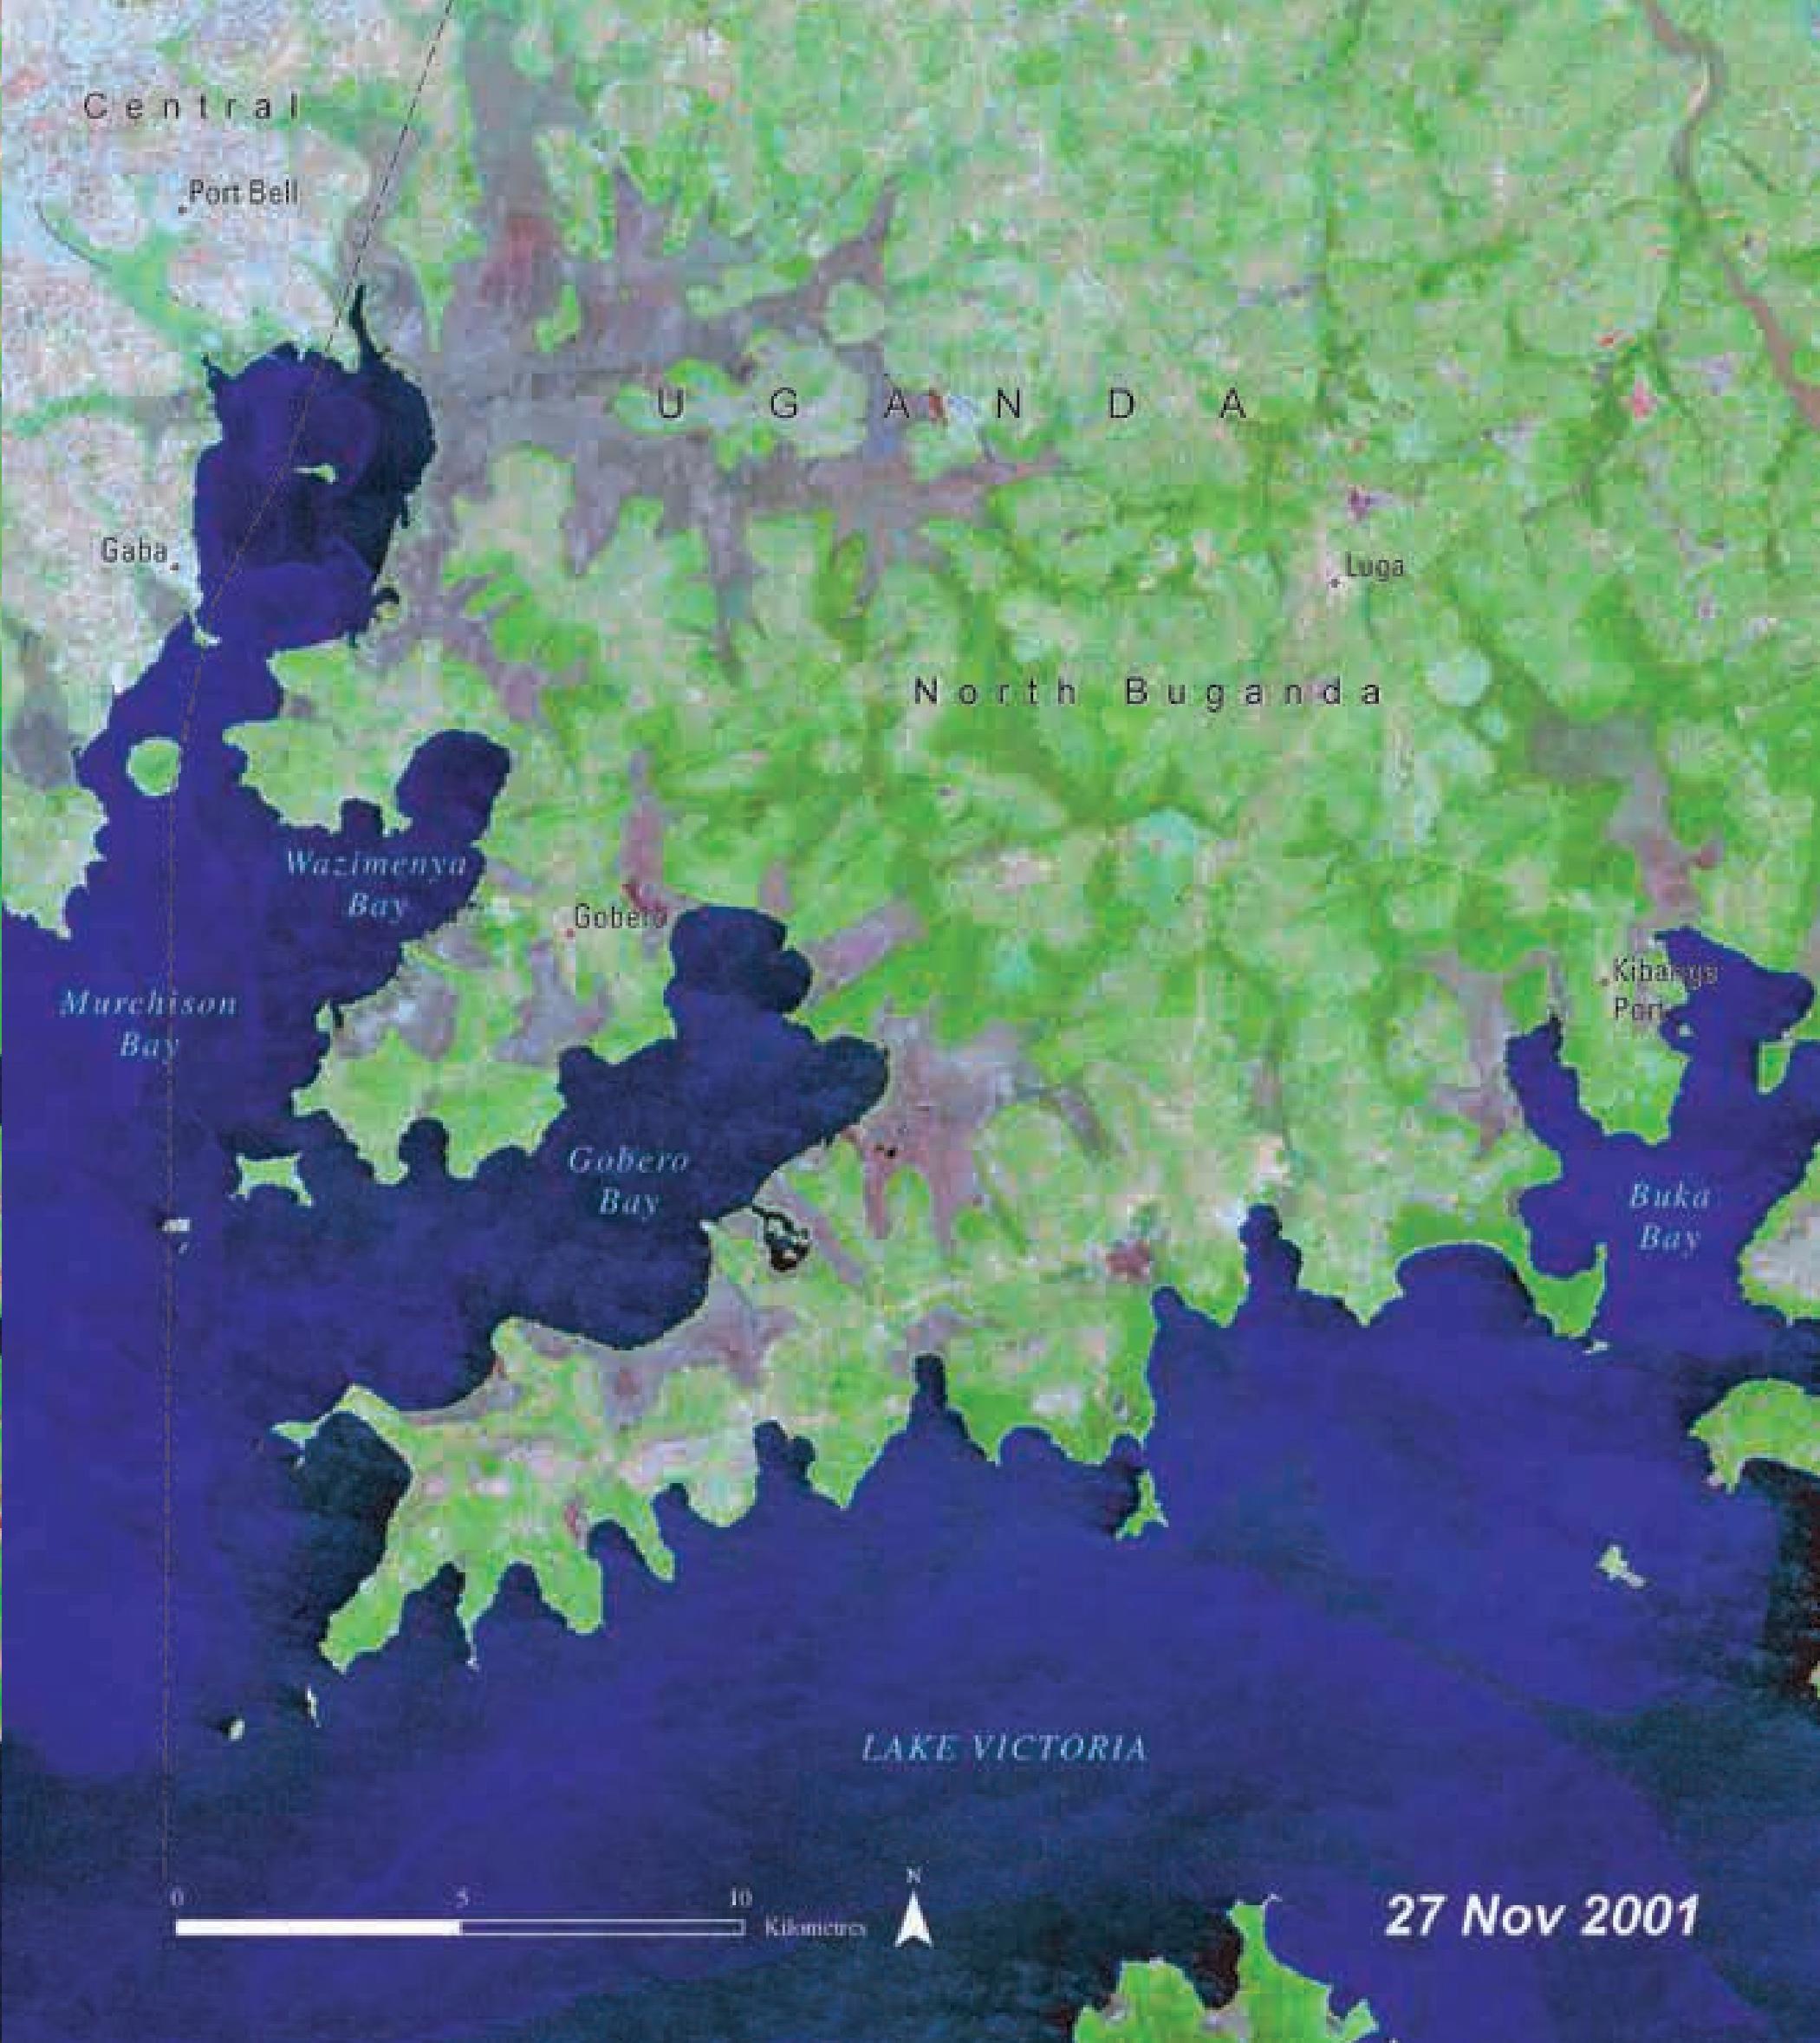
WATER
LAKE VICTORIA, UGANDA

The 1995 image shows several water-hyacinth-choked bays: Murchison Bay near Gaba; large parts of Gobero and Wazimenya Bays; an area outside Buka Bay; and near Kibanga Port (yellow arrows).

Initially, water hyacinth was controlled by hand, with the plants being manually removed from the lake. But re-growth quickly occurred. A more recent control measure has been the careful introduction of natural insect predators of water hyacinth. As the 2001 image shows, this approach seems to have been successful, as the floating weeds have disappeared from all the locations noted above.
