3.3 Water

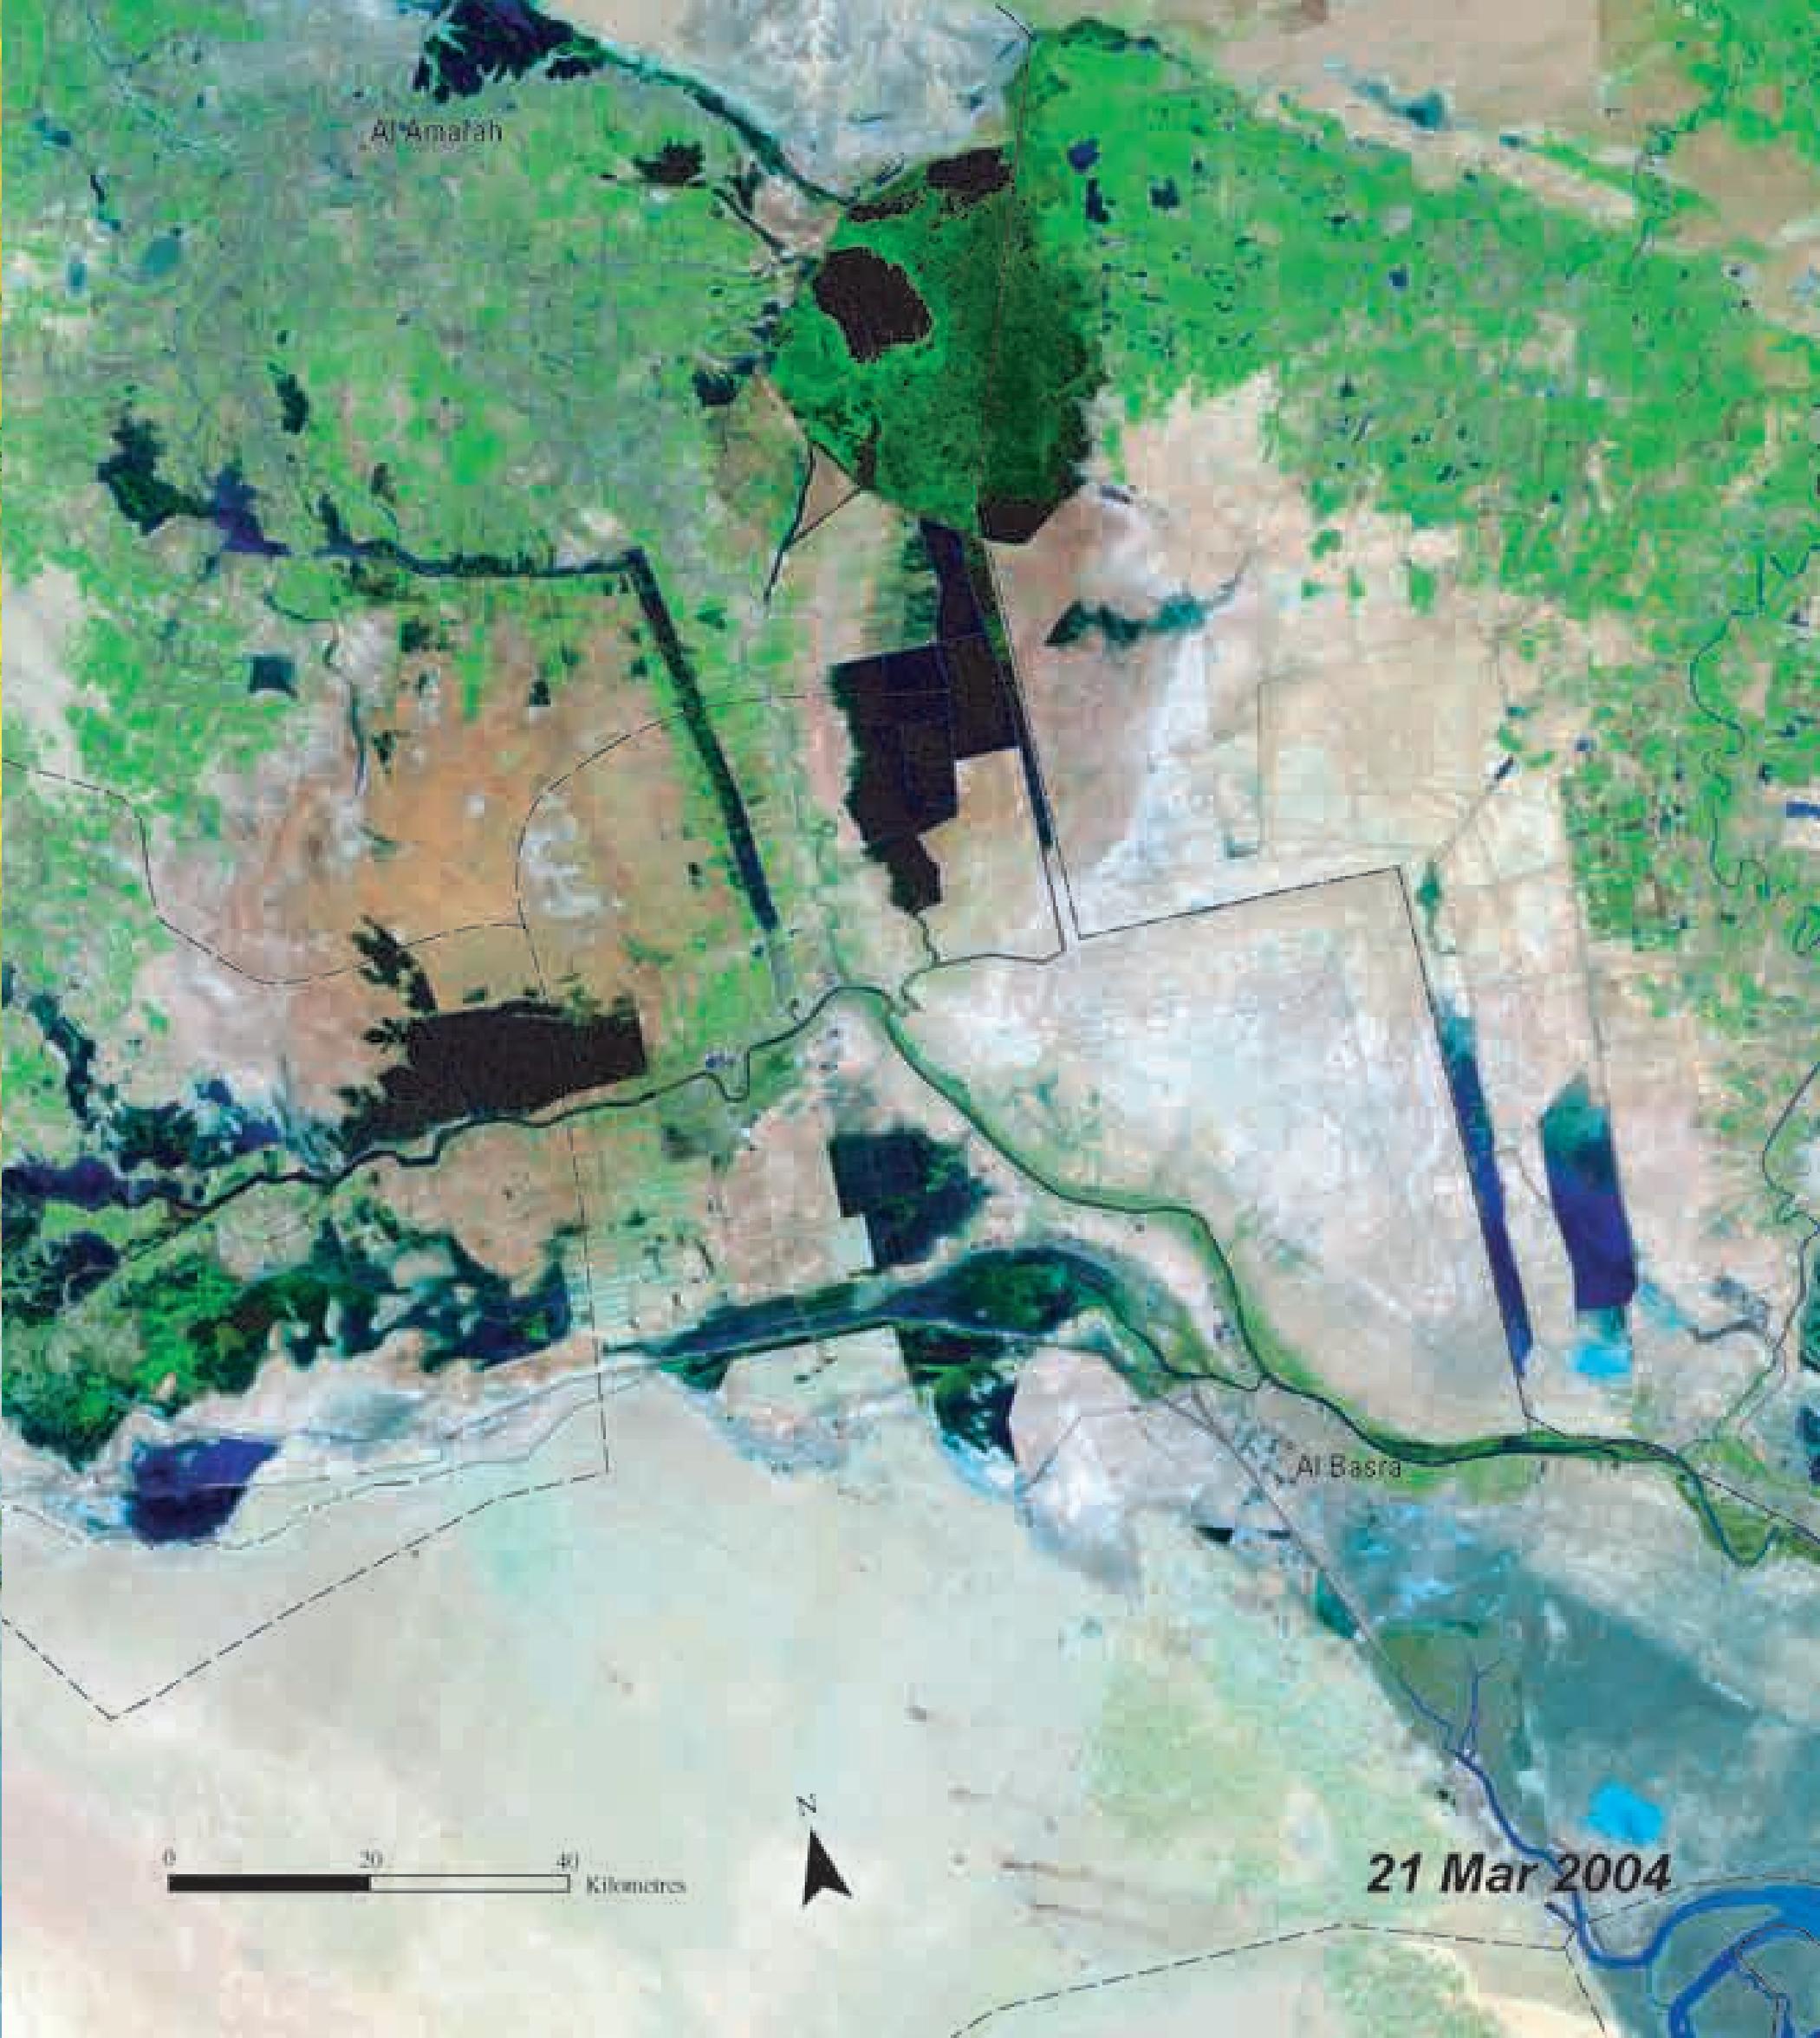
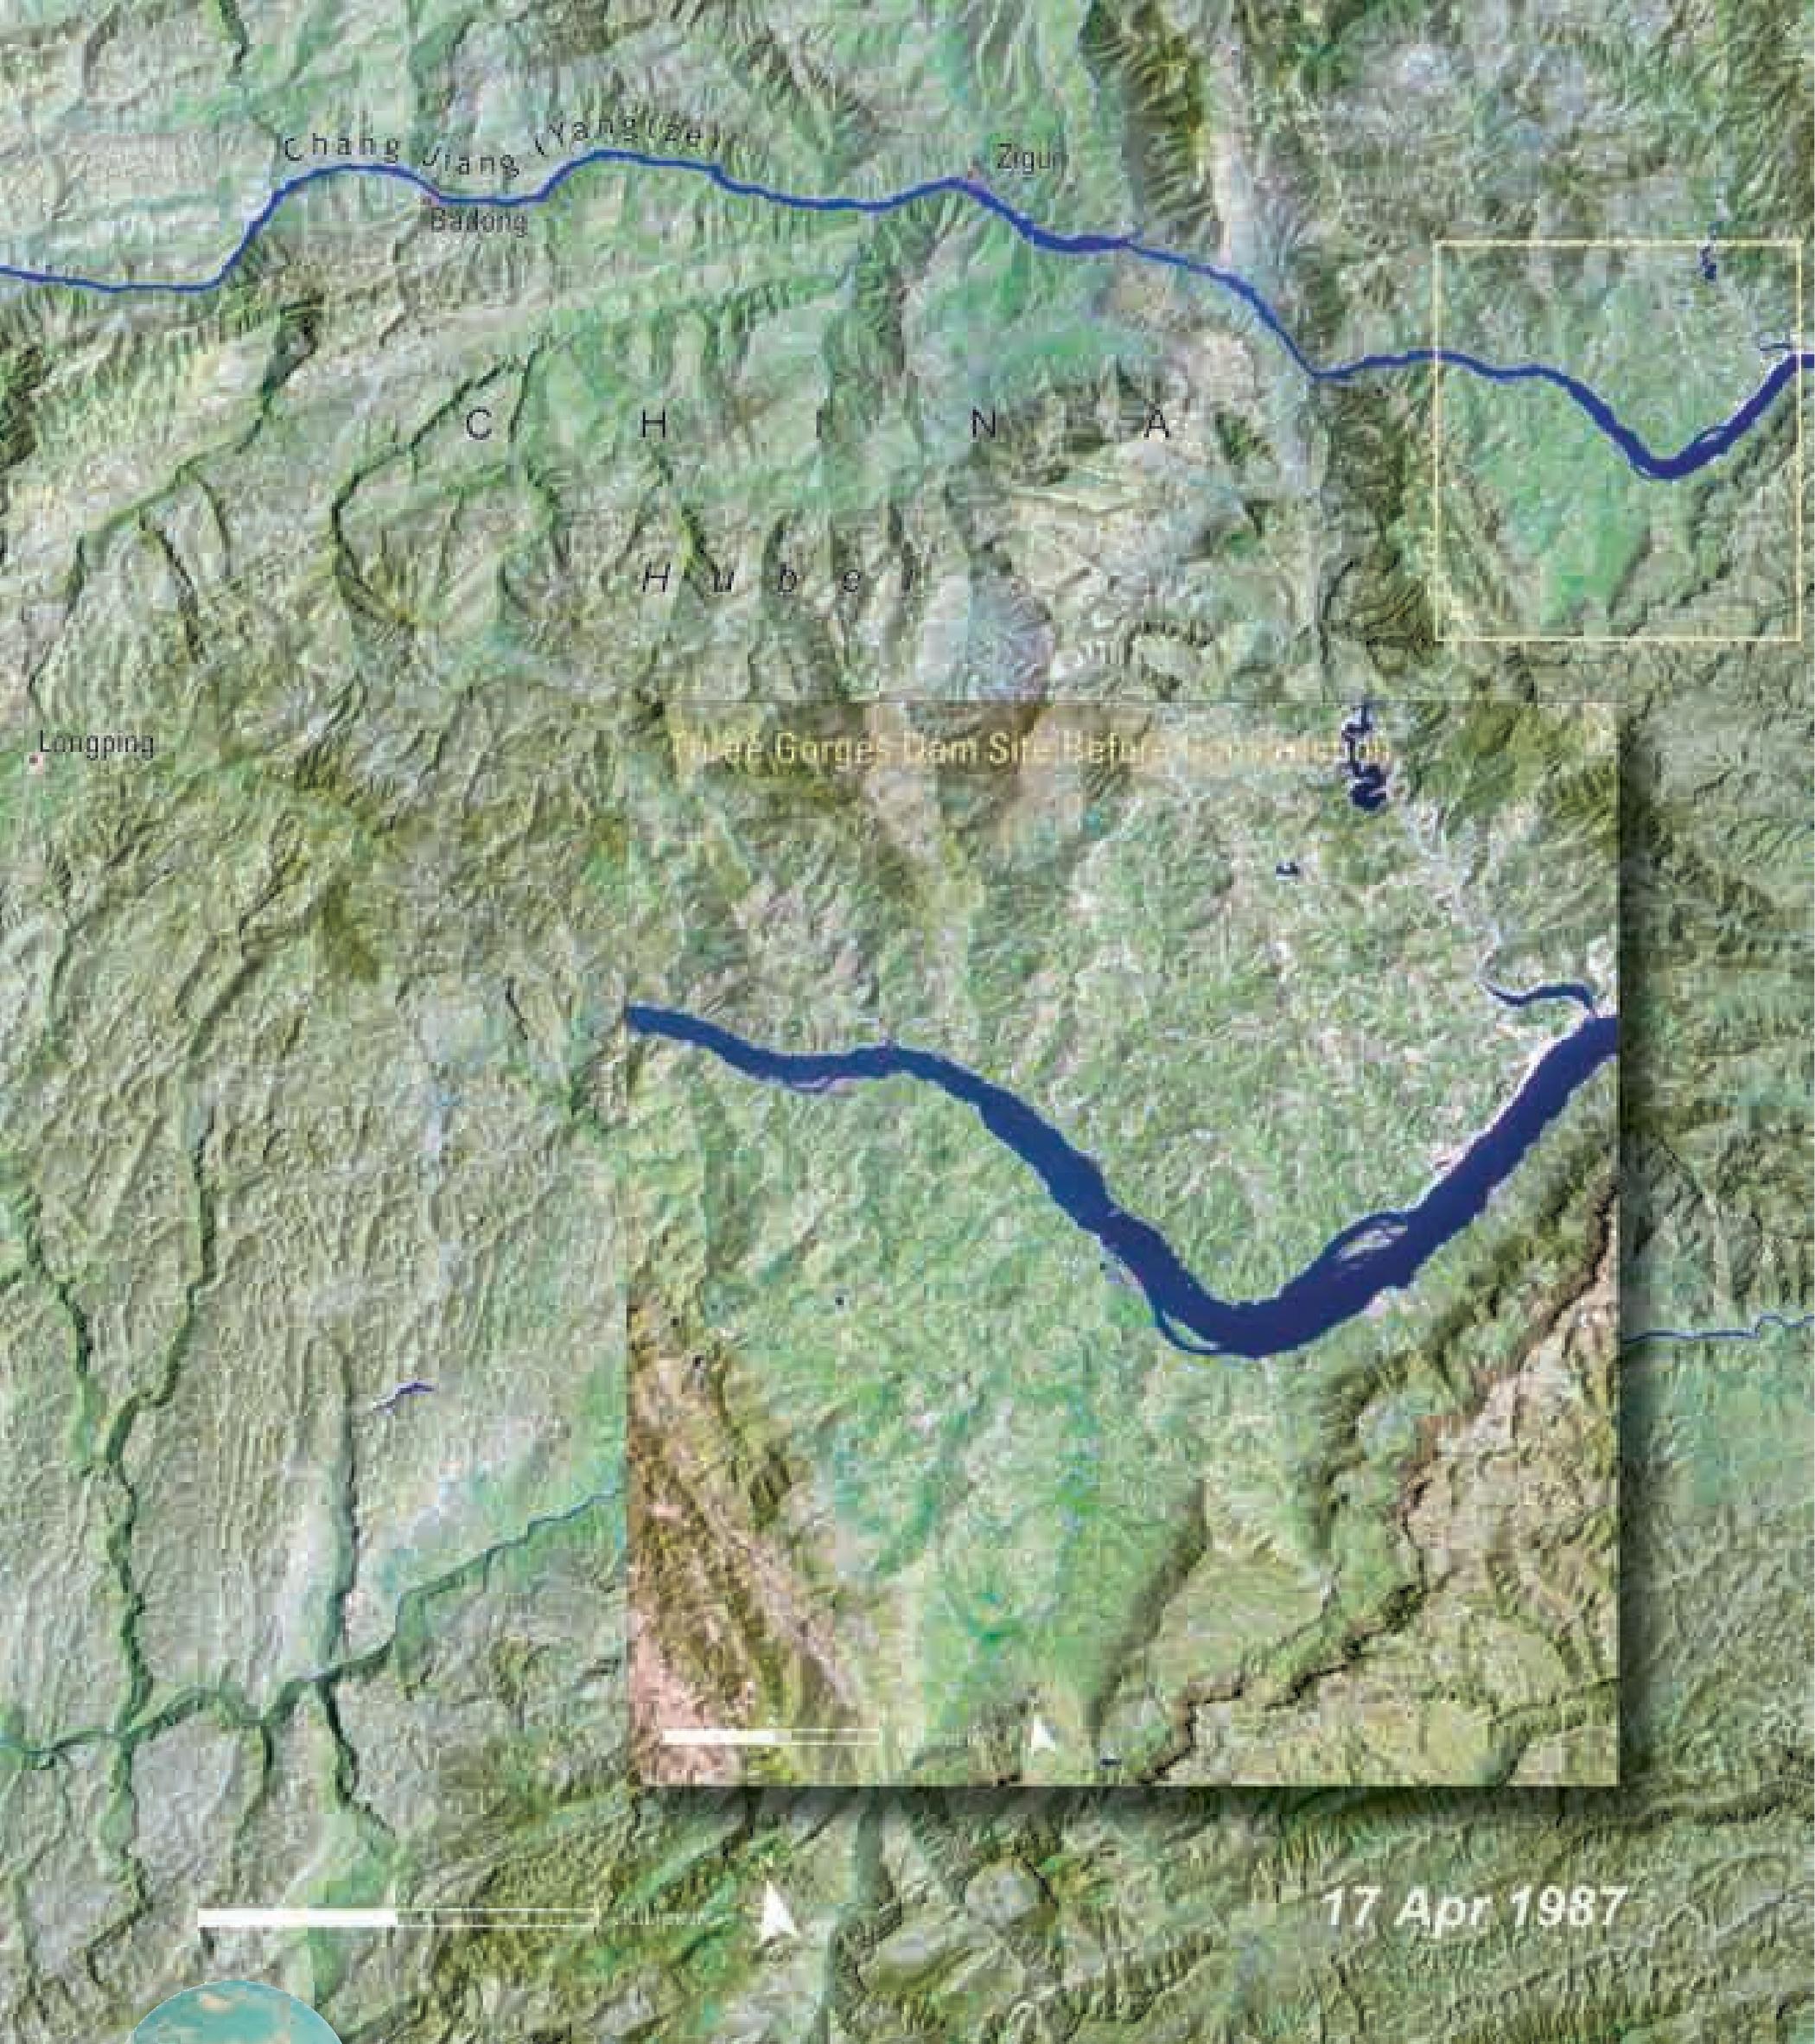
MESOPOTAMIA MARSHLANDS, IRAQ

This set of images provides a synoptic illustration of the changes. While the 1973 image (inset left) shows the extent of the original marshlands, the 2000 image (inset right) reveals the area after being drained, with most of the wetlands having disappeared. On the other hand, the 2004 image illustrates recovery in progress with major portions in the central and western sections having been restored to some extent.

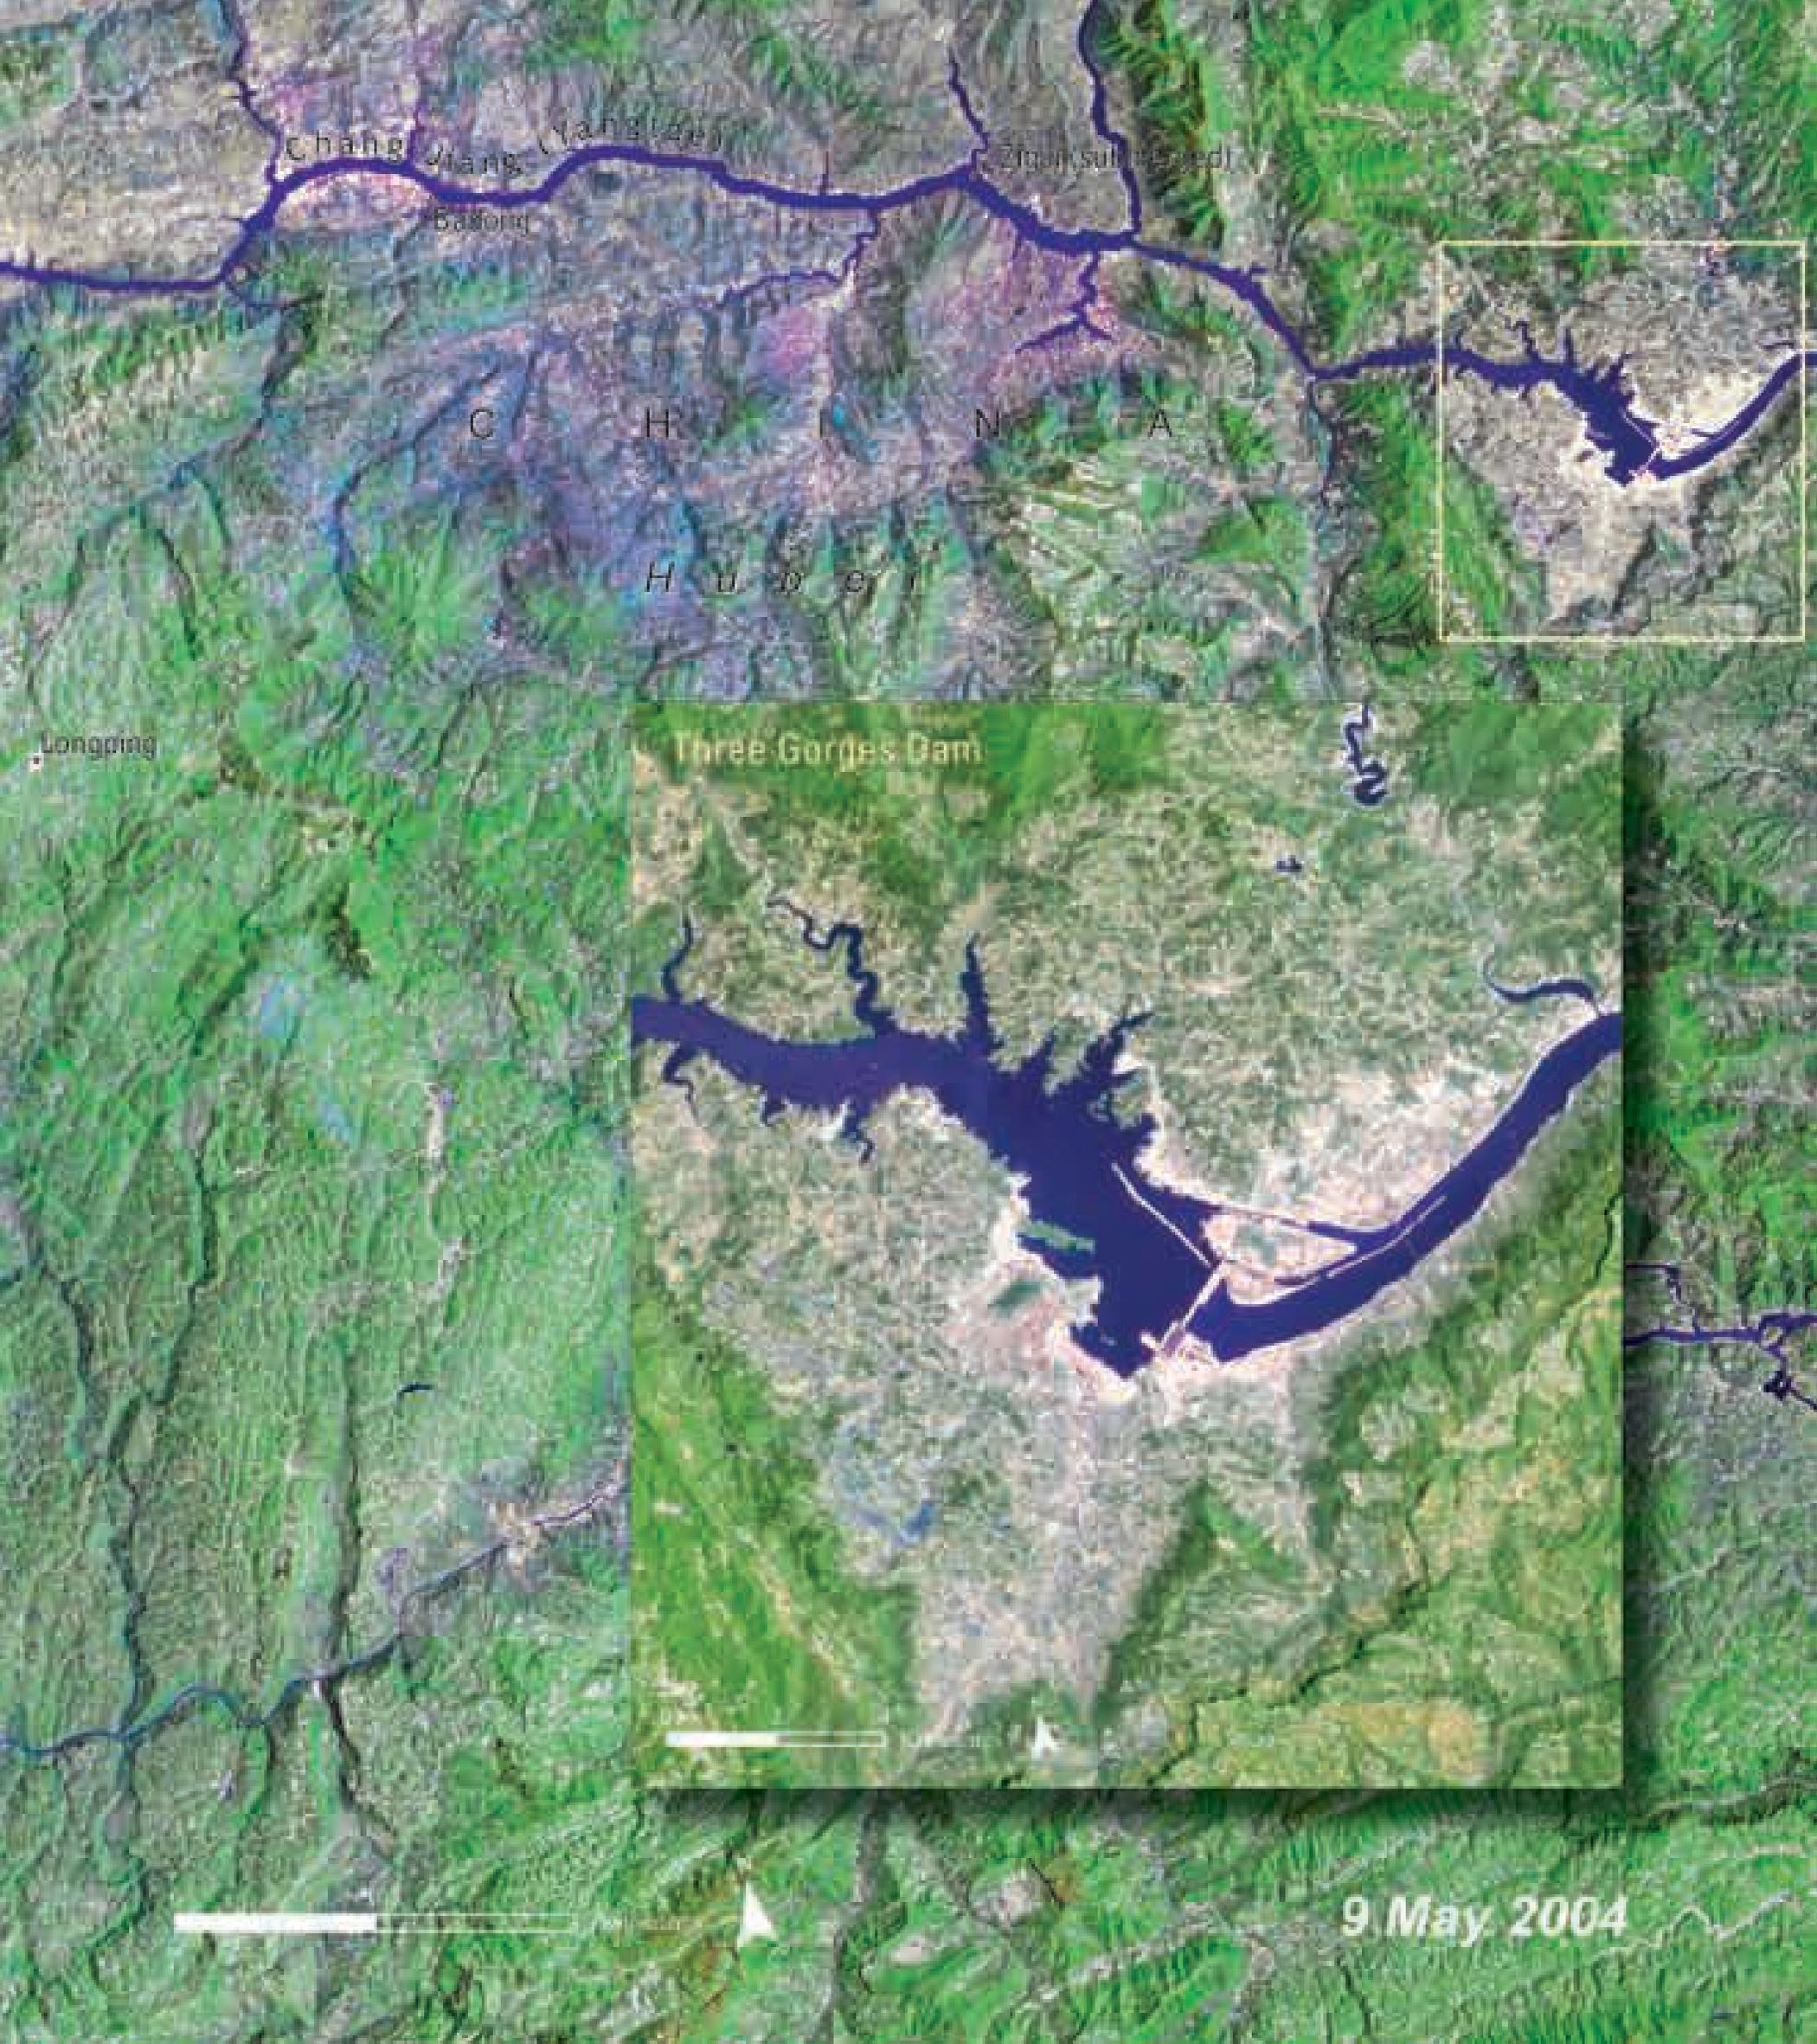
THREE GORGES DAM, CHINA

mergence of land along the river above the dam. The former village of Zigui (top center of image) has already been submerged.

The 1987 image shows the nature of the river and surrounding landscape before work on the dam was begun. In the May 2004 image, the enormous Three Gorges Dam is clearly visible, as is the reservoir of impounded river water that has been created behind it.
