3.2 Images of Change: Africa's Lakes

Africa's Killer Lakes

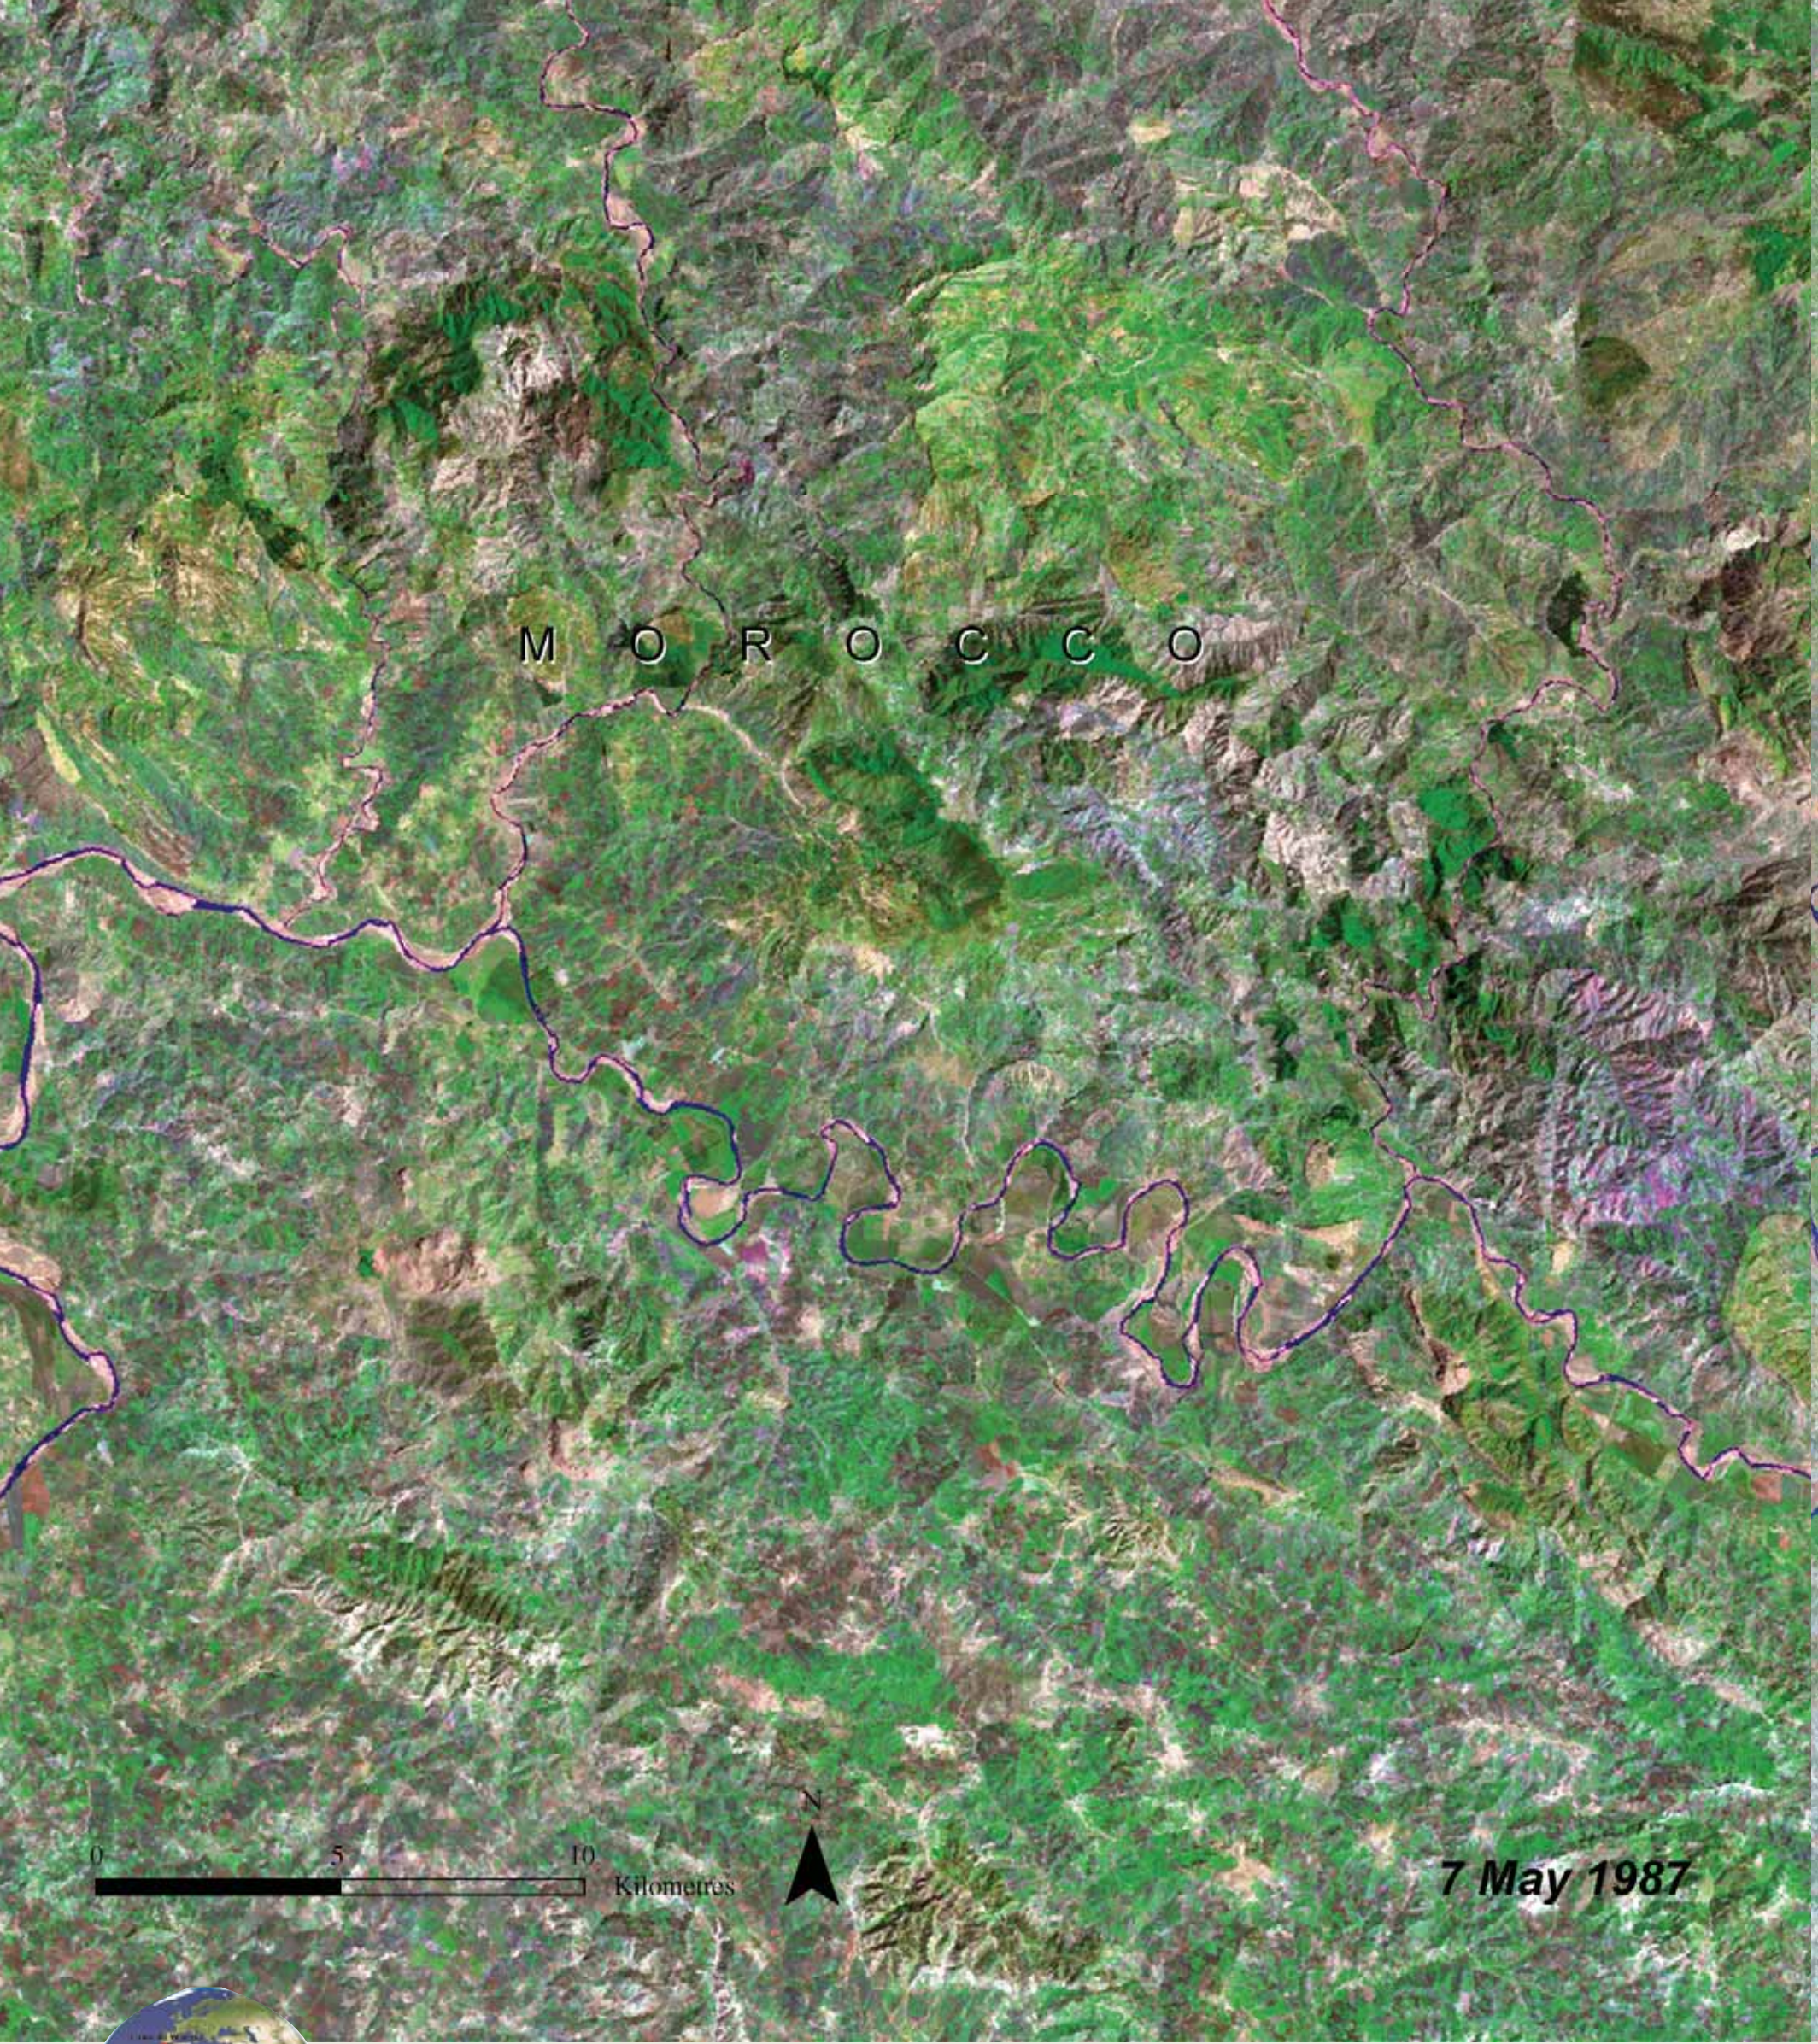
LAKE AL WAHDA

fallouts for social and economic development of the country. There are now 110 large dams in Morocco, with a storage capacity of 158 000 millions of m³. These two satellite images illustrate the change in land cover before and after the Al Wahda reservoir was constructed.

Morocco's Al Wahda reservoir is the largest in the El Abid Basin, with a capacity of 13 109 m³ (17 146 cubic yards). It is used for irrigation, electric power generation and drinking water supply.

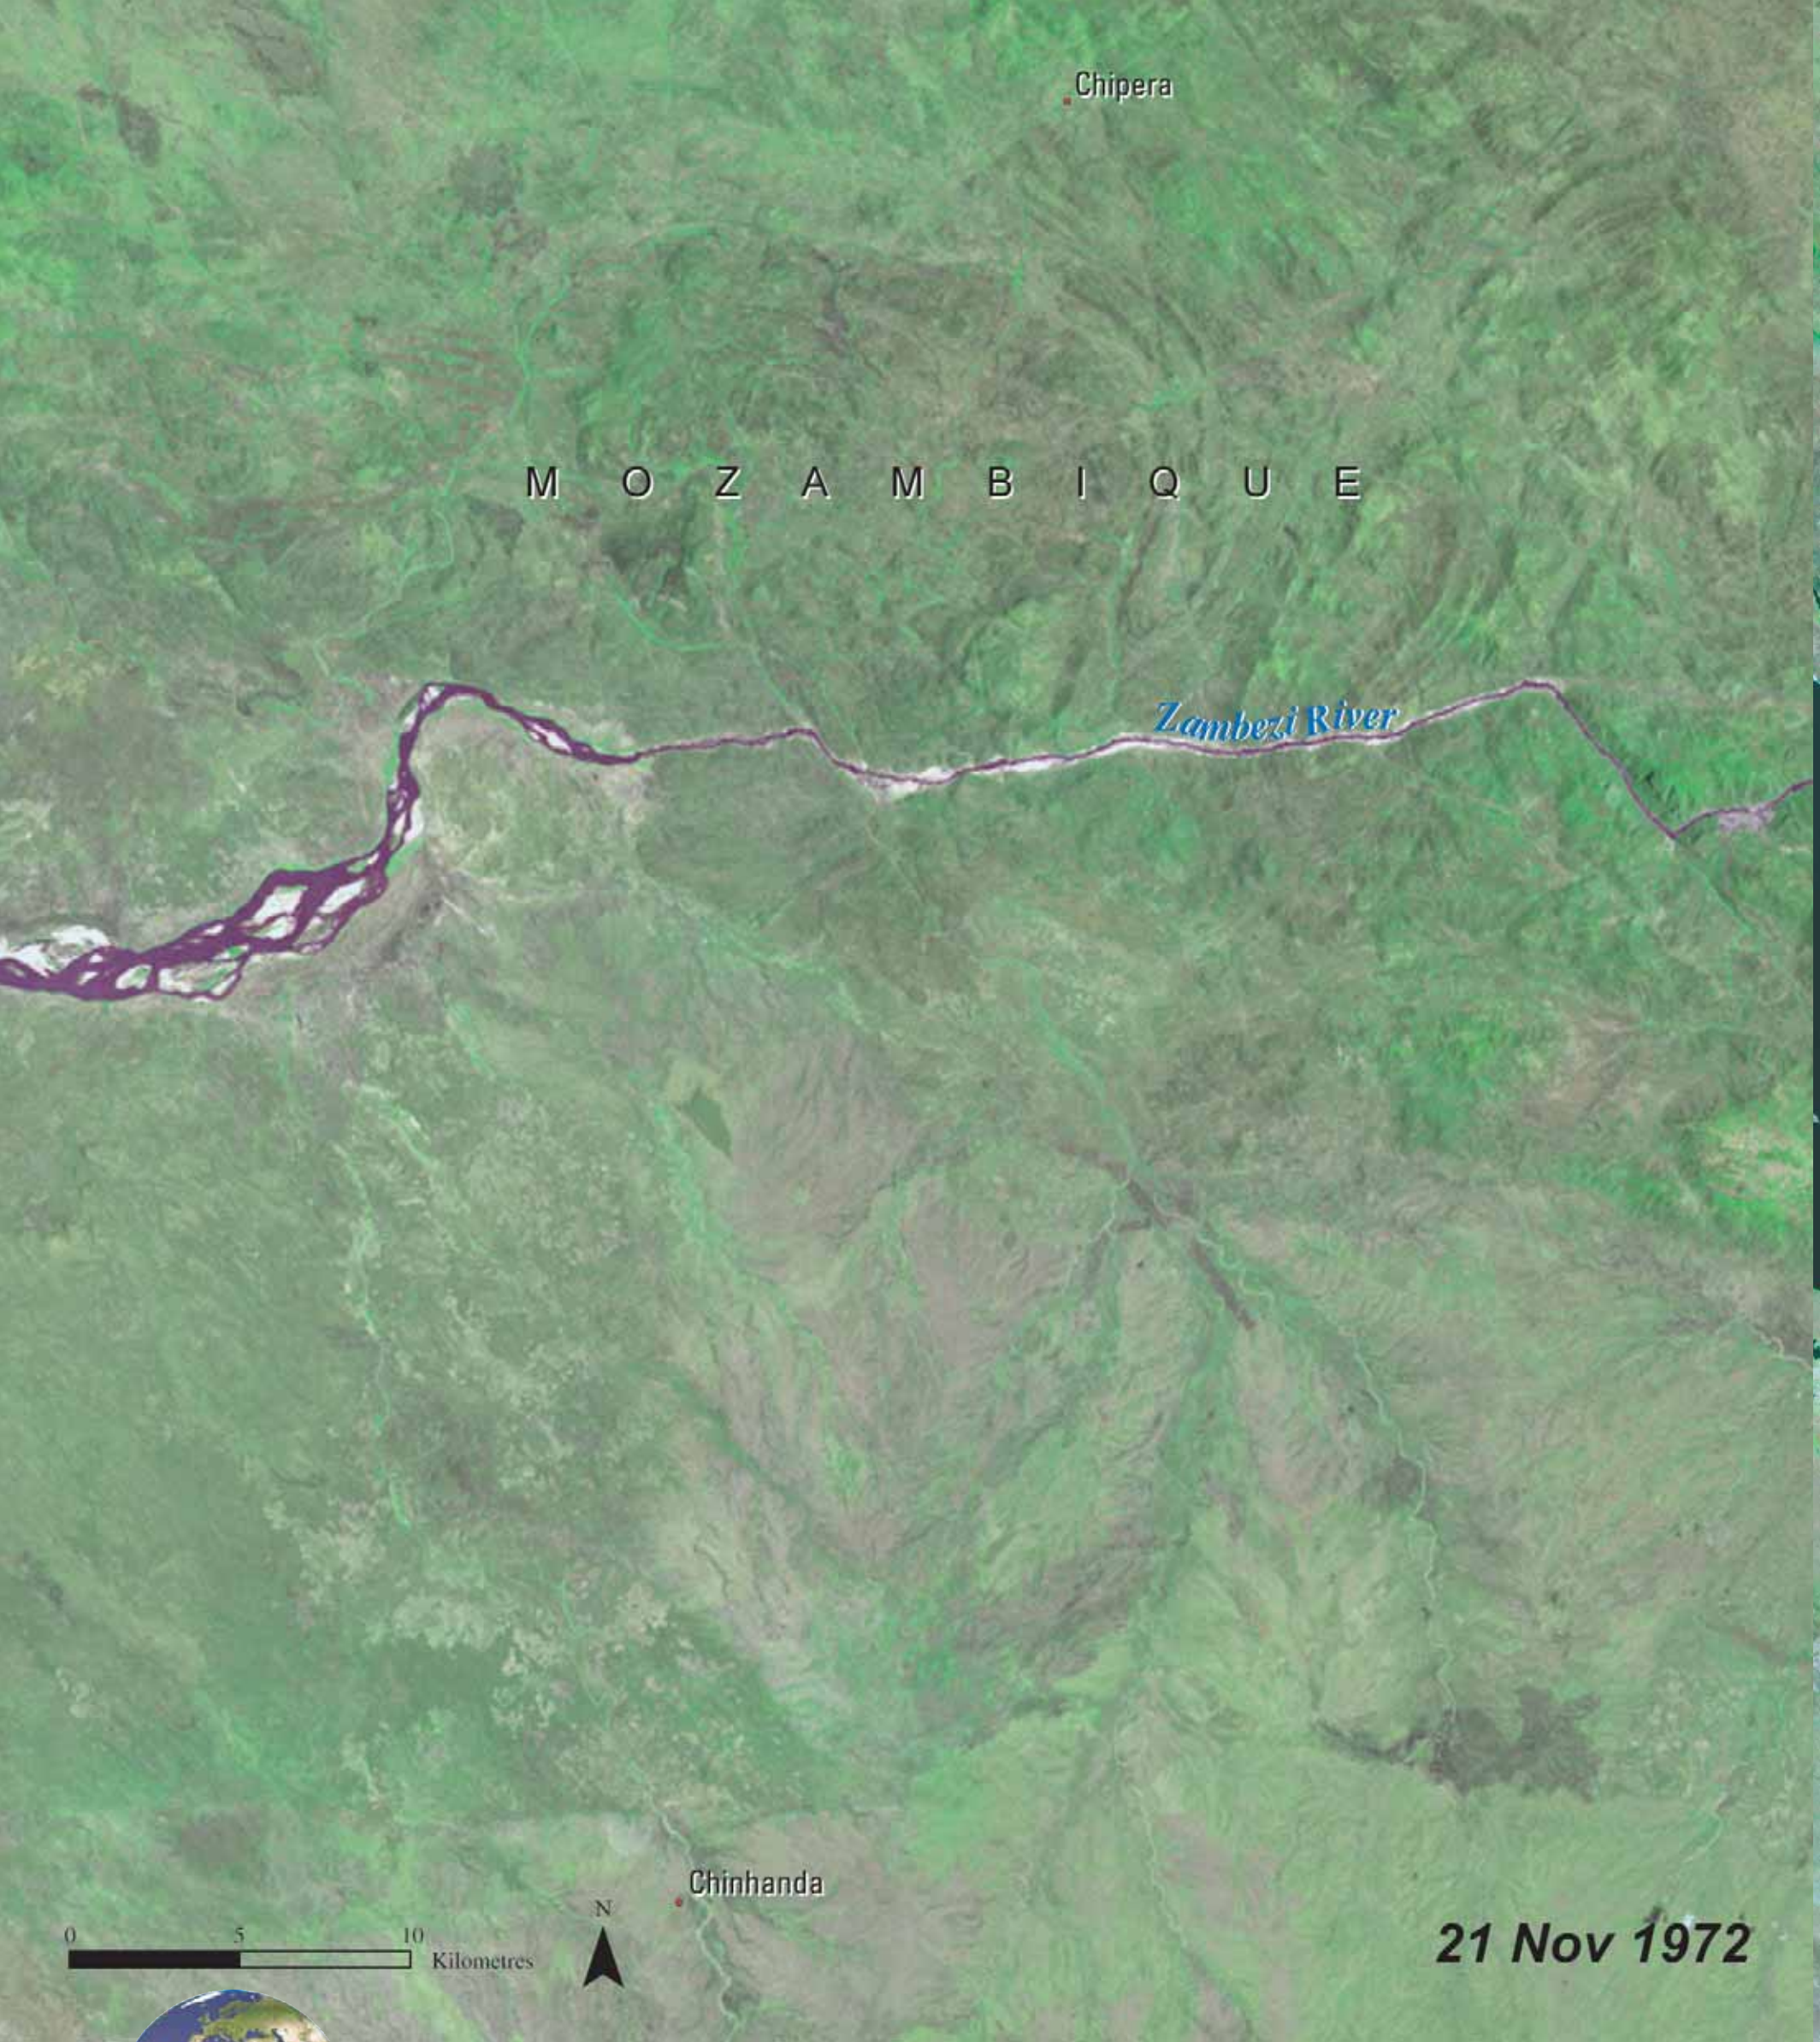
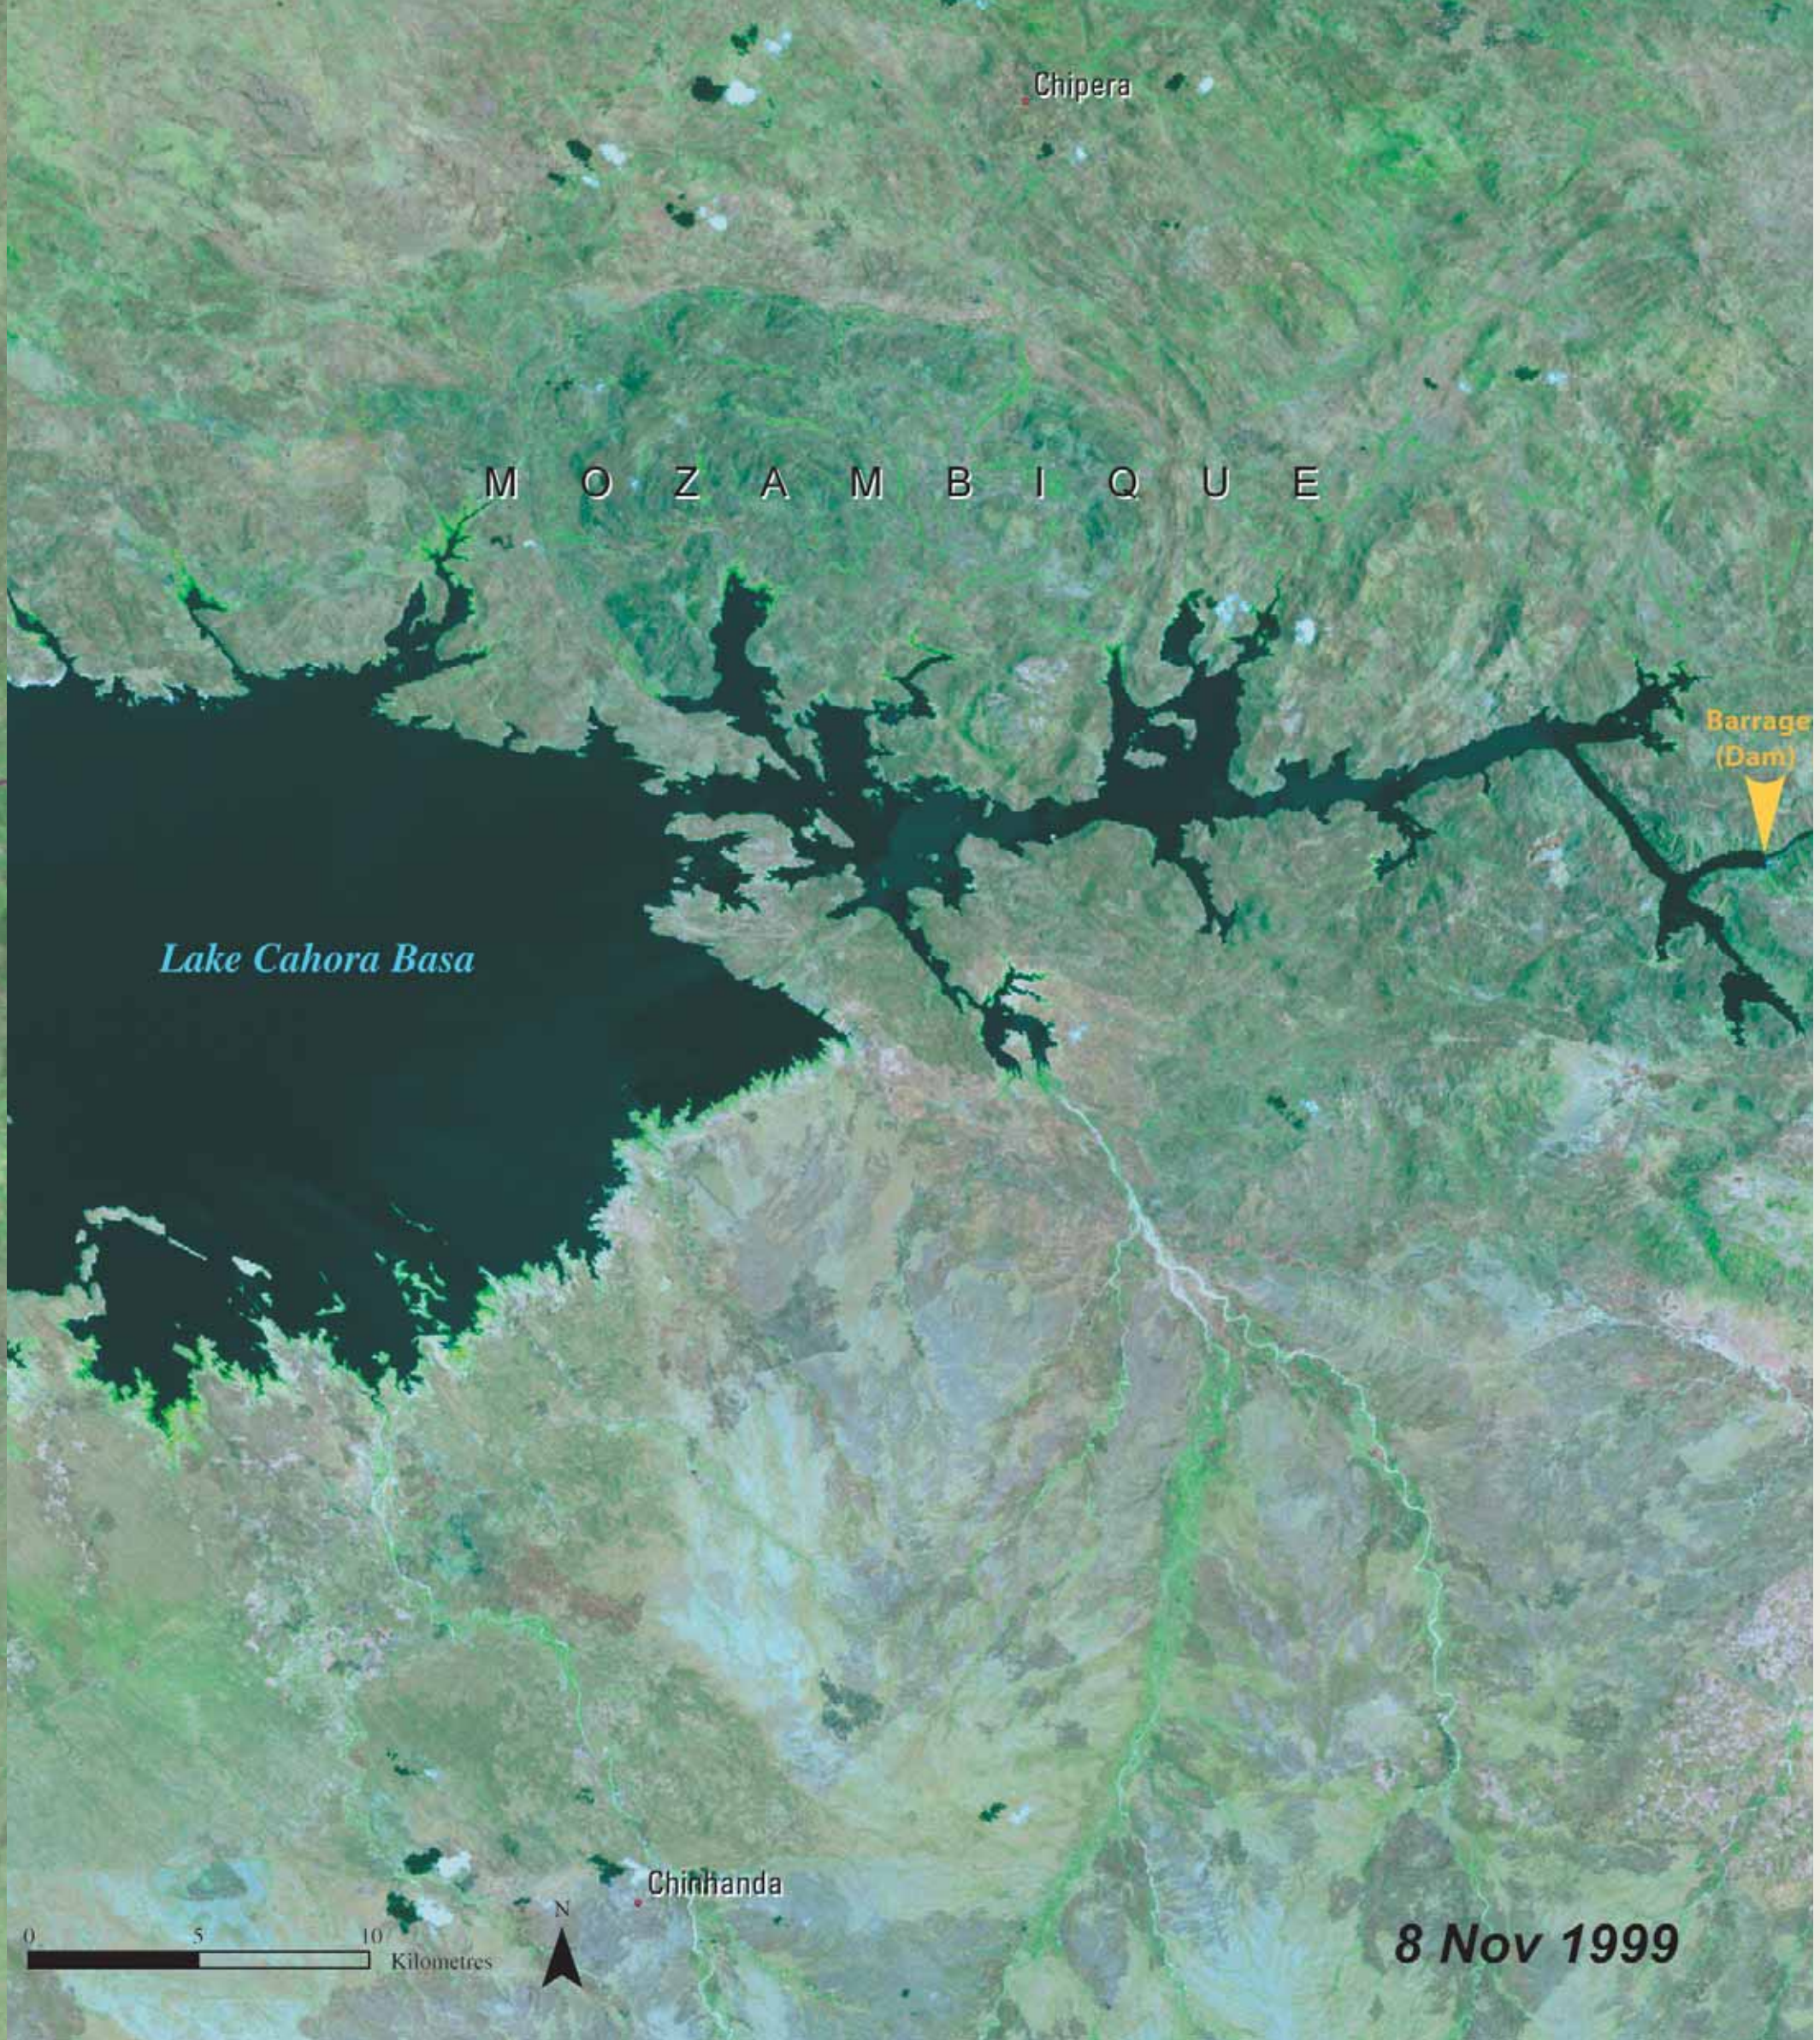
LAKE CAHORA BASA

Cahora Basa Reservoir in Tete Province of Mozambique is the site of the country's largest dam on the Zambezi River. These satellite images show spectacular changes in the Zambezi riverine system over the past three

decades. The 1972 image shows the Zambezi River a few years before the Cahora Basa Dam was constructed, while the 1999 image shows part of the enormous dam and the lake. The eastern/right tip of the river is visible in both images, entering into a narrow gorge, which provides an obvious location for a power-producing

barrage (dam) of this size. Although the construction of Cahora Basa was seen as a strategic move to meet the region's growing energy needs, it has also reduced the extent of annual flooding on the Zambezi River downstream—in turn reducing the size of the floodplains on which local communities grow their crops.
